93 DOC P4.0.A

Heritage Statement

Existing Windows

16 John Street, London, WC1
March 2015

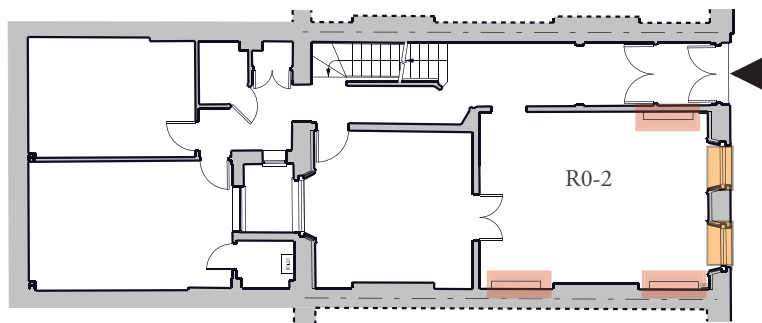
Ground Floor Plan showing original Georgian sashes (highlighted in orange) and radiators (highlighted in red) in the front living space R0-2.

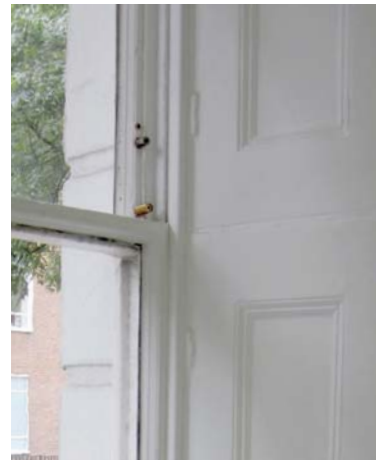
Original glazing bar without horns composes a refined and elegant window and is exemplary of the craftsmanship and quality of timber in the original sliding sashes.

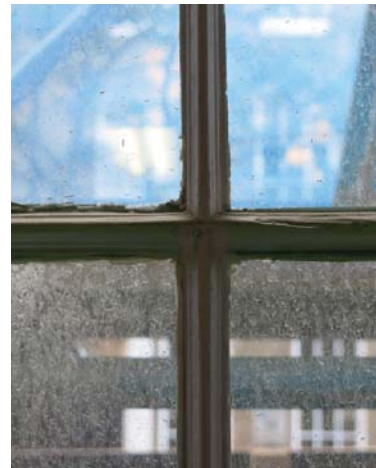
The profile of the 18mm broken lambs tongue glazing bars catches the light so as to accentuate their verticality and slenderness.

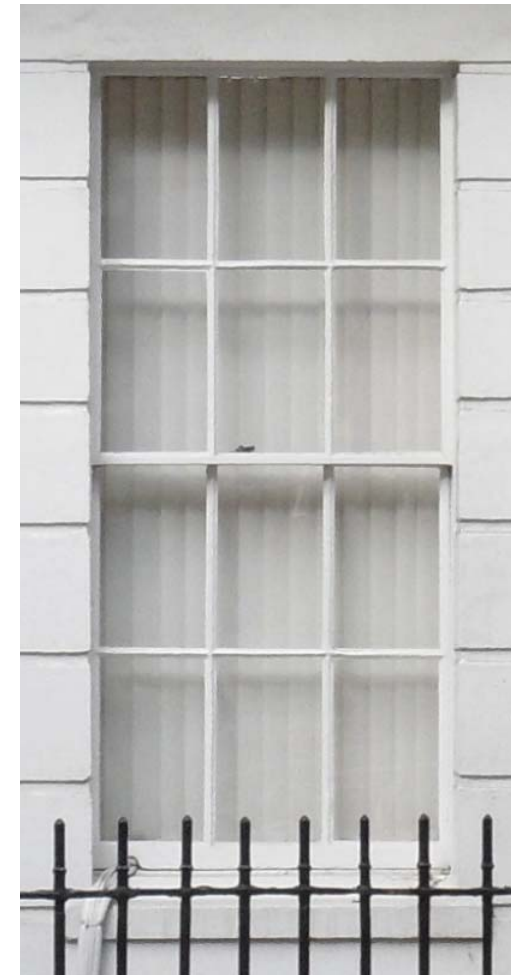
The fine glazing bars and mid-rail appear visually the same, with only a few millimetres difference in their width.

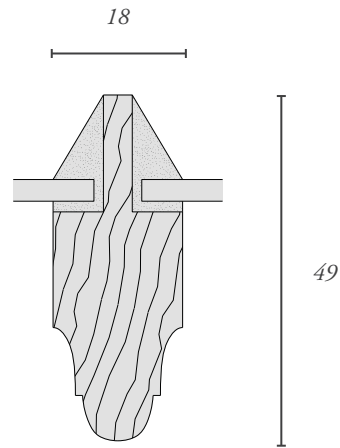
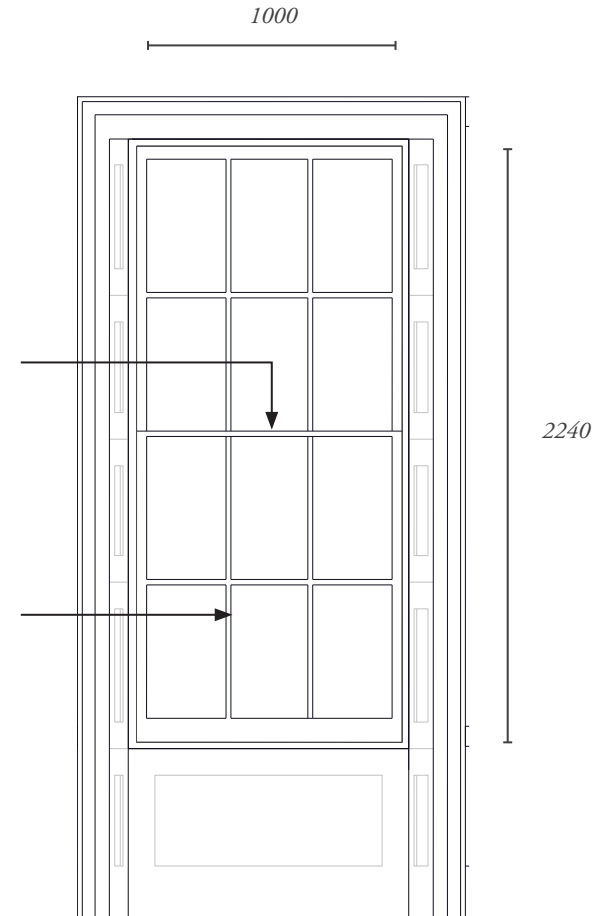
The interior elevation and glazing bar detail of one of the existing original sliding sashes (below) shows the refined detailing of the glazing bar and elegant elevation that results. These particular details distinguish the original windows from the other later replacements in the building and carry high architectural and historical significance.

18mm original broken lambs tongue glazing bar adds to the refined aesthetic of the sliding sashes.

Original 20mm mid-rail without horns reveals the quality of Georgian craftsmanship and strength of original timber.

Original 18mm broken lambs tongue glazing bars. Significant to the property as the only glazing bars to show the cultural and aesthetic values of the original Georgian architecture.

Interior elevation of one of the original windows.

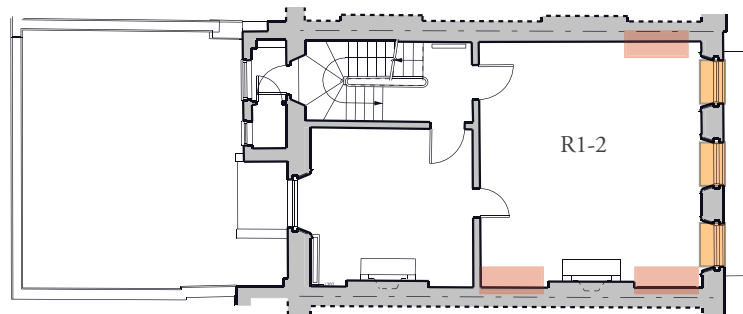
First Floor Plan showing Victorian-style sashes (highlighted in orange) and radiator (highlighted in red) in the front living space R0-2.

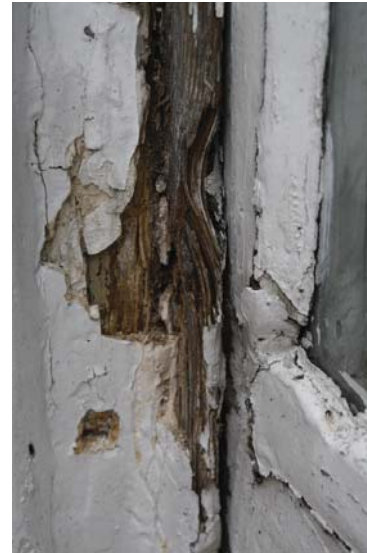
Severe damage to the skirting due to moisture ingress through the sill.

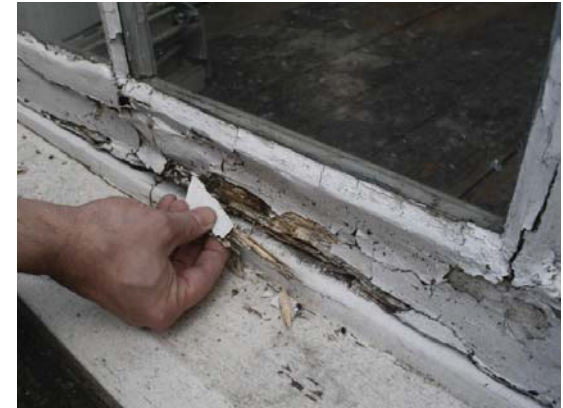
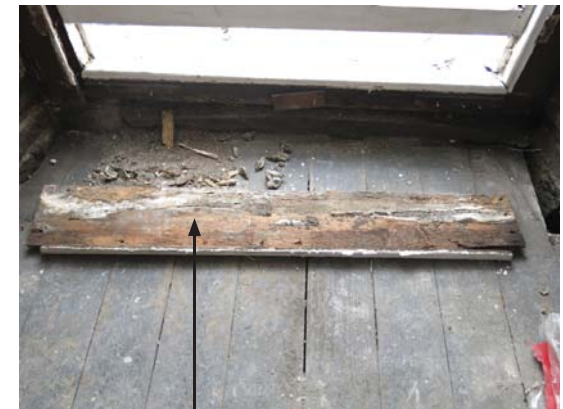
The condition of the windows is also of concern. The bottom rails of the lower sashes show signs of extensive rot due to moisture penetration, as evidenced in the accompanying photos (right).

These photographs show the extensive degree of rot on the bottom rail of the lower sliding sash and sill.

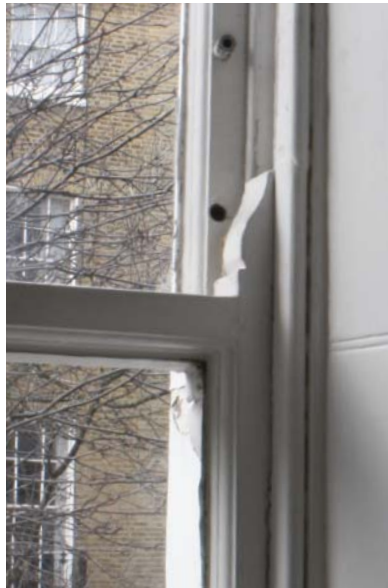
An example of one of the horned, wide mid-rails, which differ greatly from the original windows on the ground floor (shown on page 4).

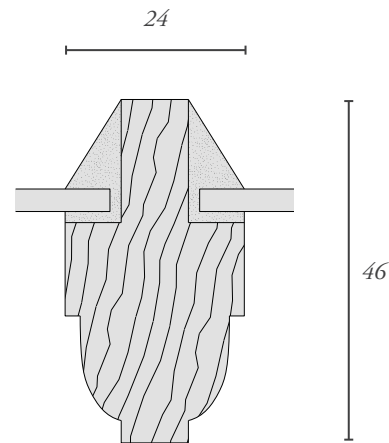
Non original fillet and ovolo glazing bars, 6mm wider than the broken lambs tongue profile on the original sashes.

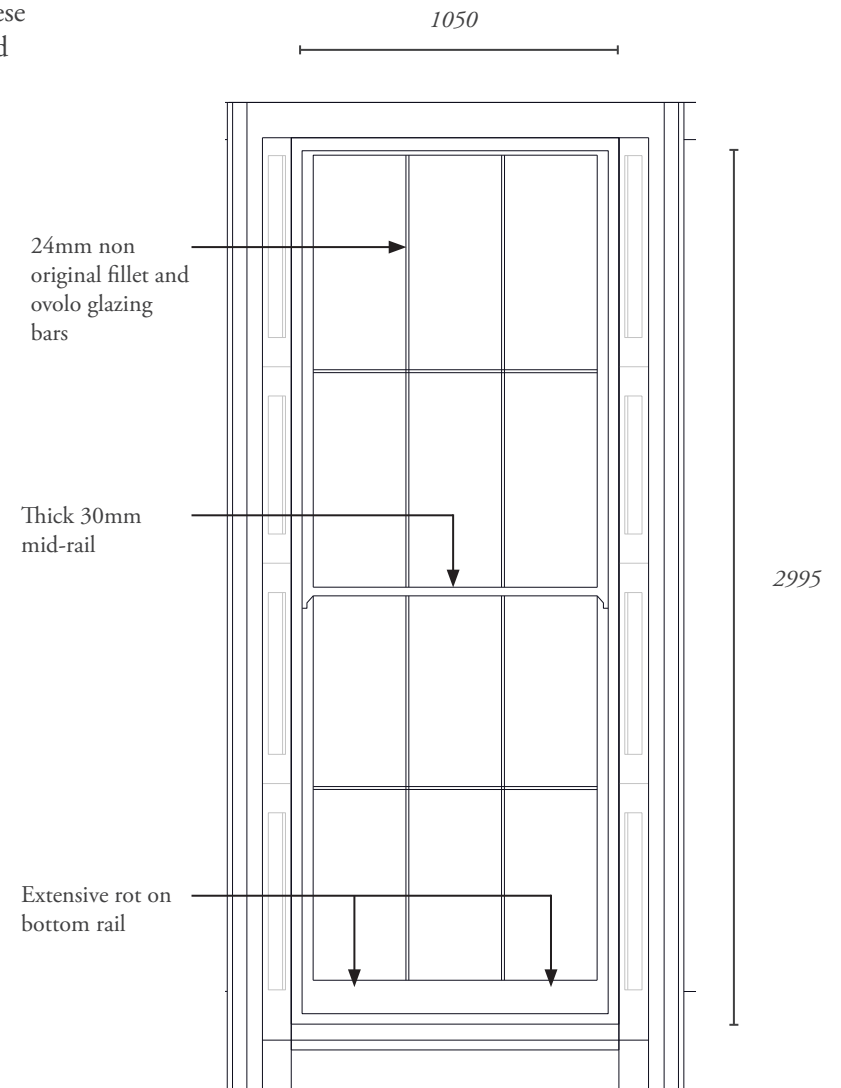
The interior elevation and glazing bar detail of one of the first floor front windows (below) shows the comparatively unrefined detailing of the glazing bar and stocky elevation that results. These details are more typical of the Victorian era and detract from the buildings overall historic and architectural value.

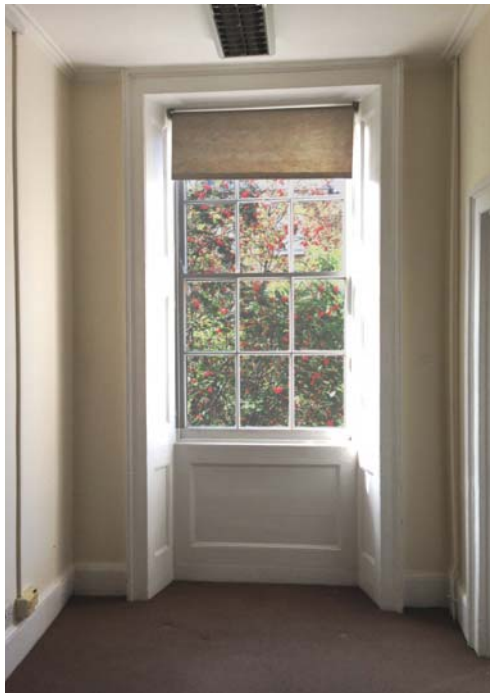
First floor front windows viewed from interior showing wide glazing bars and mid-rails that are much less fine visually than the Georgian originals.

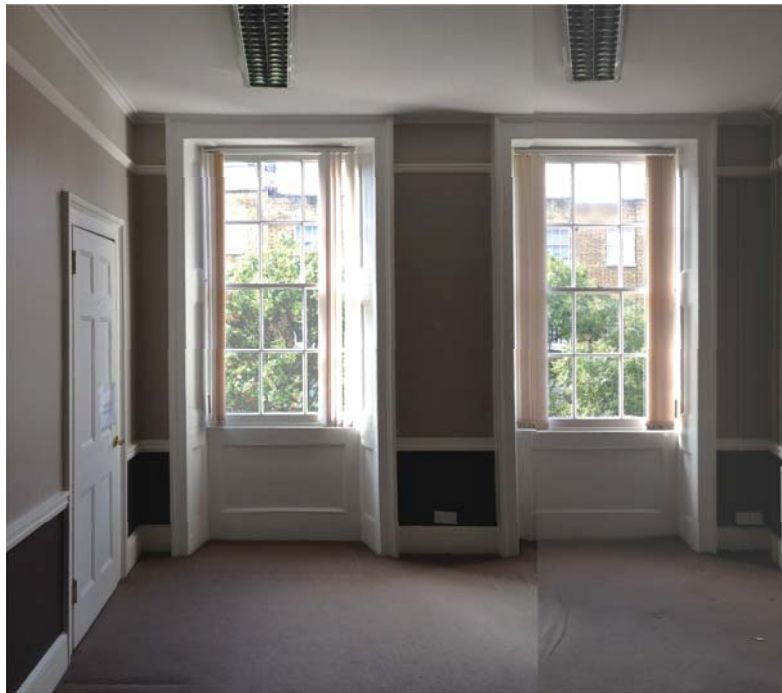
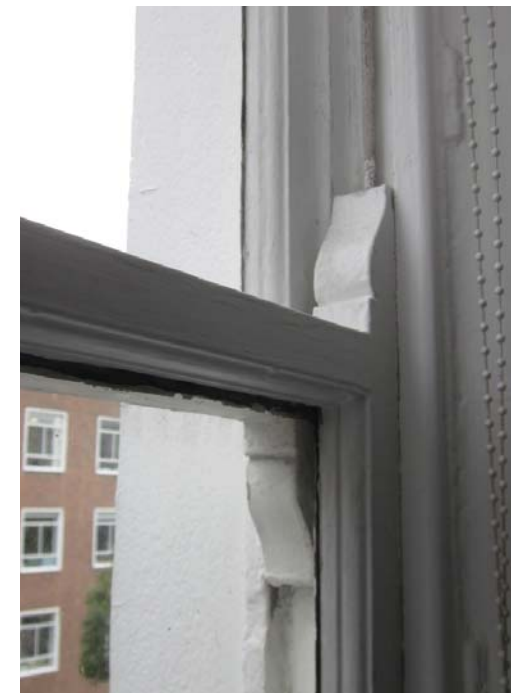
Detail of second floor front window showing the thick mid-rail with horns on both the upper and lower sliding sashes fillet and ovolo glazing bars in the Victorian-style.

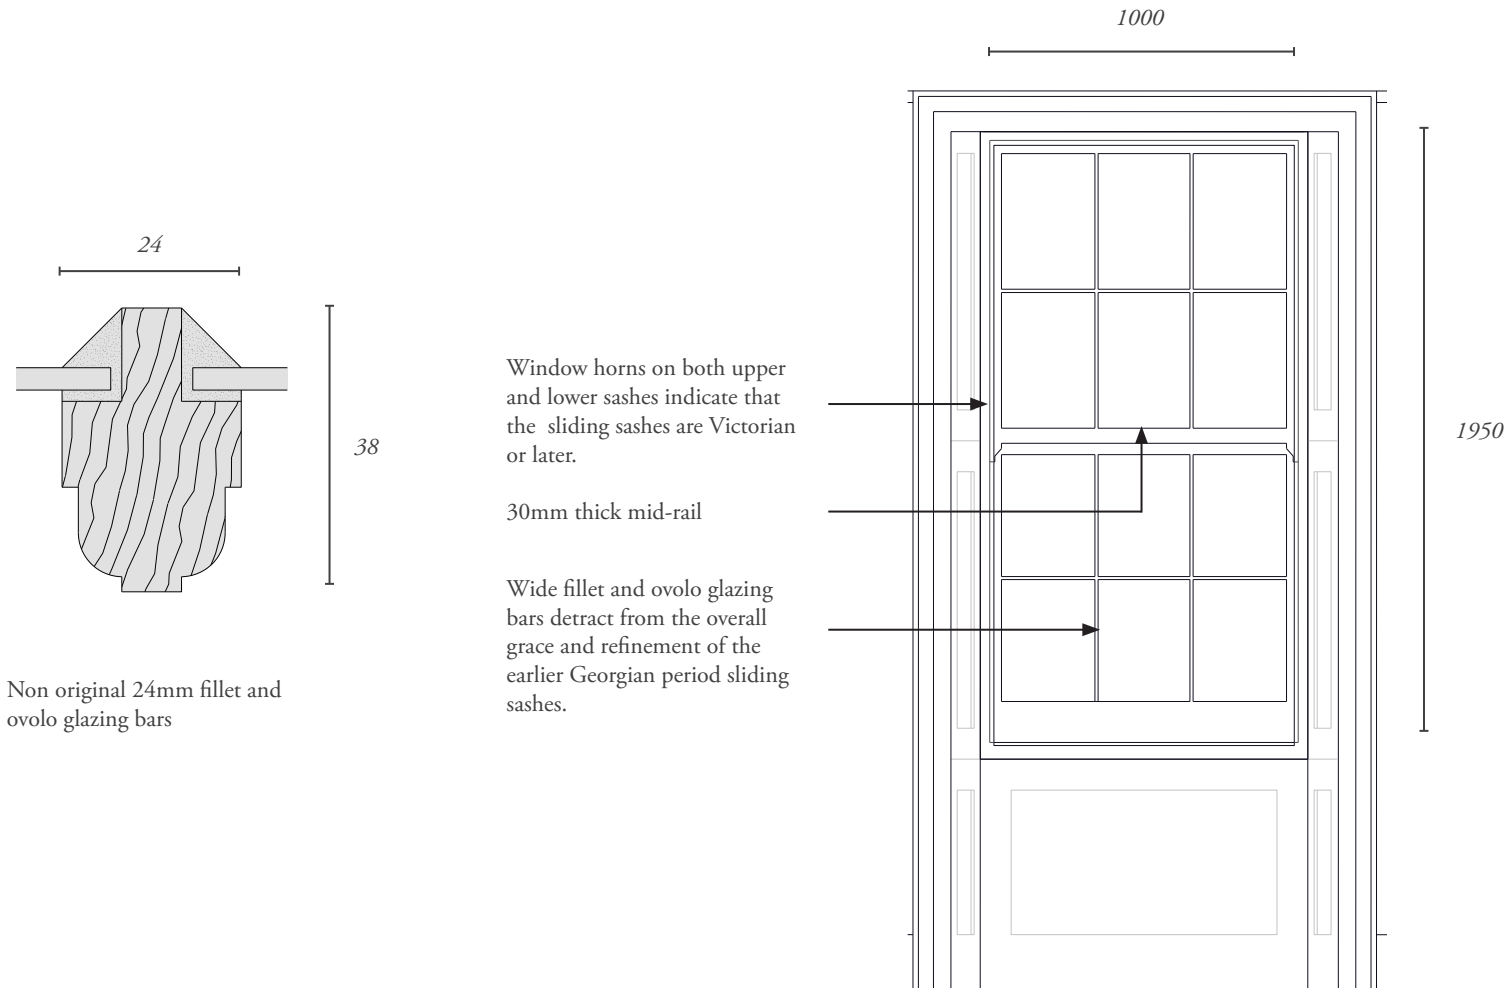
The interior elevation and glazing bar detail of one of the second floor front windows (below) shows the wide, horned mid-rail in the Victorian style, which create a stocky appearance in elevation and detracts from the original elegant detailing of the Georgian building.

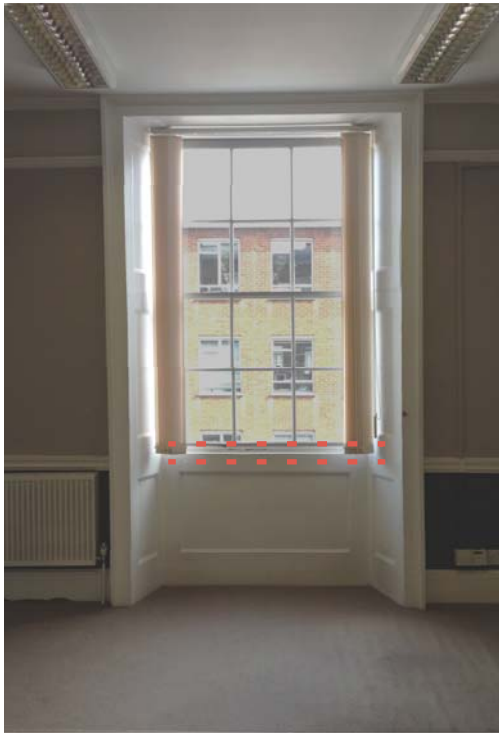
The sliding sash also shows signs of extensive rot on the bottom rail, that should be appropriately addressed to preserve the condition of the building.

Second floor rear sash window viewed from interior highlighting the rot on the bottom rail.

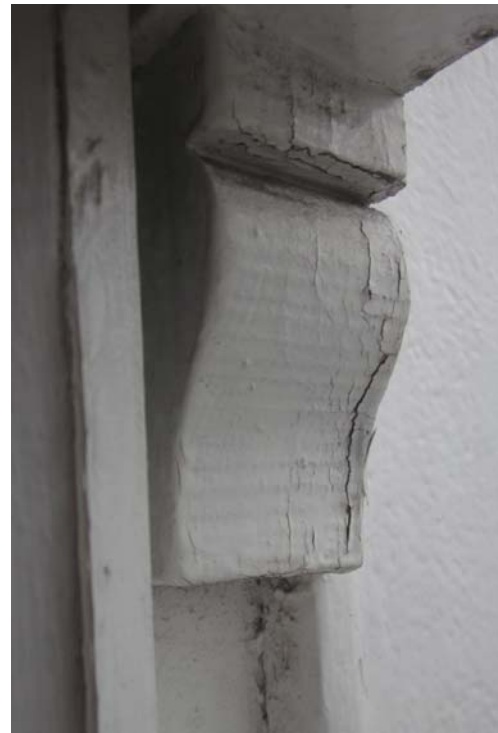
Mirroring the second floor front sliding sashes, the rear window uses the same 24mm fillet and ovolo glazing bars and features a wide mid-rail with horns. There are also signs the horns have been machine worked, further indicating that these windows are a later addition to the Georgian building.

An example of one of the horns on the upper sash, which are in the Victorian style and show signs of having been machine worked.

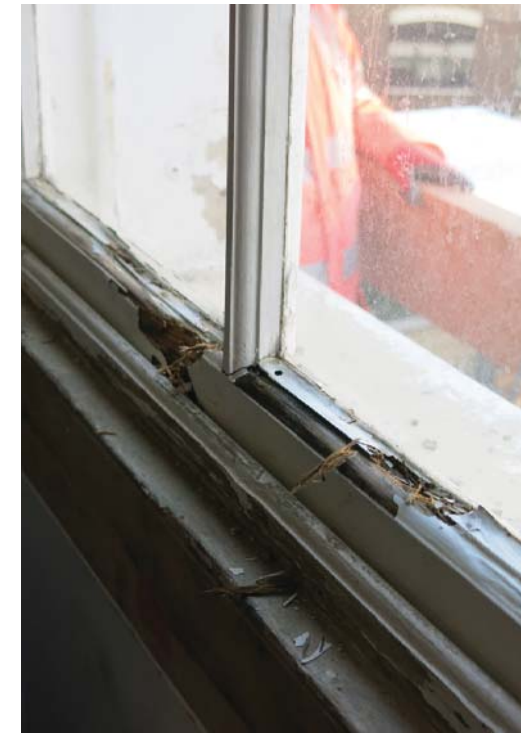
Extensive rot on bottom rail requires addressing for the health of the building and its occupants.

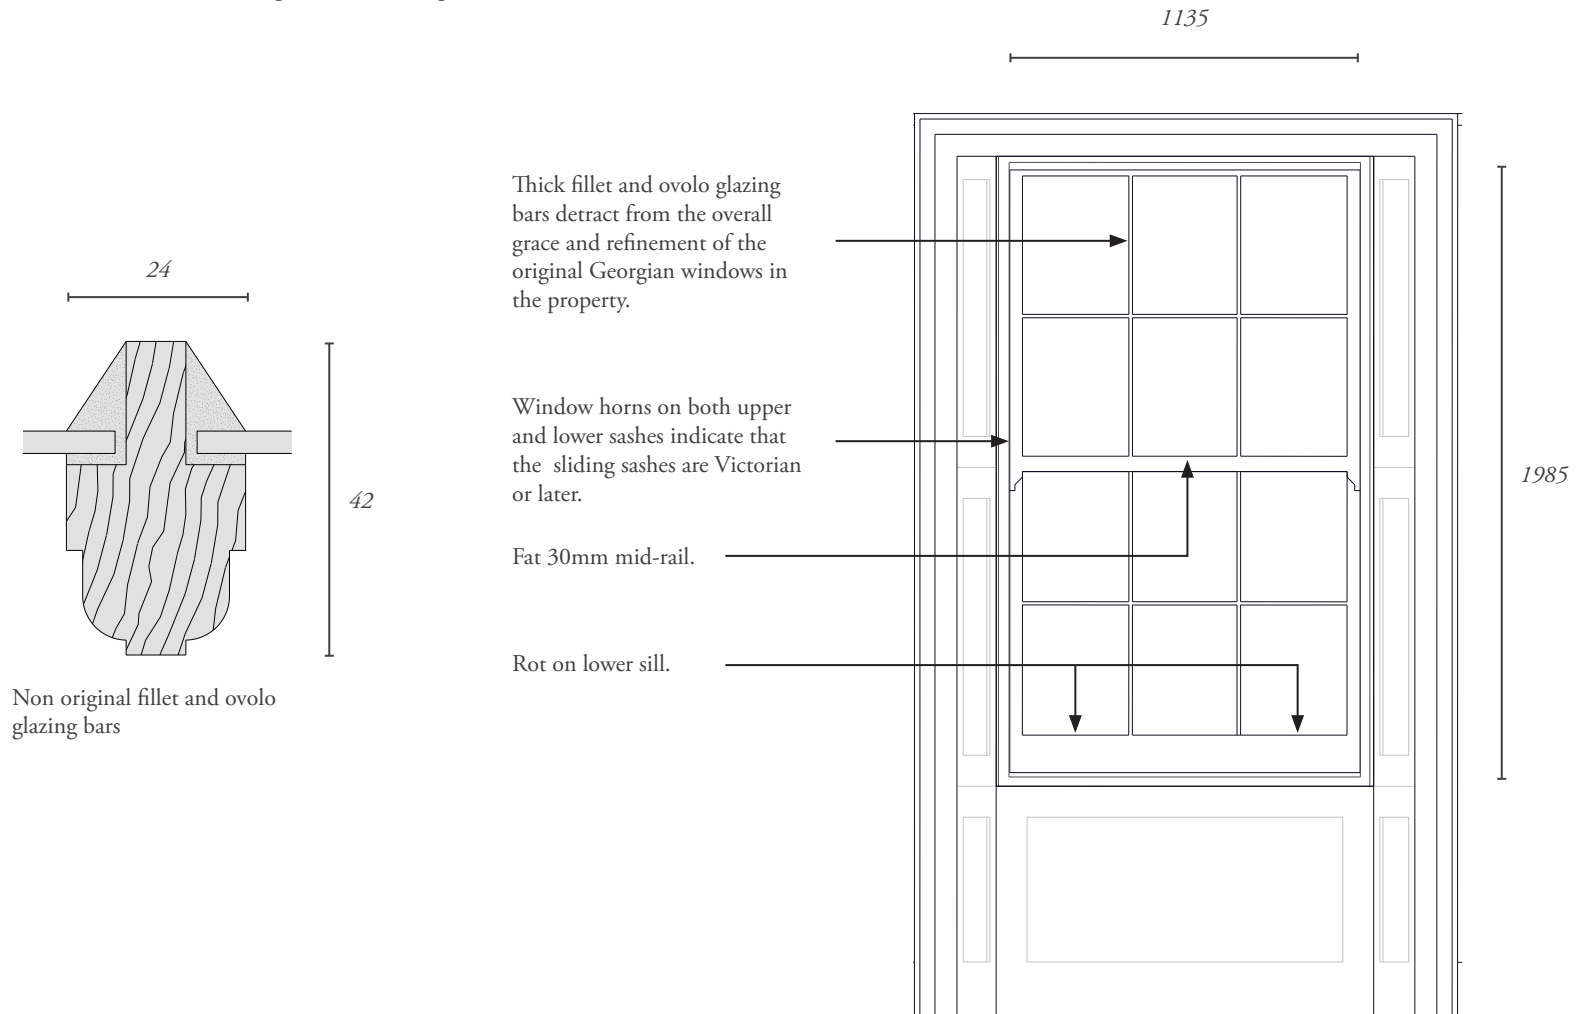
The existing window elevation and glazing bar detail of second floor rear sliding sash shows typical features of the Victorian period, with thick glazing bars, mid-rail and horns. These non-original features detract from the heritage of the Georgian architecture.

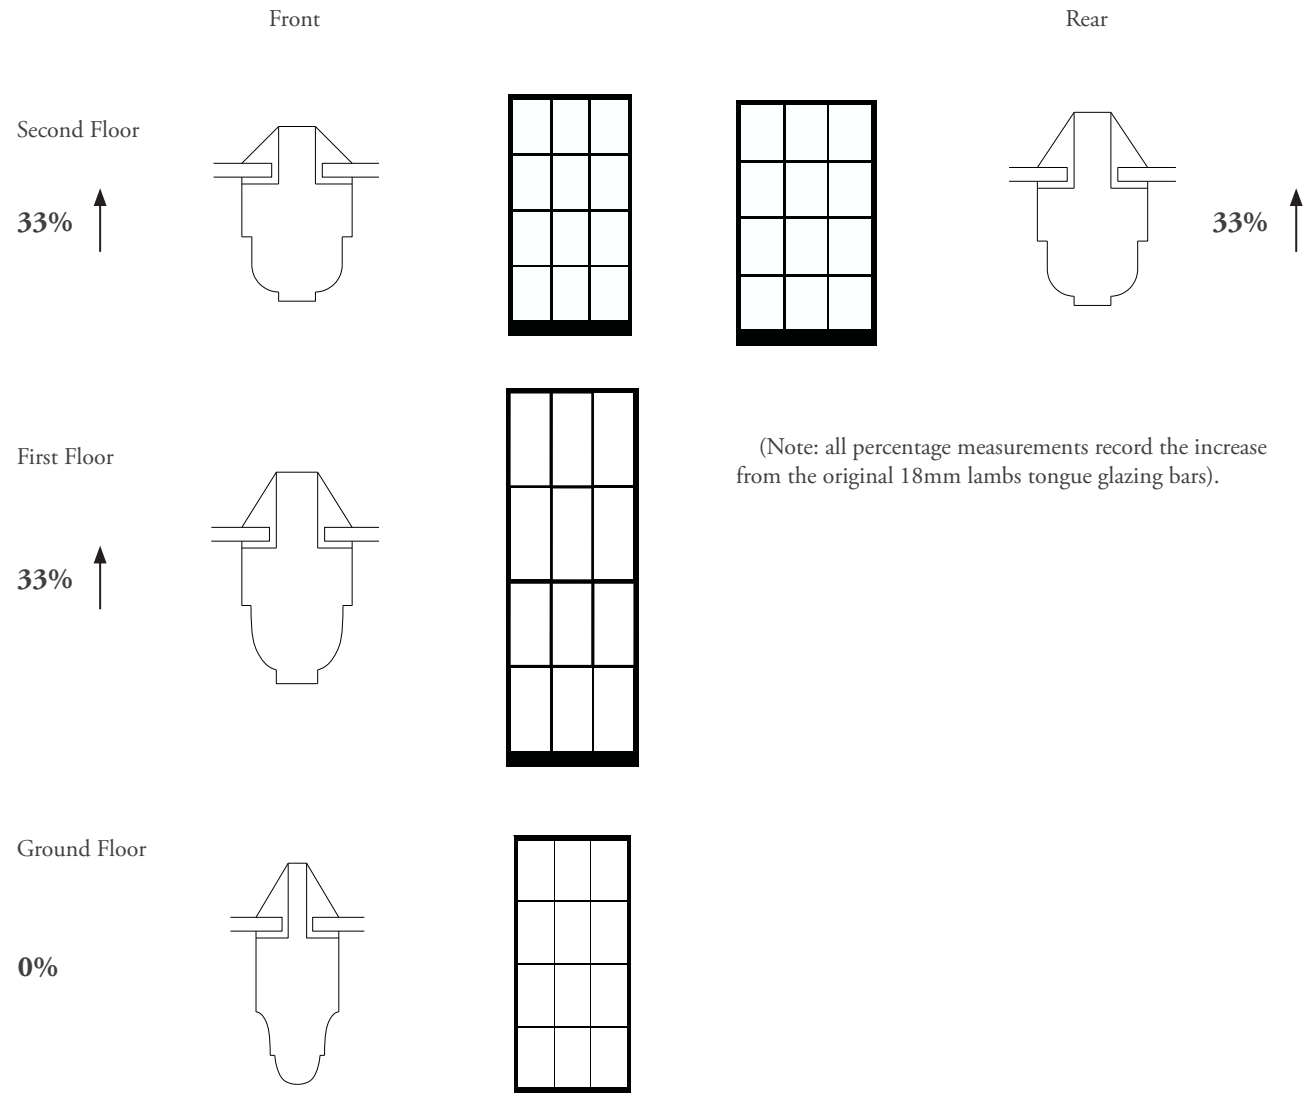
This page illustrates the visual difference between the original and sliding sashes on the ground floor and later windows on the first and second floor.

It also clearly illustrates the significant percentage increase in frame that results from the non-original glazing bars, when compared with the original.

The 33% increase in frame cover not only detracts from the original Georgian architectural principles to which this building was designed but also reduces the amount of daylight available to occupants.
