TREE SURVEY, ARBORICULTURAL  
IMPLICATION ASSESSMENT &  
METHOD STATEMENT &  
TREE PROTECTION PLAN  
BS5837:2012

Title:	<b>Arboricultural Report</b>
Instructed by:	Felix Xylander 25 Hatton Garden London EC1N 8BQ
Site Address:	Christchurch Primary School Christchurch Hill London
Date of Site Visit:	Wednesday 13 <sup>th</sup> August 2014
Prepared by:	Reuben Hayes
Ref:	PA.S
Date

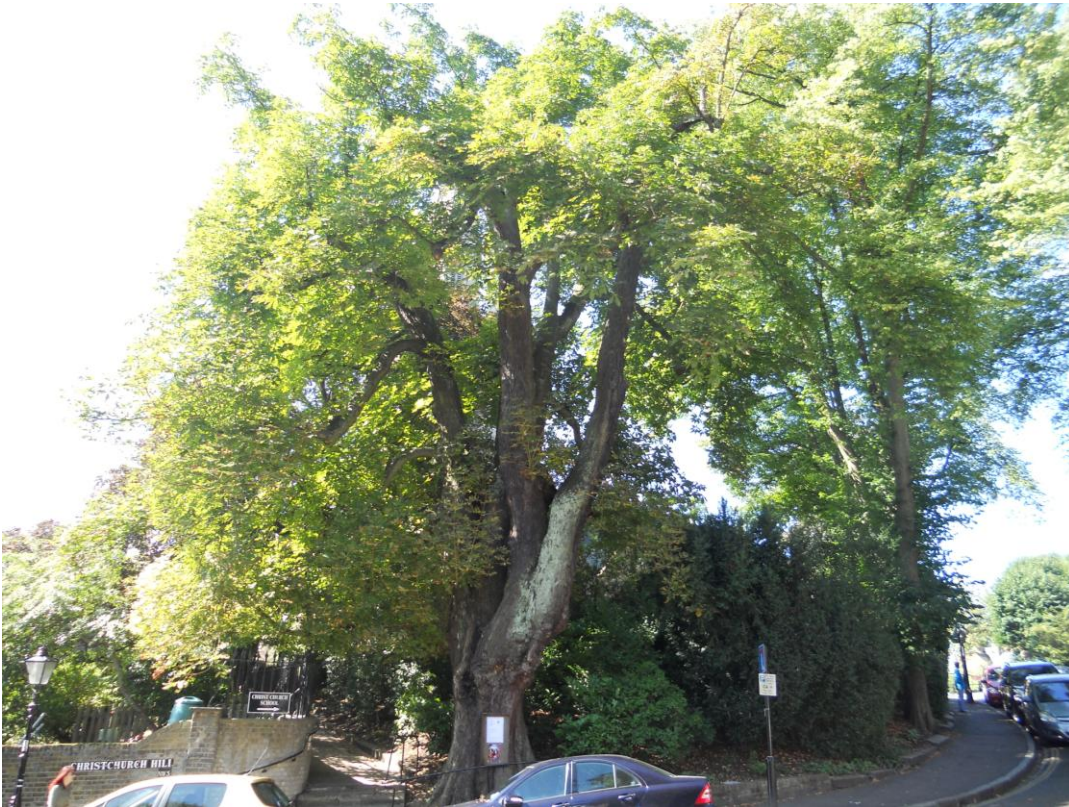
- 6.12. The significant trees on or near to the site are the Horse Chestnut tree, Beech tree and the Sycamore tree.
- 6.13. The Horse chestnut (T1) has high visually amenity value. The itself has a ganoderma spp fungus bracket on the main stem, this is an external sign that decay and rot is occurring on the inside. The tree has also been topped at some point in the recent past (within 10 years), and although new growth is forming, this will be of a weaker attachment.

Horse Chestnut tree (T1)

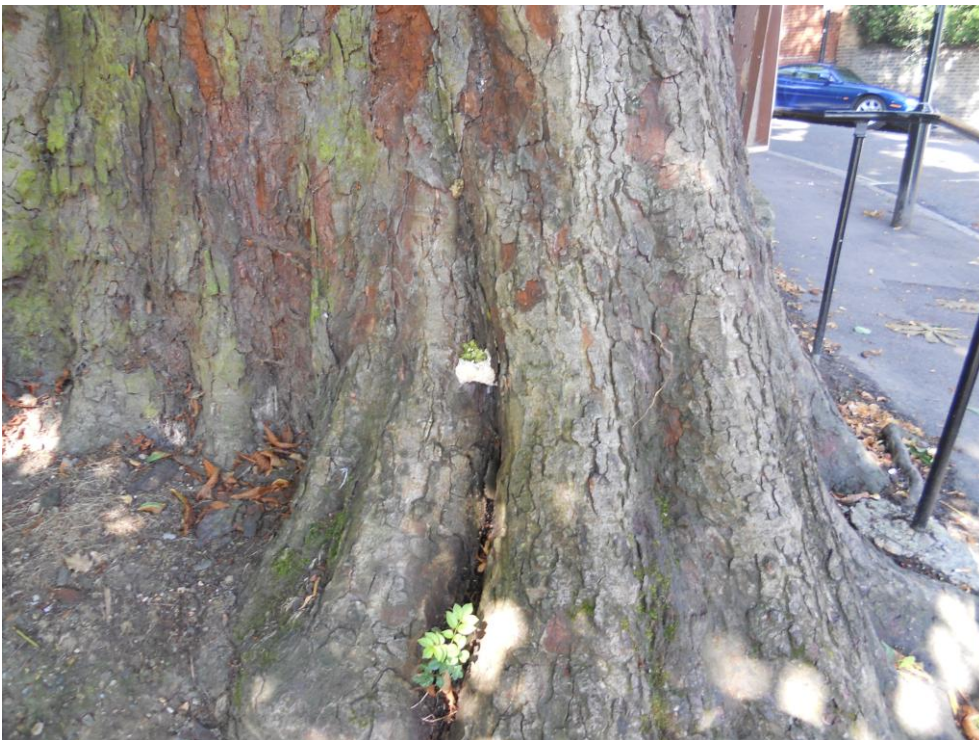
Ganoderma on Horse chestnut tree (T1)

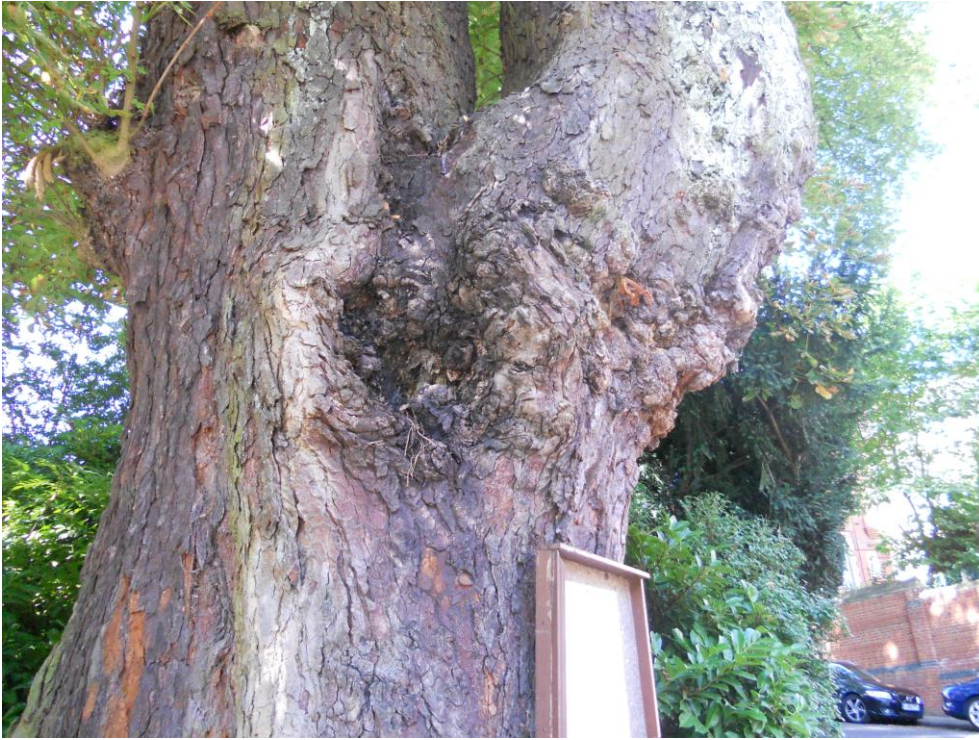
Decay and cankers on Horse Chestnut tree (T1)

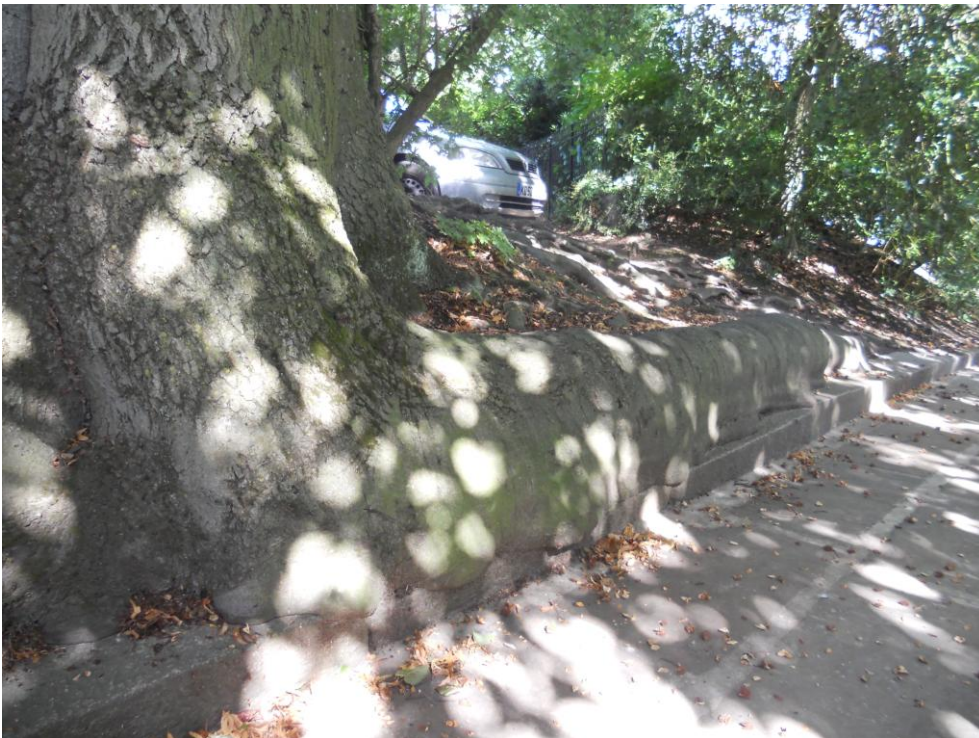
- 6.14. The Beech tree (T4) is a striking copper beech tree. This is a large mature tree with extensive lateral root system. It is likely that the roots will extend towards the car park area and the church area as opposed to the school area.

- 10.1. After assessing the site in full I have determined the following:
- 10.2. The Beech tree T4 has large lateral roots which spread in either direction of the path. There is no evidence that the roots have crossed the path by any major degree and as such it is unlikely that there will be main roots within the School area. In any case the development is some distance away and outside of the tree root protection area (RPA).

Lateral roots on Beech tree (T4)

- 11.1. There will be a need to submit a detailed method statement for the inclusion of heavy duty road mats within the RPA of the Beech T4.
- 11.2. There will be a need to outline the phasing of works, and the erection of tree protection.
- 11.3. All tree works recommended are to be carried out prior to any Site personnel being present or commencing works or any materials being delivered. (Reason): to ensure the Site is prepared and ready for the demolition and construction processes to commence.
- 11.4. Tree protection will be required in order to protect the remaining trees, these will include:

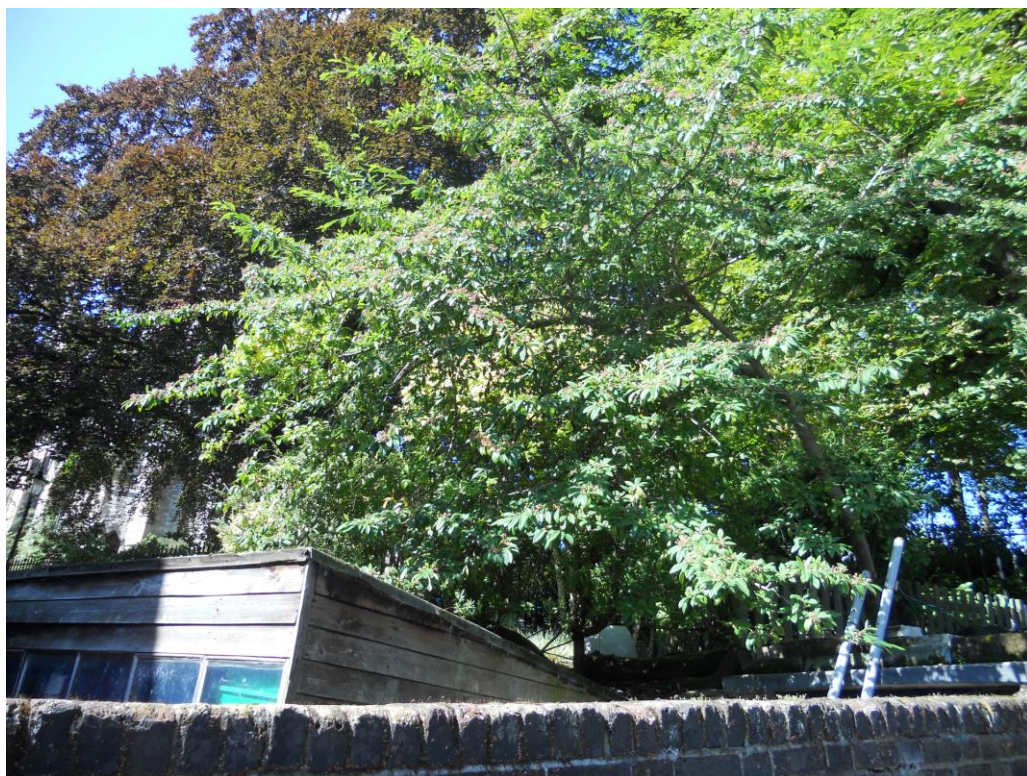
Suppressed Cotoneaster (T5)

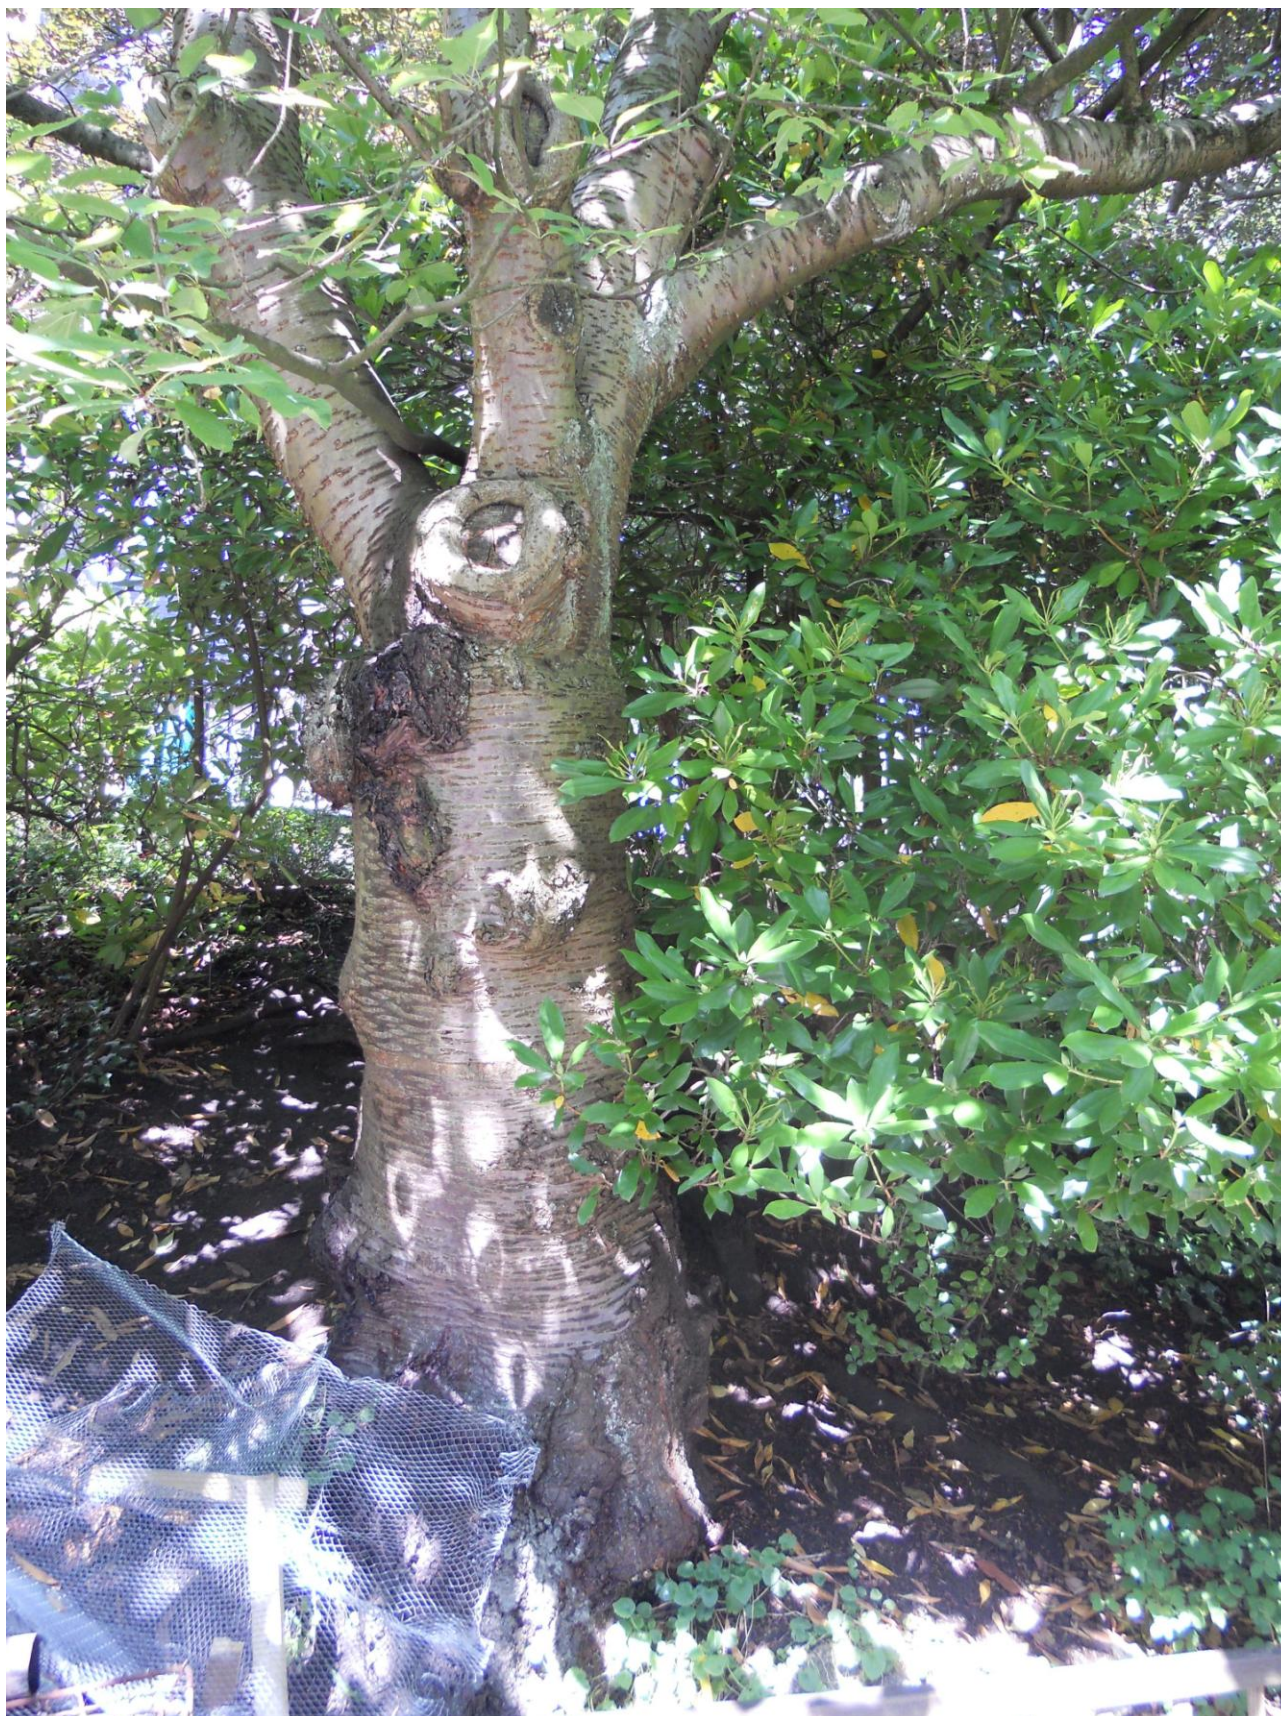
Cherry tree trunk with cankers, poor pruning and possible canker (T9)
