**LIMITED STRUCTURAL INSPECTION REPORT**

**ON BOUNDARY WALL AT**

**OLD FROGNAL COURT  
23 FROGNAL LANE  
HAMPSTEAD  
LONDON  
NW3 7DB**

Issue No: 1    8<sup>th</sup> April 2015

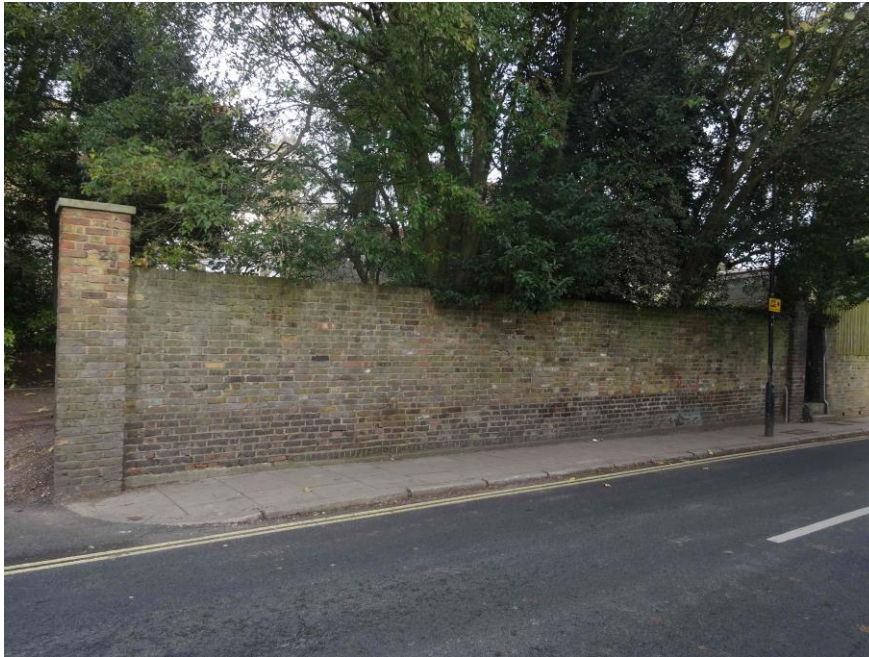
- Evident overturning/ leaning toward the road. This varies along its length and is worst at the positions nearest the trees and will be due to the retaining situation combined with tree growth.
- Spalling at low level and erosion of mortar joints. This appears due to incorrect pointing mortar specification unsympathetic to the stock bricks.
- Evident significant structural fractures to the wall at the tree positions due to tree growth.

The wall is suffering from overturning onto the pavement and structural damage primarily due to the tree growth but also the retaining situation. To a less structurally significant extent the wall has been pointed in inappropriate mortars, particularly at low level. It is likely that further tree growth will result in further overturning and structurally significant fracturing of the wall.

- 1) The three Chinese privet trees immediately behind the wall are removed and the remainder of the trees remain.

- 2) The retained soil is banked down behind the wall.

- 3) The wall is rebuilt to match existing using reclaimed bricks where possible and built in a lime mortar suited to the brick. The low level 'darker' bricks should be rebuilt in the same position to match existing. A panel showing the lower and upper section should be built for approval by the planning department and this should include the coping detail. A new foundation suitable for the ground conditions and adjacent trees will be required.
