HERITAGE STATEMENT

48 Delancy Street

Camden NW1 7RY

14 November 2014

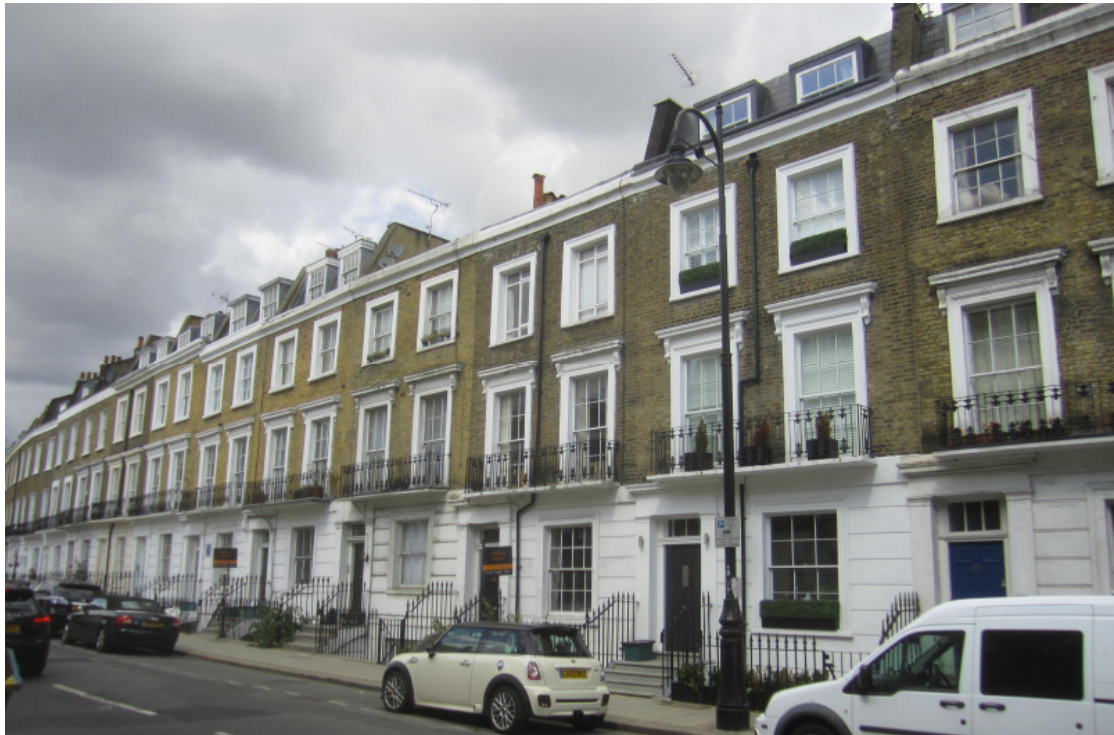
street setting

The site is one of only 2 houses in the terrace which does not have a mansard roof extension. The other mansard extensions have been designed with generally flat top roofs, keeping the level of the party wall parapets low. The dormer windows are generally similar in width to the windows below, and the tops are close to the flat roof level. There is a variety of detailing of the dormers. The railings are reasonably intact and uniform.

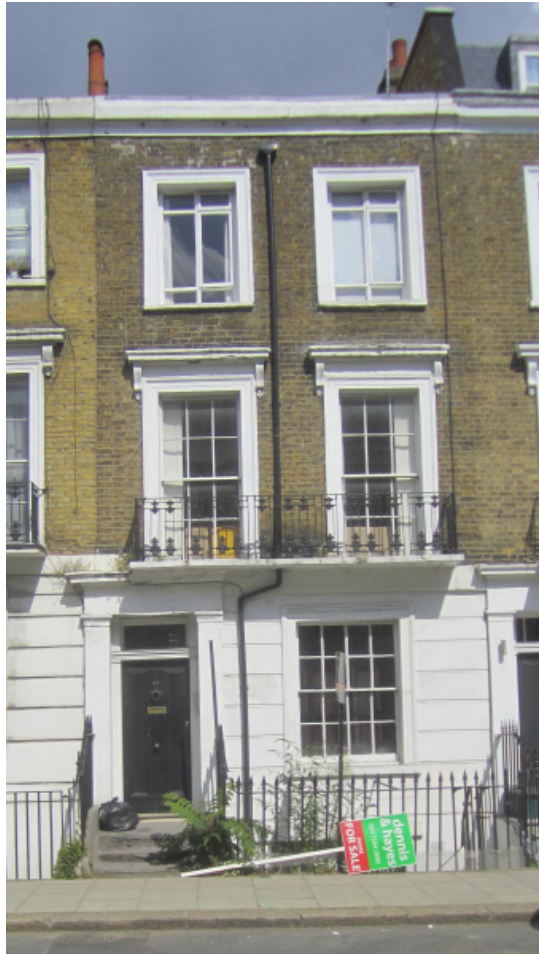
front view

The overall condition of the building is a state of disrepair. Stonework and render generally is crumbling and plants growing on the entrance cornice. The railings have been dislodged and are loose in places. the brickwork at the top parapet needs repointing and has stained. The original windows are deteriorating and in places rotten. The top windows have been replace with modern casement windows out of keeping with the original. The basement front windows have been replaced with steel windows and security grates

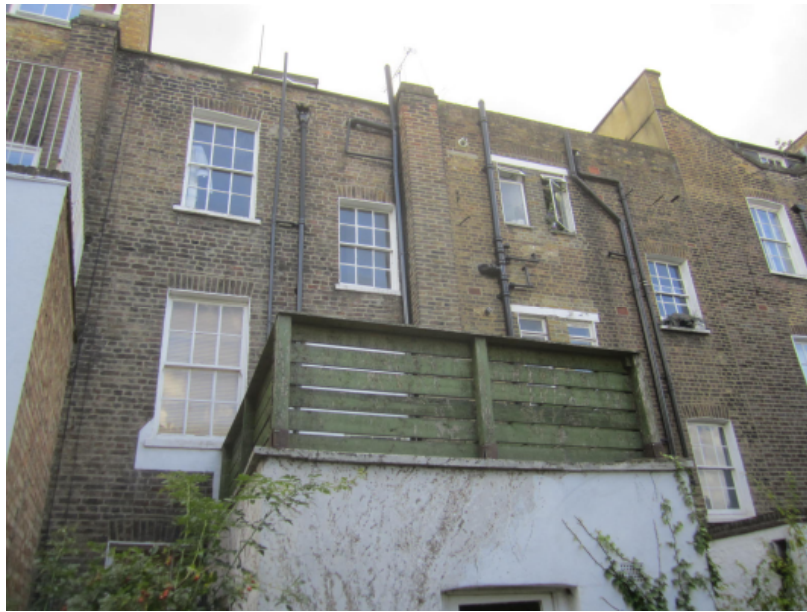
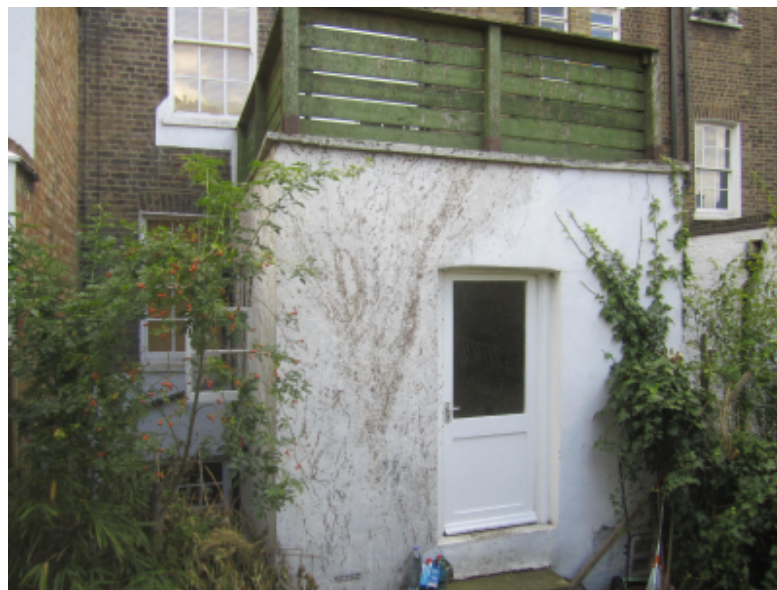
rear view

The rear elevation has a rear extension with a rotten timber balustrade and modern door. Brickwork needs repointing and repair, the flat roof needs replacing and the render needs repair and repainting.

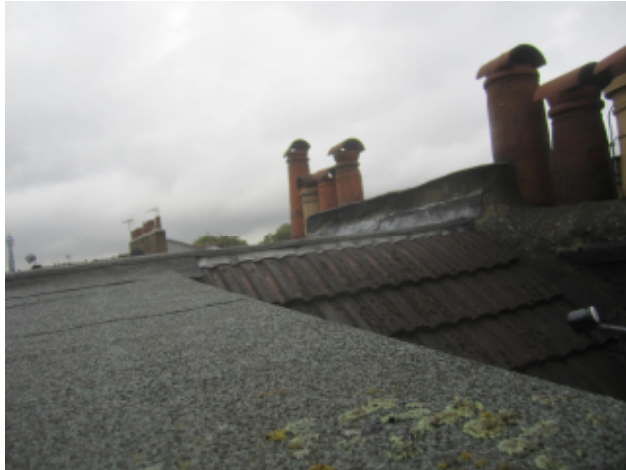
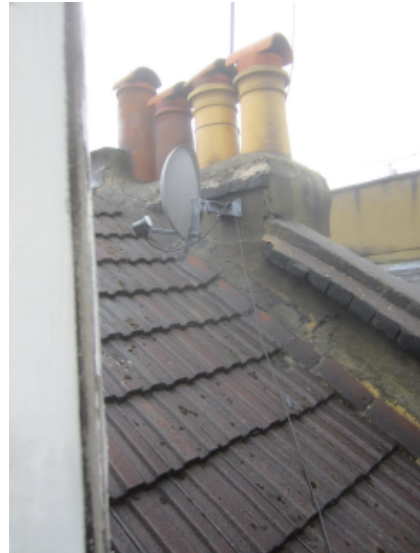
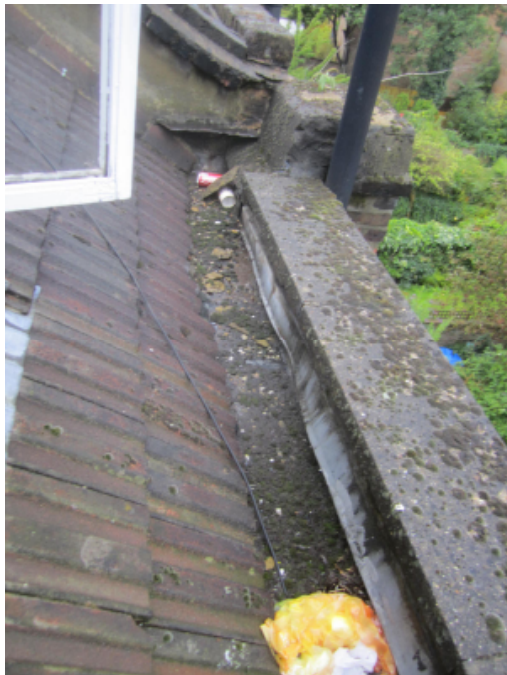
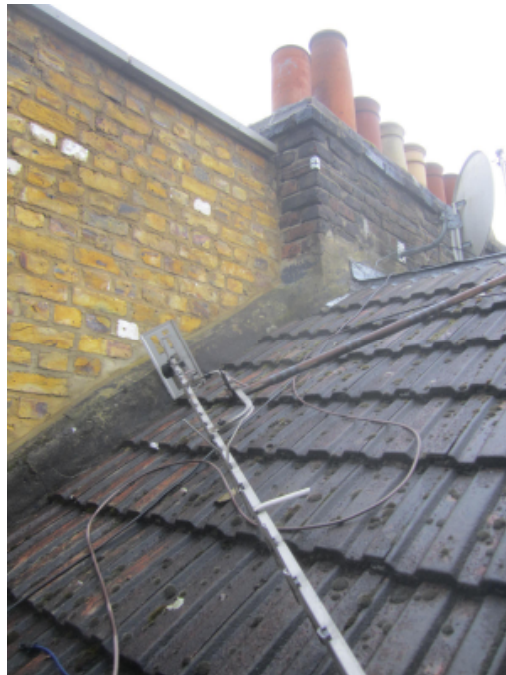
main roof

The roof is not original, with concrete tiles and flat felt roof. this is in a poor condition and in need of replacing.

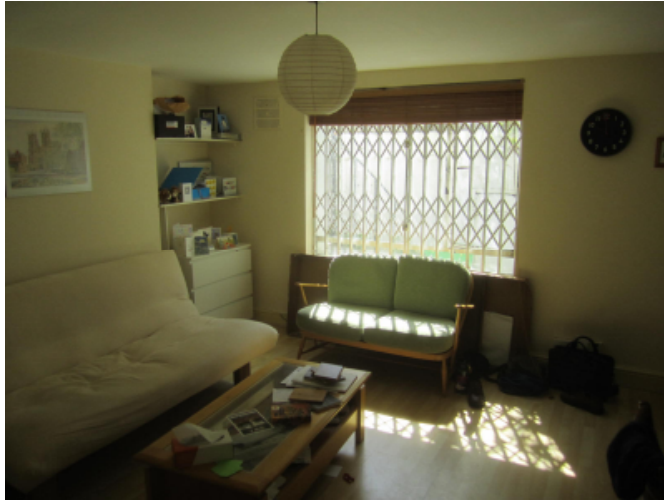
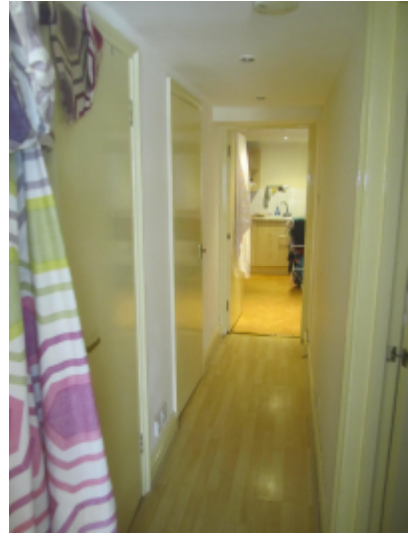
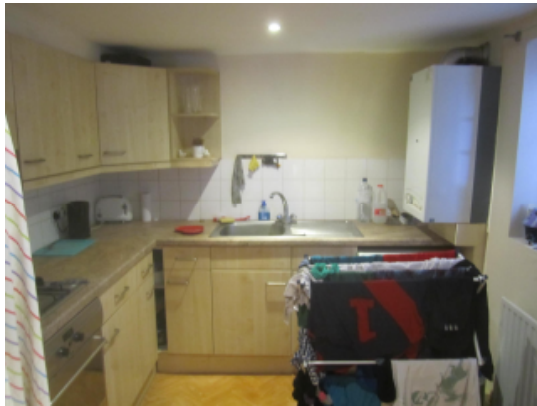
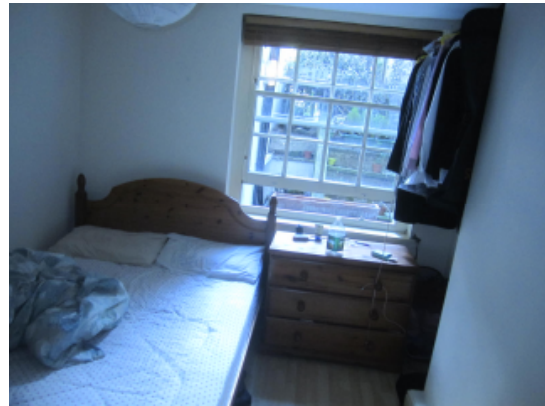
The basement has no retained features, and is affected by mildew and damp.

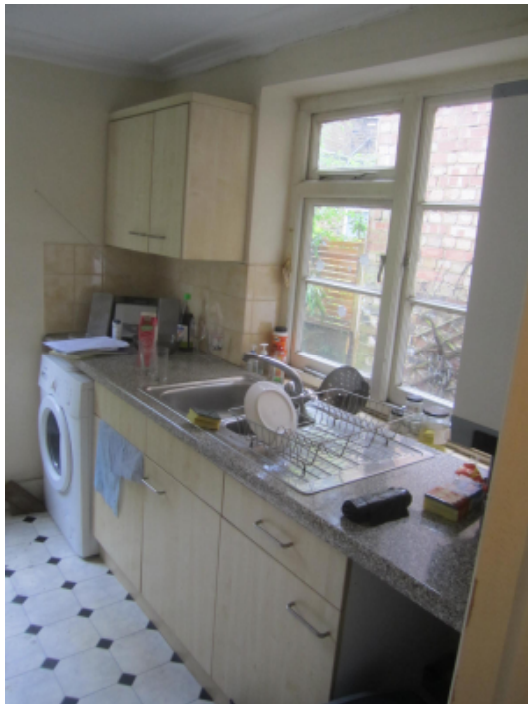
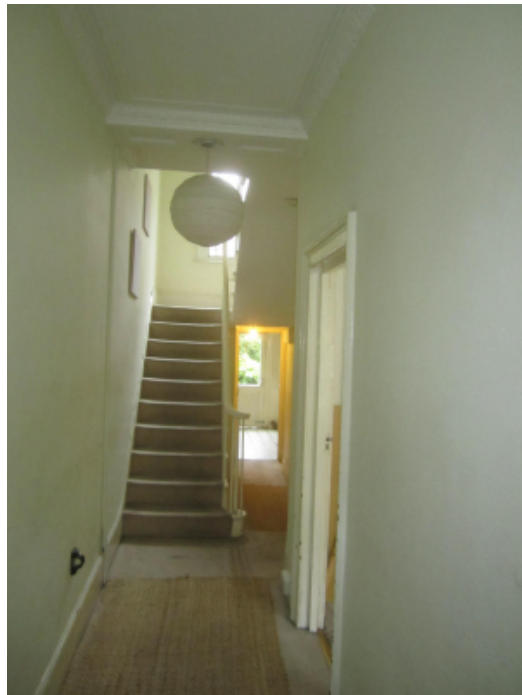
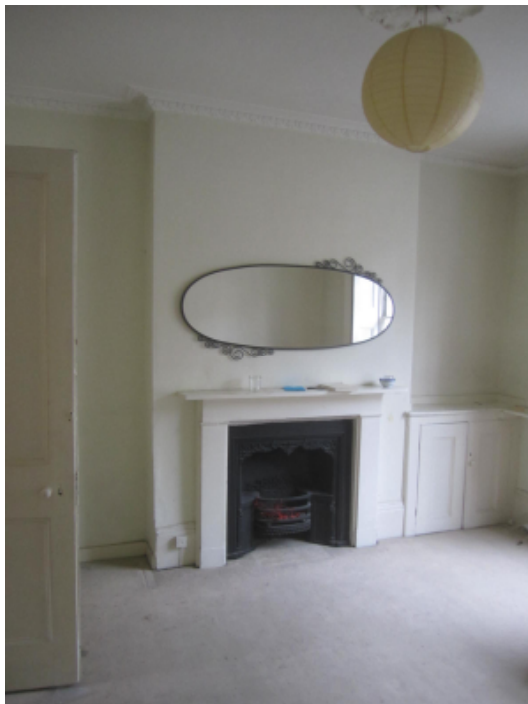
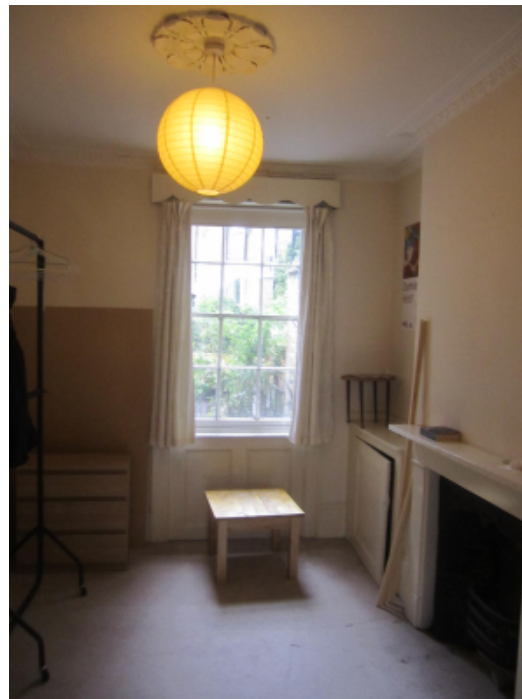
The ground floor has attractive, presumed original, covings, ceiling roses, skirtings and fireplaces. The stair balustrade is in reasonable condition and would be refurbished.

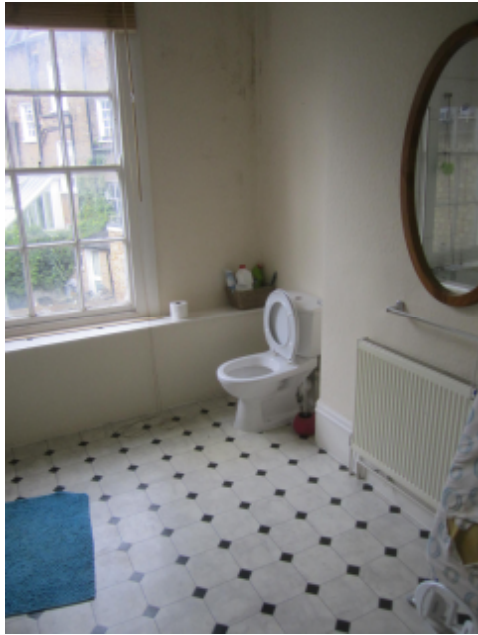
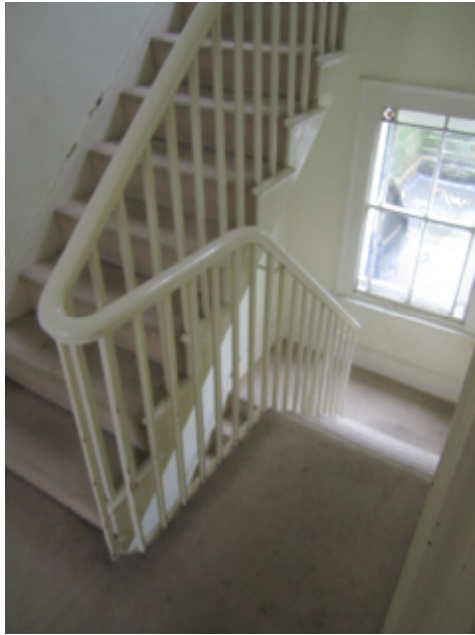
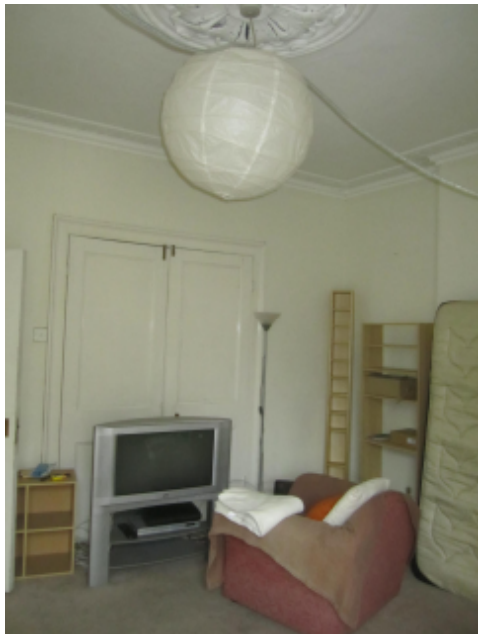
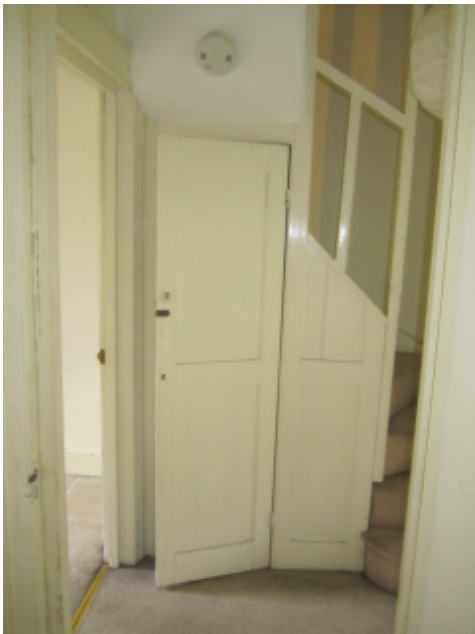
first floor

The stair, cupboards and front room have retained the original features, but the rear room has been stripped out and replaced with a bathroom with modern plumbing and boxing.

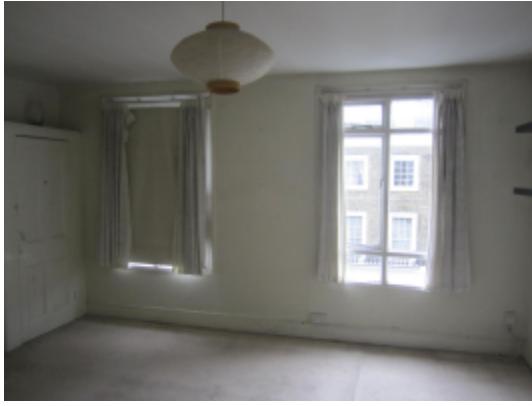
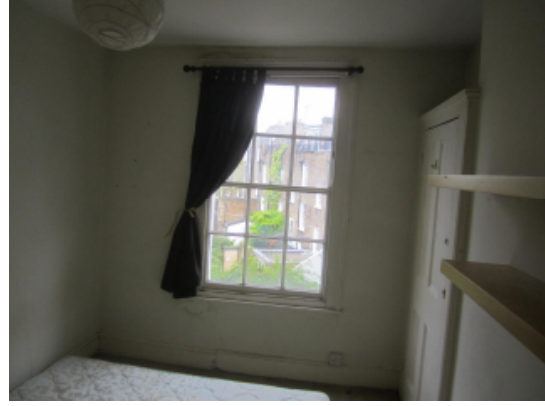
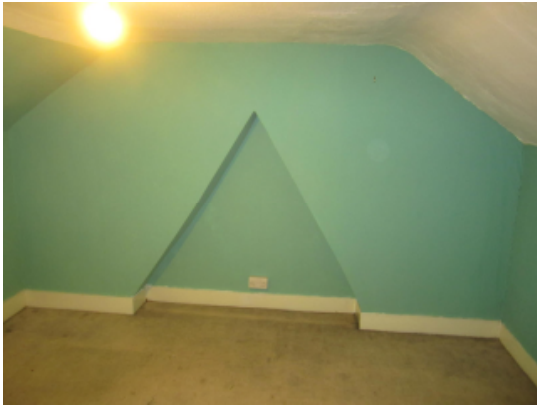
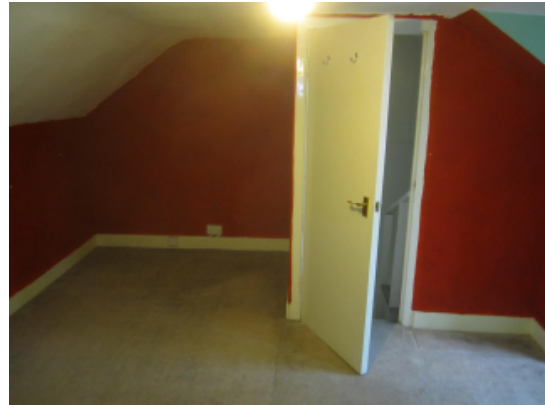
second and third floors

Original features have been stripped out of the second floor, and the third floor is a modern extension.
