# Arboricultural Consultancy for AXA Insurance

<b>Insured</b>	6 Langland Gardens Ltd	<b>Address</b>	6 Langland Gardens, London, NW3 6PY		
<b>Client</b>	GAB Robins	<b>Contact</b>	David Nimmo-Smith	<b>Claim No.</b>	B1214169
<b>MT Ref</b>	NL/3007121153/TP	<b>Consultant</b>	Thomas Peppiatt	<b>Contact No.</b>	08702 416 180
<b>Report Date</b>	17/08/2012

## 2. Property and Damage Description

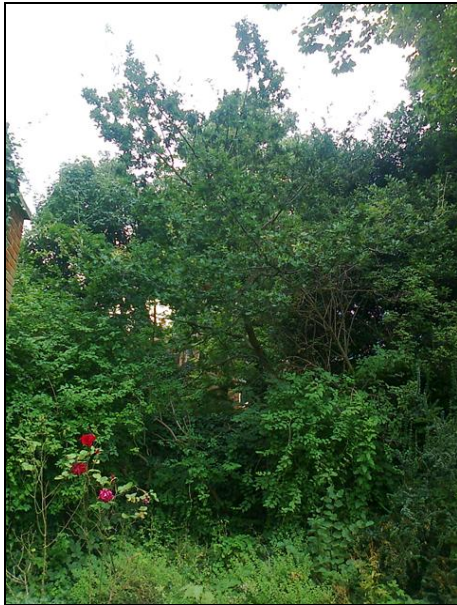
T1 - Oak

We also consider that, whilst not directly implicated by current site investigations, T1 (Oak), T6 (Laurel (Bay)), T7 (Elder) and SG2 (Mixed Species Group (H)) will also be exerting a significant (albeit secondary) influence in the current damage. This influence is determined by size and proximity relative to the area of advised damage.

T1	Oak	3	7	5	C - Insured	Remove	Remove and treat stump to inhibit regrowth subject to heave assessment.
T10	Acer	3	14	15*	D - Unknown	Action to avoid future risk	Reduce to 10-12m and maintain at reduced dimensions.
T11	Walnut	1	5.5	5	A - Third Party No 8 Langland Gardens. London. NW3 6PY.	Action to avoid future risk	Reduce and maintain at 4m height.
T2	Plane (London)	3	22	12.5	D - Unknown	Remove	Remove and treat stump to inhibit regrowth subject to heave assessment.
T3	Holly	3	11	13.5	D - Unknown	Action to avoid future risk	Reduce and maintain at 9m height.
T4	Plane (London)	3	18	21	D - Unknown	Action to avoid future risk	Do not allow to exceed current dimensions by way of regular pruning.
T5	Oak	3	10	15.5	C - Insured	Action to avoid future risk	Do not allow to exceed 12m height by way of regular pruning.
T6	Laurel (Bay)	1	9	7.5	A - Third Party No 8 Langland Gardens. London. NW36PY.	Remove	Reduce to 6m height and maintain at reduced dimensions.

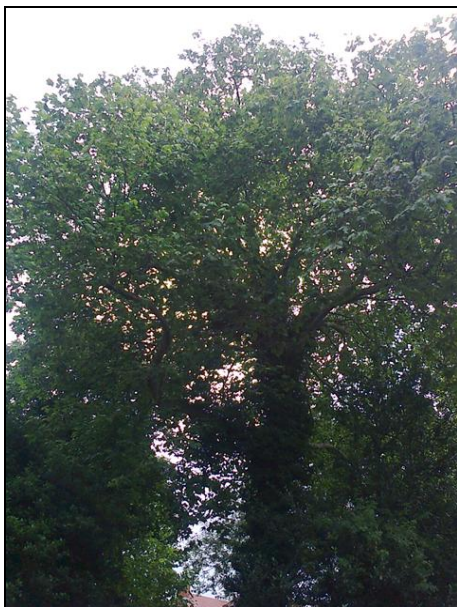
T2 - Plane (London)

Platanus roots have been identified that confirm the influence of T2 (Plane (London)) below foundation level.

Based on our site investigations, and taking account of vegetation location, relative to the focal area of movement/ damage, it is our opinion that T2 (Plane (London)) will be exerting the principal vegetative influence.

Vegetation management in the form of removal and appropriate stump treatment will help to promote the restoration of long-term stability to the insured property; pruning should not be considered as representing an effective or reliable long-term alternative solution given the size and proximity of the vegetation.
