**Landmark Trees**

**FURTHER INVESTIGATION REPORT:**

2 Fitzroy Park  
London  
N6 6HP

Ref: KAR/2FP/PCS/01

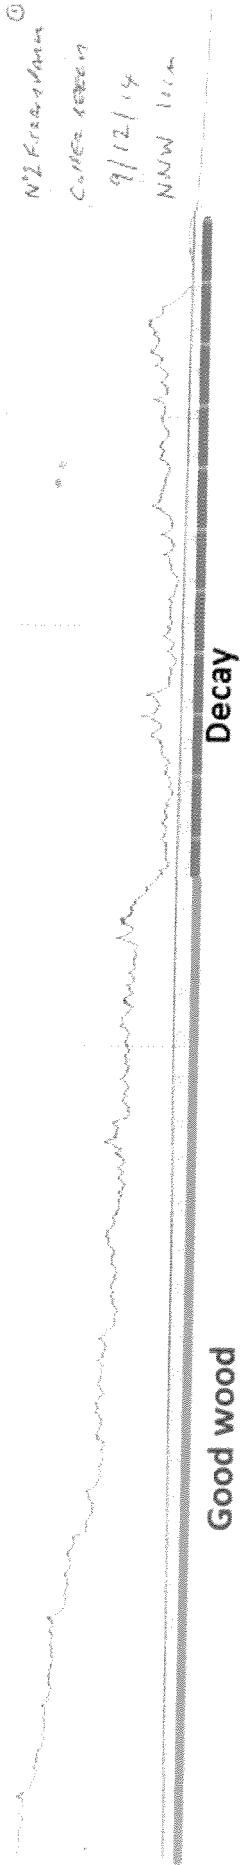
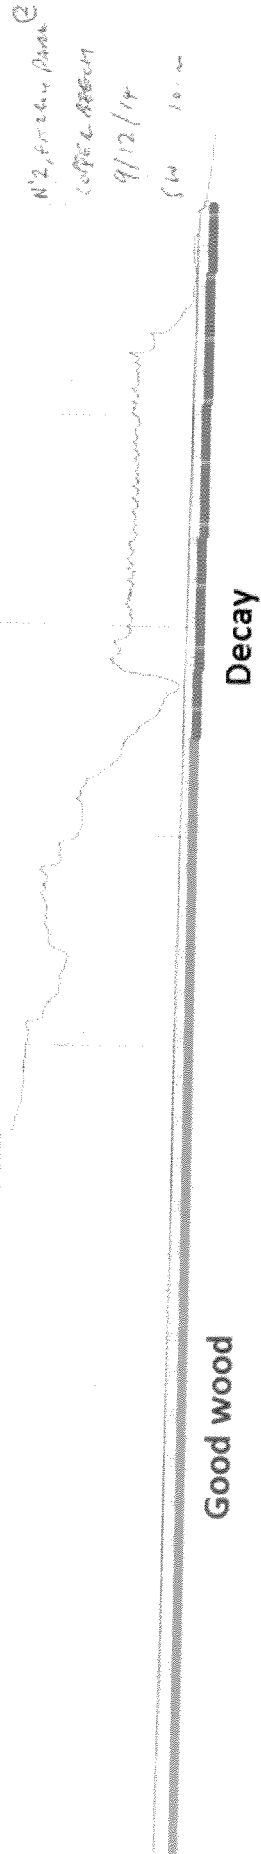
Direction	Height of Test	Result
North North West	10cm	Decay to 16cm, good wood 16-40cm (60% sound wood)
North East	5cm	Decay to 16cm, good wood 14-40cm (60% sound wood)
East	5cm	Decay to 16cm, good wood 14-40cm (60% sound wood)
West	5cm	Decay to 31cm, good wood 31-40cm (20% sound wood)

The Resistograph tests show that there is external decay around most of the stem but there doesn't appear to be any central decay/cavity. This pattern of decay and the die back and dead wood in the crown are symptomatic of a more pathogenic mode of action, possibly brought on by the historic piling of garden waste against the base of the tree or swimming pool construction. The latter will have a moderate effect on the tree's long-term anchorage. As yet, the amount of decay is not significant enough to majorly affect the structural integrity of the stem (justify felling), though the western cross section does give some cause for concern, and the integrity of the root system remains in some doubt. Root plate failure from honey fungus is generally prefigured by marked crown decline. This tree would be best described as in moderate decline.

The dead wood should be removed as soon as practically possible, and should be combined with a crown reduction of 25% by area (i.e. removal of outermost 25% of branch and twig length). The remaining ivy should also be removed, as this will significantly affect the trees wind resistance. The tree should be re-inspected in 2 years or if it shows signs of significant / accelerated decline in the interim.
