Mrs S Husain,
1 Frognal,
London,
NW3 6AL

My ref 15/001

Trees and damage at the front of the property

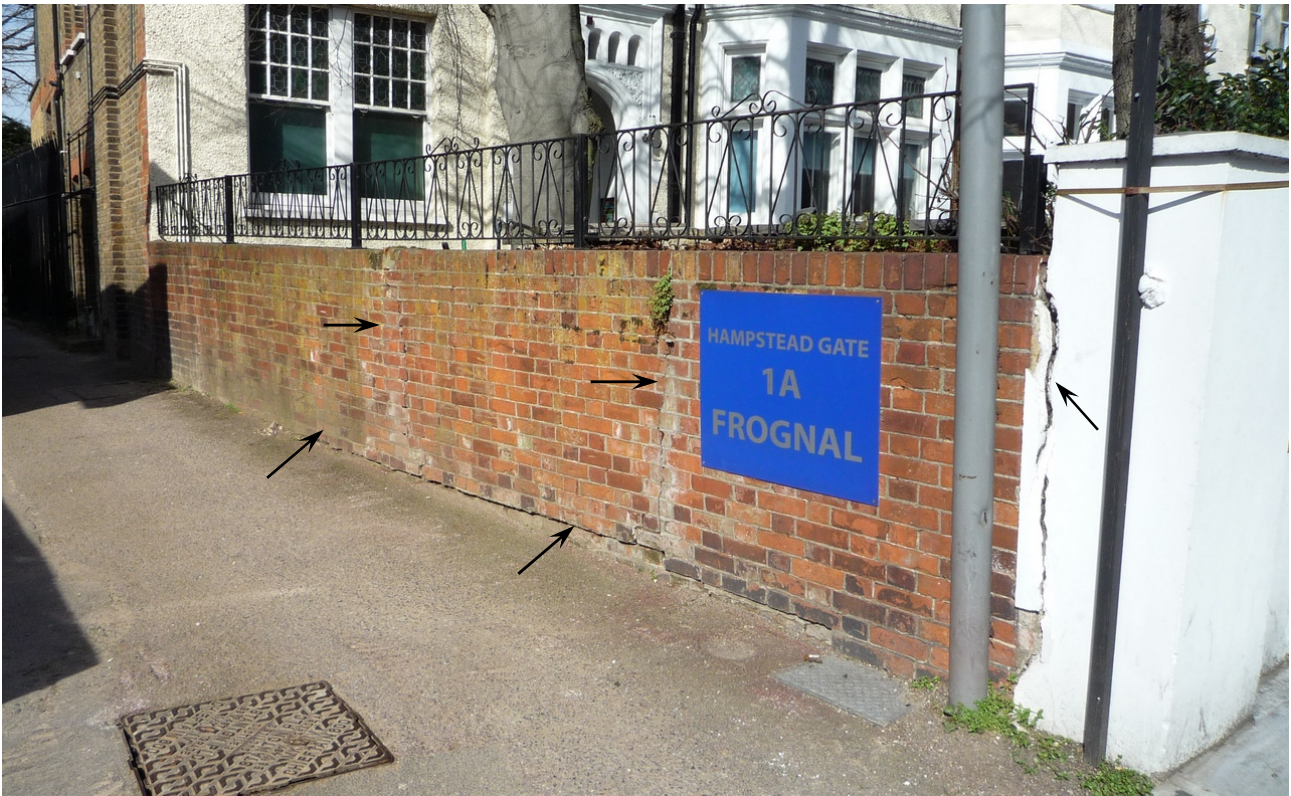
Photograph

- The pier at the front left hand corner of the garden leans out towards the pavement by about 15mm in 300mm (i.e. 1 in 20) and there are large cracks at the junction with the front and side walls.

- The left hand side wall has a long horizontal crack just above ground where it has been displaced out towards the side passage, it bulges and leans out by about 10mm in 300mm (1 in 30). The lean creates a gap between the rear end of the wall and the front corner of the house; this has been filled recently but there are signs on ongoing movement.

- There are also several vertical cracks, the most severe is next to the beech tree and has been repaired and repointed in the past before breaking out again. The outward lean is most severe at this point.

16. Although tree roots extend through the soil with little direct force the expansion of the larger roots and lower trunks of growing trees can be sufficient to damage lightweight structures. It is common for them to lift paving and push walls laterally, particularly where ground level differences mean that there is no lateral restraint on the far side. This is clearly the cause of the various problems in the front garden, with the main causes of the severe damage to the front and left being the smaller lime and the beech, trees 2 and 3.

View along the side wall showing horizontal and vertical cracking and the corner pier detaching and leaning towards the pavement. Trunk of the beech is behind the wall about half way along and the smaller lime is behind the pier and metal post.

18. The front and left hand side of the garden are far more severely affected and the side wall and pier at the front left are starting to look unstable. Detailed consideration of the remedies is a matter for a building specialist, but it appears that the only practical remedy is to demolish both walls and the piers and to replace them. The side wall has cracked above ground and it might be possible to reuse the existing foundation, which would reduce ground disturbance, but that would need to be determined once the walls were down.

22. This is the main cause of the problems at the front left and is growing in the corner, so repairs would involve working round two sides. It has been suppressed all its life so is a poor specimen with a heavy lean over the road that makes little contribution to local amenity, individually or as part of the group. Although it might be possible to work round it a better long term option would be to remove it and replace it with a species better able to tolerate the shade from the larger trees. Holly would be well suited, as it would also provide some screening and reduce noise. Other possibilities would be hornbeam or field maple.

Fell and remove stump. Replace with holly, field maple or suitable shade tolerant alternative.
