## Fenton House

## Windmill Hill House Retaining Wall

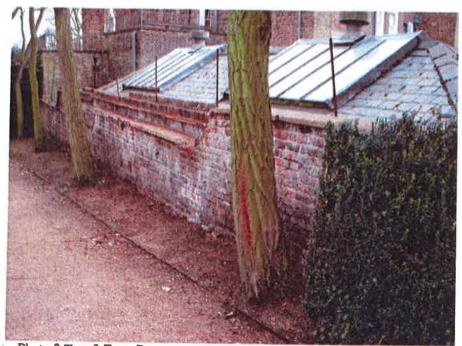
Fenton House - Photo 2 Tree 9 Zone B

The historic wall is displaying significant movement and a number of young trees have been planted very close to the wall, tree numbers 6, 7, 8, 9 zone B. Refer to photo 2.

We recommend the young trees planted adjacent to the wall are removed. We would like to inspect the wall from Windmill Hill House to assess any damage and would recommend horizontal monitoring is carried out.
