Arboricultural Consultancy for Natwest

1. Case Details (REVISED)

Insured	Ms Rosalind Franey	Address	78 Marquis Road, London, NW1 9UB	Site Visit Date	20/10/2014
Client	Subsidence Management Services	Contact	Kalwinder Bhatti	Claim No.	IFS-DLG-SUB-14-0053600
ES Ref	NL/0810141444/TP-REV1	Consultant	Will Argent	Contact No.	0330 380 1036
Report Date	29/10/2014 Revised 27/01/2015

5. Technical Synopsis (REVISED)

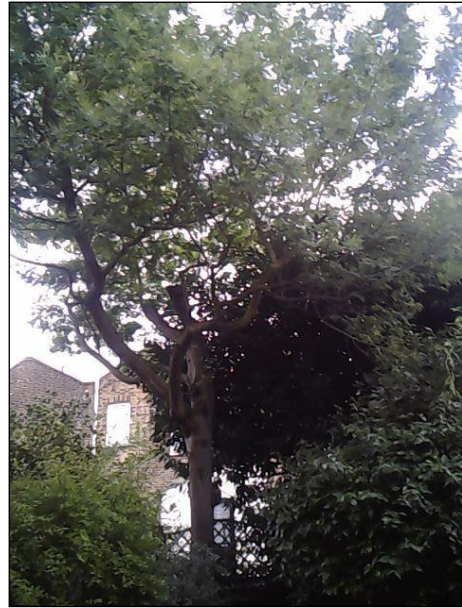
T1 - Mimosa

Our survey of the site identified T1 (Mimosa), which, given its position relative to the damage, it is our opinion that the roots identified emanate from this tree.

In assessing the extent of damage and the potential drying influence of the vegetation on site, T1 (Mimosa) is judged to be the dominant feature and accordingly we have identified it as the principal cause of the subsidence.

Tree No.	Species	Age Cat	Approx. Height (m)	Distance to Building (m)	Ownership	Action	Requirement
T1	Mimosa	1	8.5	10	C - Insured	Remove	Remove.
Age Cat: 1 = Younger than property; 2 = Similar age to the property; 3 = Significantly older than property

Removal of T1 will offer the most certain and reliable arboricultural solution likely to restore long-term stability.
