Drainage Investigation Report

For Subsidence Management Services

Risk Address: 78 Marquis Road, London, NW1 9UB

Report Date: 08/04/2015

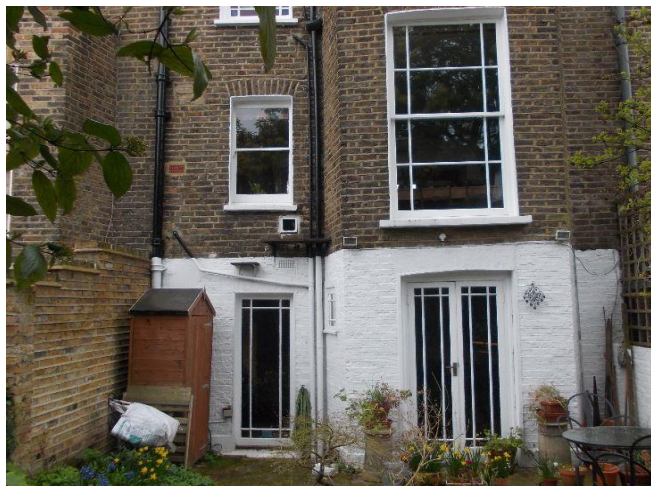
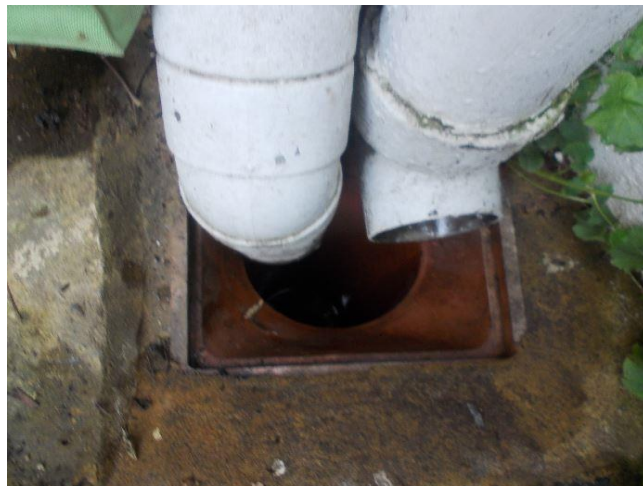
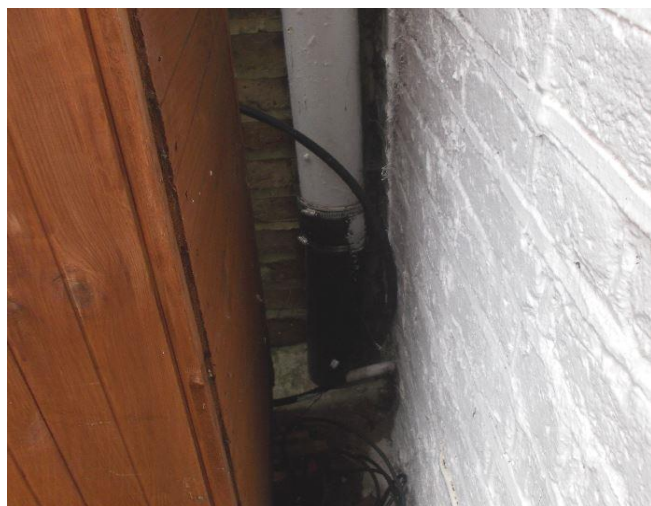
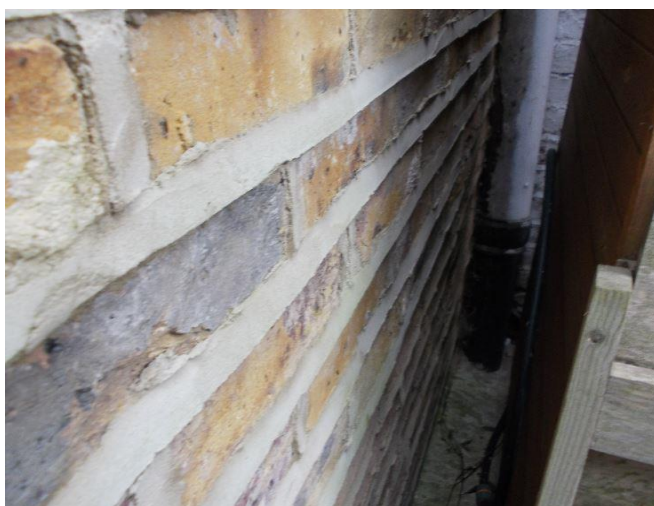
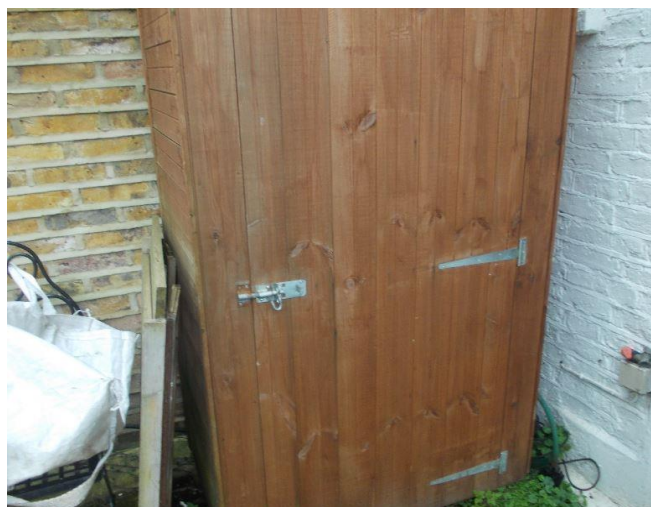
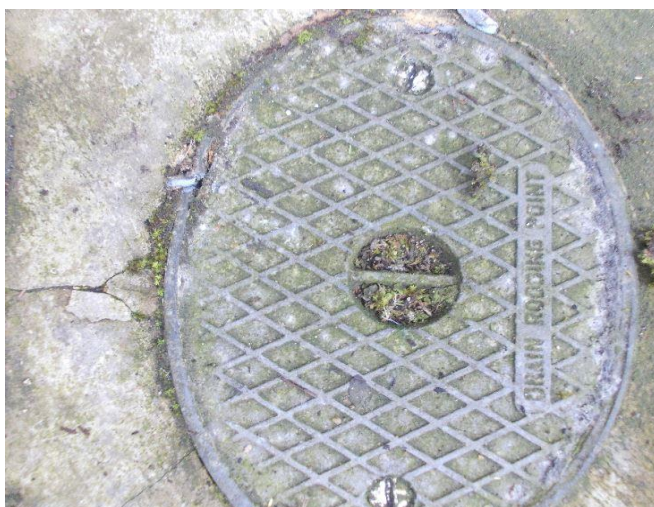
Our operatives could not gain access into the SVP line due to limited access as the shed was in the way. In order for this survey to be carried out, we would require the home owner to move the shed.

We were unable to access the rodding eye as the screws for the access cap have corroded.

The hydraulic water pressure test could also not be done as the gully (CWG1) is deep and constructed of a straight section of pipe with a hopper at ground level.

Over all the drains were found to be in a good condition and look to have been repaired previously including the SVP line (see photographs) as there is new pipe connected approx 0.7m from ground level up on the stack pipe.

No repairs have been recommended as the drain line was found to be free from defects.
