**18435**

**26 Lyndhurst Road**

**NW3**

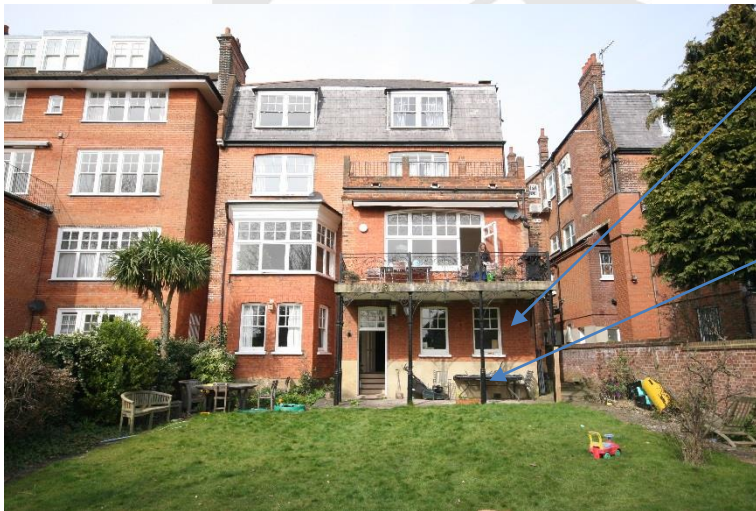
The rear elevation with its concrete terrace supported on iron posts was noted to be further from mature trees and not to have any significant structural defect.

Wall to be replaced with a box frame.

Posts to be replace with a beam and new posts as part of overall alterations.

The rear wall will be replaced with a discrete steel box frame to properly support the masonry, distribute the loads along the original foundation line and ensure the load path is maintained.

The terrace structure can be redesigned with a longer span beam and additional steelwork as required to support the masonry alterations, on independent posts and bases.

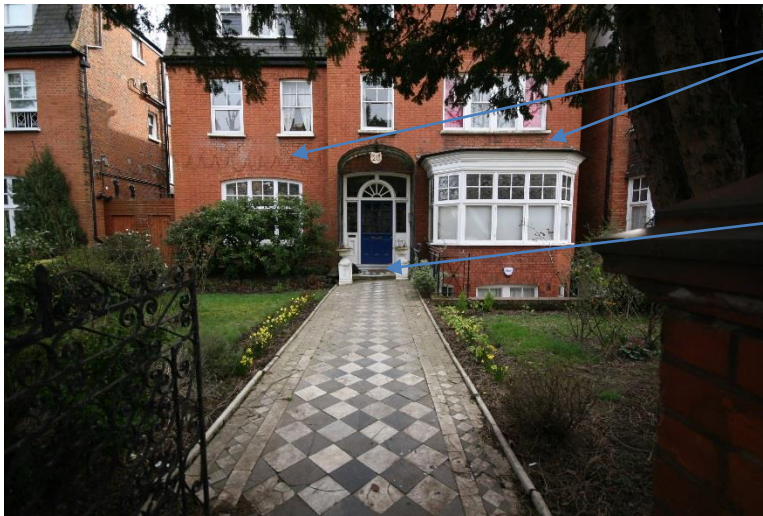
Some cracking was noted over the front bay opening, assumed to be due to relaxation of the lintel.

Some disturbance was noted to the front step and path due to localised differential ground movement, possibly caused by vegetation growth.

Cracking to masonry.

Distortion to path and step.

The defects to the front elevation masonry will required some investigation of the lintels before suitable repairs can be considered.

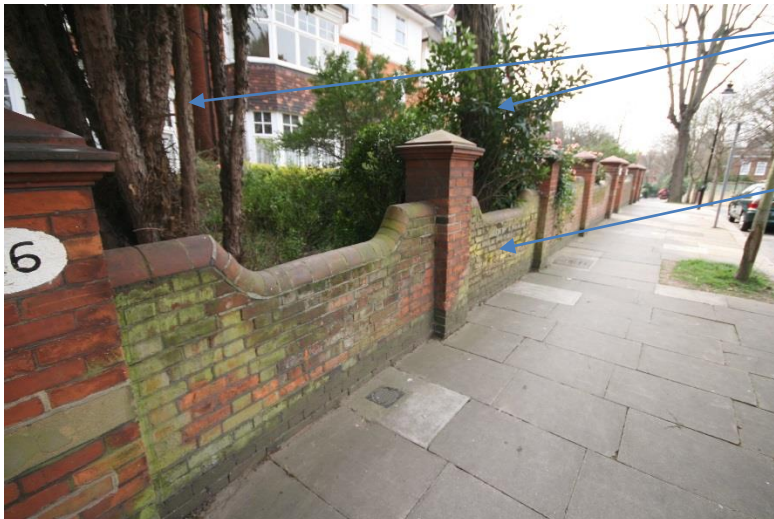
Significant disturbance was noted to the front wall caused by the immediatly adjacent trees.

Mature trees.

Distortion and cracking to masonry.

The trees immediately adjacent to the front wall have been allowed to mature and adversely affect the masonry. It is likely that the wall will require rebuilding in the near future to prevent its failure. It would be prudent to obtain a professional opinion regarding the trees which may need to be removed.
