ARBORICULTURAL ASSESSMENT REPORT

For:	Client:	Oriel Services Limited
	Insurer:	[REDACTED]
Site:	Policyholder:	[REDACTED]
	Risk Address:	11 Fawley Road, London, NW6 1SJ
Refs:	OCA Ref:	56369
	Client Ref:	7783239
	Insurer Ref:	8648023

Report By:	Dave O'Connell		
Title:	Arborist	Date:	16 th September 2014
Amended By:	Dave O'Connell		
Title:	Arborist	Date:	26 th March 2015

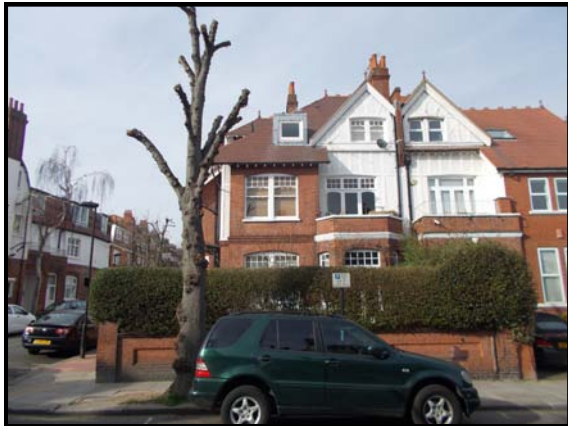
Roots were recovered from TP1 (SI-1) and had been formally identified as Tilia and a Conifer. Given its size, species, and proximity to the location of the trial pit/borehole we consider that the Tilia roots have emanated from Lime T1.

1. Lime T1 front left, Privet G1 behind

Tree No:	Species	Works Required
T1	Lime	Fell and grind stump
T2	Fig	Fell as close to ground level as practicable and treat stump
T4	Hawthorn	Fell and grind stump
T5	Hawthorn	Fell and grind stump

Tree No:	Species	Works Required
G1	Privet	Reduce to 2m in height and maintain on an annual basis

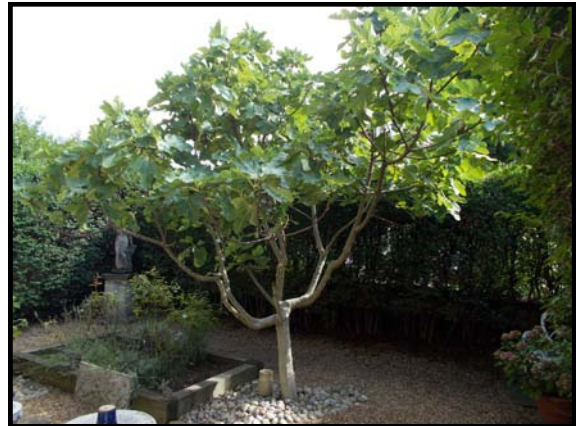
Roots have been recovered from TP1 (SI-3) and have been formally identified as Ficus. Given its size, species, and proximity to the location of the trial pit/borehole we consider that the Ficus roots have emanated from Fig T2.

2. Fig T2 front centre

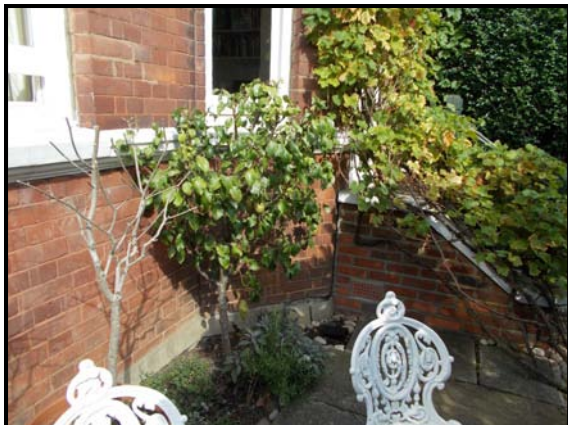
Roots have been recovered from TP1 (SI-2) and have been formally identified as Pomoideae. Given its size, species, and proximity to the location of the trial pit/borehole we consider that these roots have emanated from Pear T3. However, this tree alongside Virginia Creeper S1 & S2 is relatively small and maintained regularly and as such they will have a limited capacity for water use. Therefore we consider that any influence this vegetation may be having on soils beneath the property is likely to be negligible and as such do not consider them to be factors in the current damage.

3. Pear T3 centre, Virginia Creeper S1 & S2 right

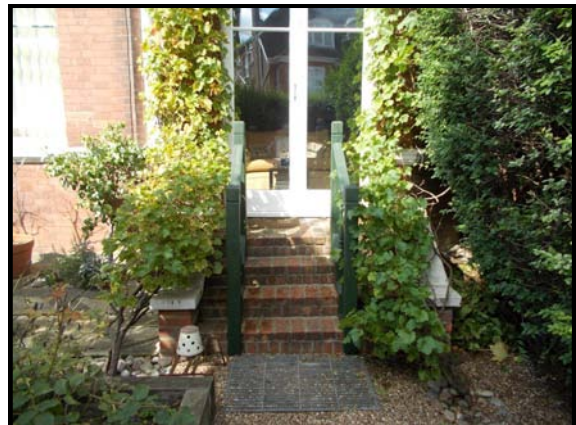
Although roots from Privet G1 are also likely to extend beneath the level of foundations, due to their size and regular maintenance we do not believe these to be a significant contributing factor in current damage. We do however feel it sensible to recommend a reduction in height of Privet G1 to 2m, and maintaining at this height on an annual basis to reduce the risk of future subsidence. This has recently been trimmed but not reduced significantly.

4. From left to right, Pear T3, Virginia Creeper S1 & S2, and Privet G1

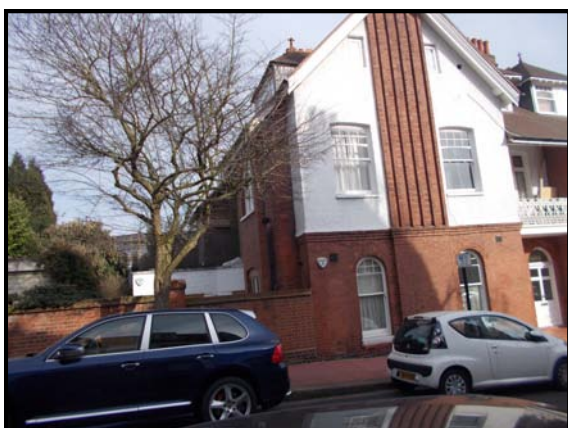
Roots have been recovered from TP2 (SI-3) and have been formally identified as Pomoideae. Given its size, species, and proximity to the location of the trial pit/borehole we consider that the Pomoideae roots have emanated from Hawthorn T5.

5. Hawthorn T5 front left

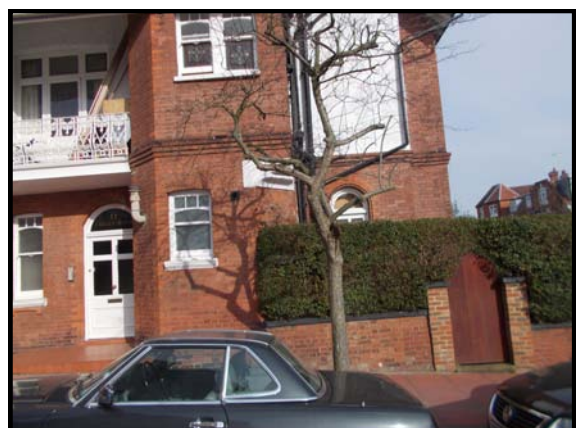
There has not been a TP/BH located in a position where roots from Hawthorn T4 would be expected. However, due to the size, species and proximity to the insured property, it is likely that roots from Hawthorn T4 have also beneath the depth of foundations.

6. Hawthorn T4 front centre, Privet G1 behind
