Arboricultural Report

Flat 1
51 Belsize Park Gardens
Belsize Park
NW3 4JL

A mature birch tree causing damage to built
structures

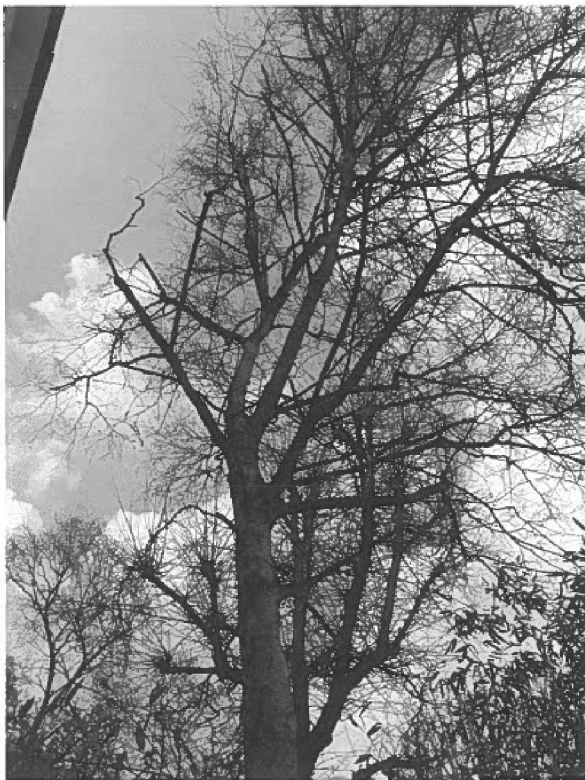
Due to it's proximity to the building the canopy has been subject to extensive pruning to alleviate encroachment towards the house.

The left photograph is taken from the front garden with the house roof in view to the left.

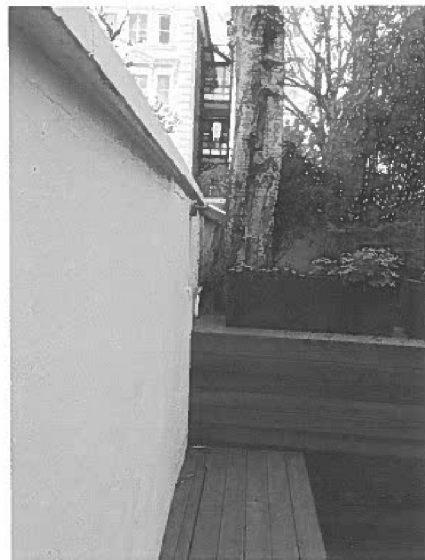
Here is a view from the house towards the road, showing the height of the root ball above the sunken garden. Also evident if the distorted wall.

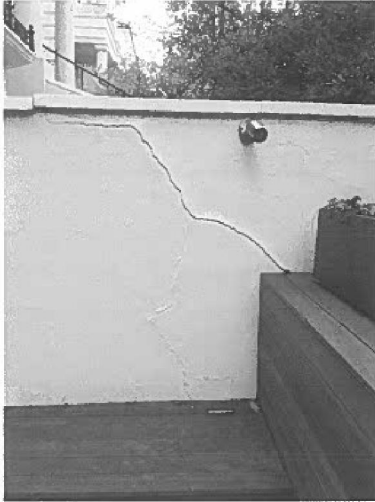
There is sign of extensive movement of the party wall and visual signs of cracking. This is both historic and recent. The wall has had cracks repaired in the past on more than one occasion as can be seen by the new plaster and painted areas. Many of these cracks are right through the brickwork and evident on the opposite side.

The tree is just out of shot to the right of this photograph with the root at the level of the bench top visible.

The tree root is close enough to the party wall for natural root expansion to have moved the wall by a number of inches. Where roots contact with lightly built structures such as garden walls they are able to inflict sufficient pressure to cause damage and movement.

My opinion is that this plant should be felled to ground level to alleviate the risk of future damage. If the stump is ground out (subject to underground services and proximity to the wall) the area could then be planted with a more suitable species. There is no doubt that a tree as replacement would enhance the area as well as giving shade to the garden though there is always going to be a problem of root size and activity. Whatever replaces the existing tree will have a limited life as this too will eventually become too big for the space available. There is no reason why a plant should not be grown with a view to enjoying it until it reaches the point of being to large and then take it out and start again.

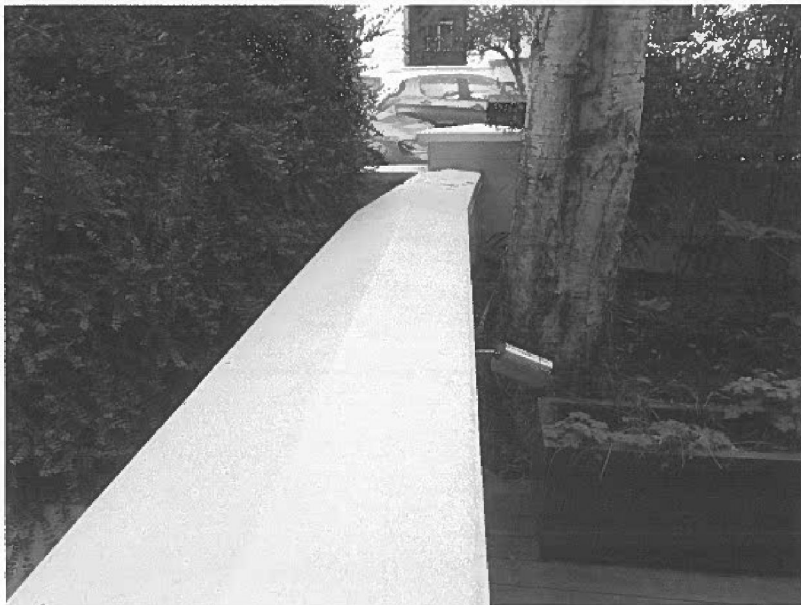
It is my opinion that this tree has caused the damage to the walls as shown and will continue to cause damage unless action is taken. It is possible that future damage could be extensive as it is likely that the wall to the sunken garden will be the next to move. Roots require compacted soil to create stability and in the process of creating that compaction within such a small area as here are very likely to damage any built structure that is unable to resist that pressure.

The replacement tree should be situated further away from the wall than the present and I suggest that close to the centre of the bed would be the best.
