Clifford Pugh House, Hampstead

Ground Conditions Desk Study Report

December 2013

Hydrock Ref: R/13868/001

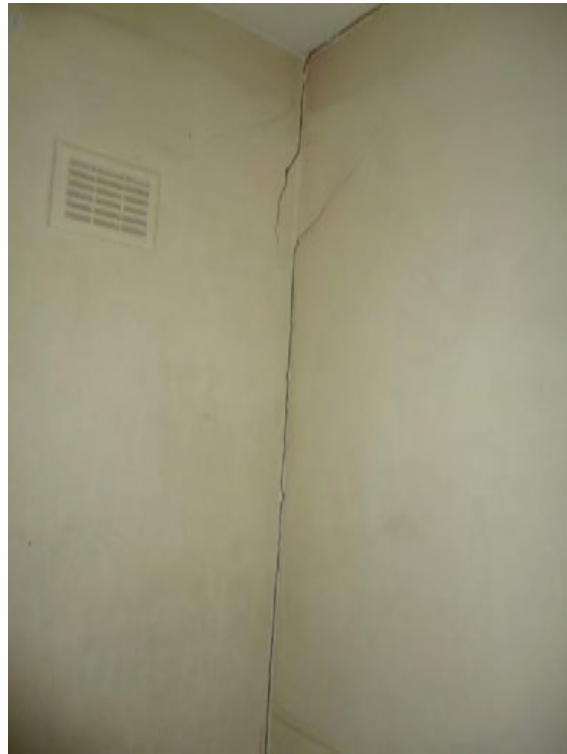
Figure 3: Internal cracking of the southern wall on the third floor

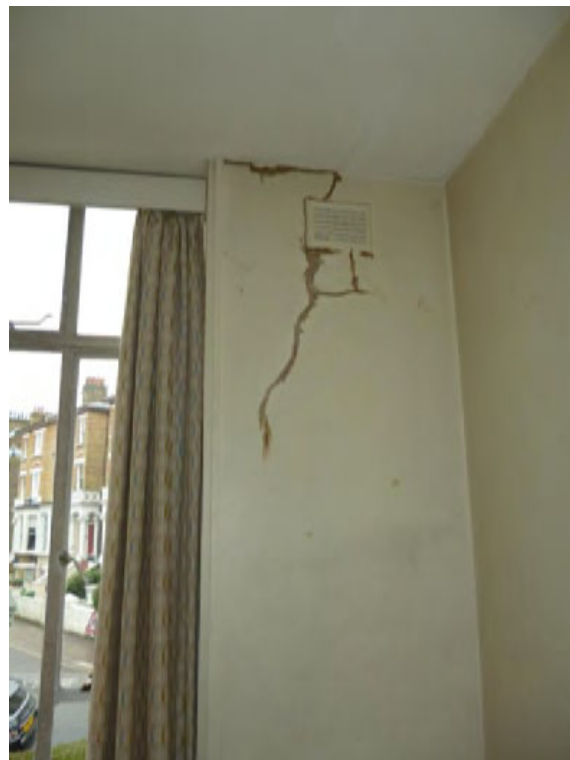
Figure 4: Internal cracking of the northern wall on the second floor.
