King's Cross Station: Clock Tower Repairs

Listed Building Consent Application
Rev A 19/03/2015

JOHN MCASLAN + PARTNERS

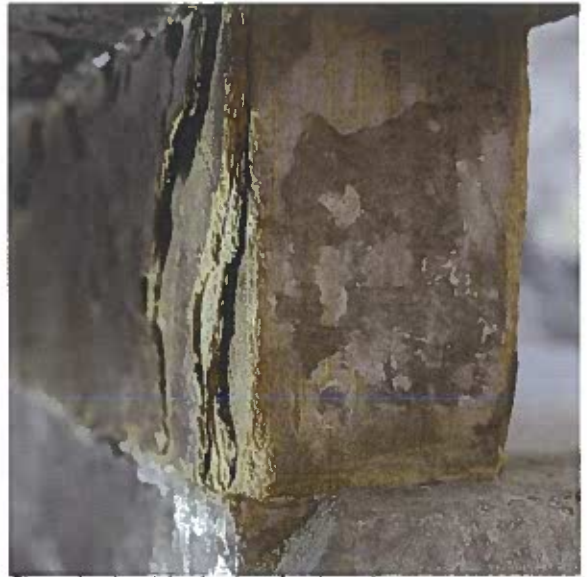
Photo showing delamination of a stone riser

The underside of the stone stair is delaminating. In most areas this is superficial but in some places, particularly under the broken tread, the delamination is extensive. In the past the stone has been painted with a cementitious coating which may have trapped moisture within the stone and is possibly the cause of the delamination of the stone.

The proposal is for a low pressure abrasive clean using a fine aggregate which will remove the delaminated and powdery stone as well as the rest of the cementitious coating. It will allow the stone to be inspected for damage so that any additional treads or risers which are revealed to have failed are identified.

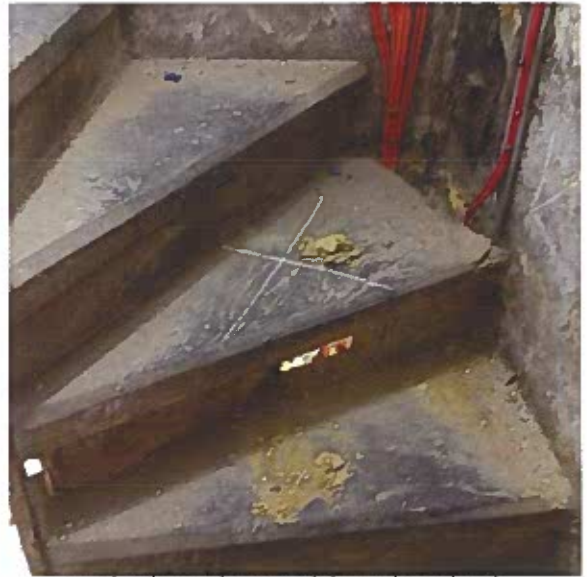
Photo showing damaged tread and riser to be replaced

One of the stone treads has failed mainly because its bearing into the wall has been compromised by an area which was cut out to allow some electrical cables to pass through. The adjacent riser has also been damaged, possibly due to a combination of the extra movement and the increased foot traffic on the stair.

This broken tread and riser will be repaired using new sandstone to match the existing.

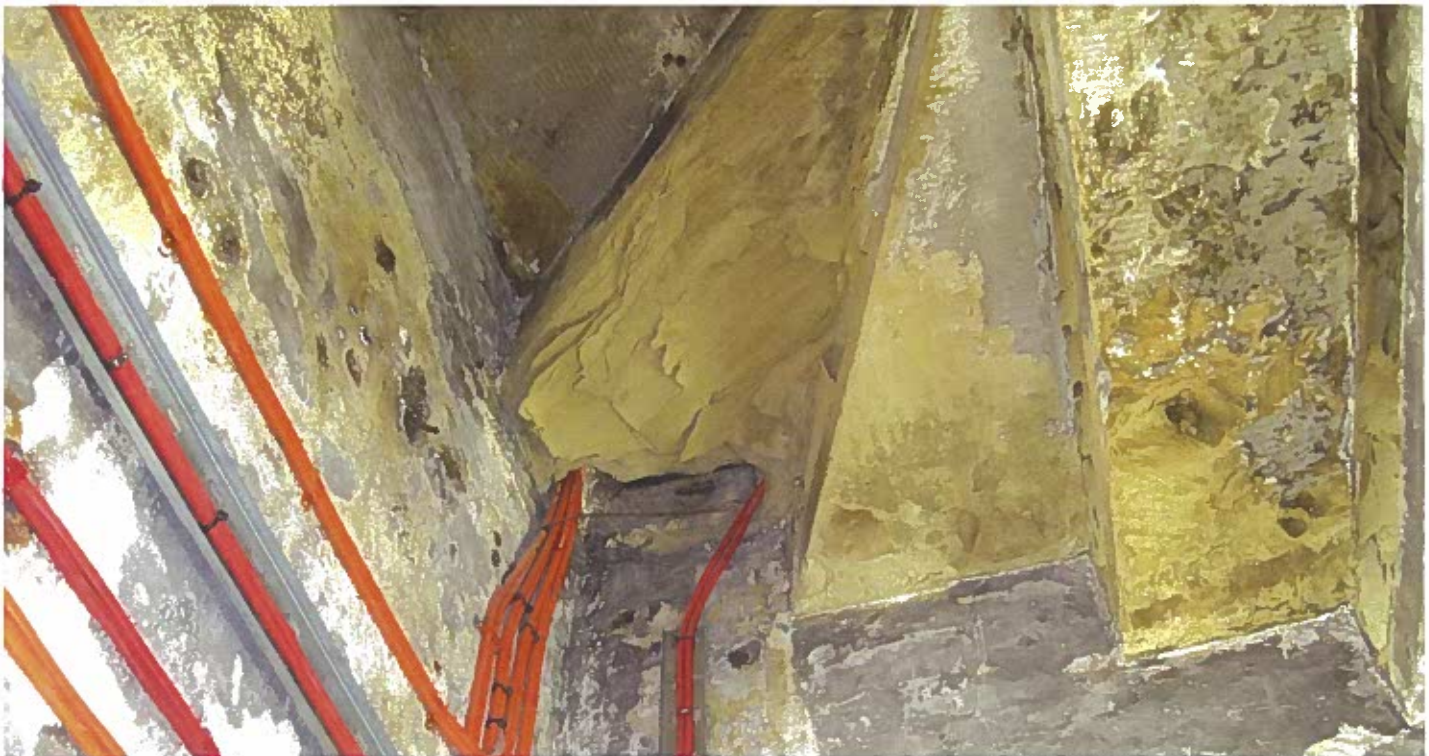
Photograph of the underside of the damaged tread showing extensive delamination and damage. It also shows the surface coating of the stone.

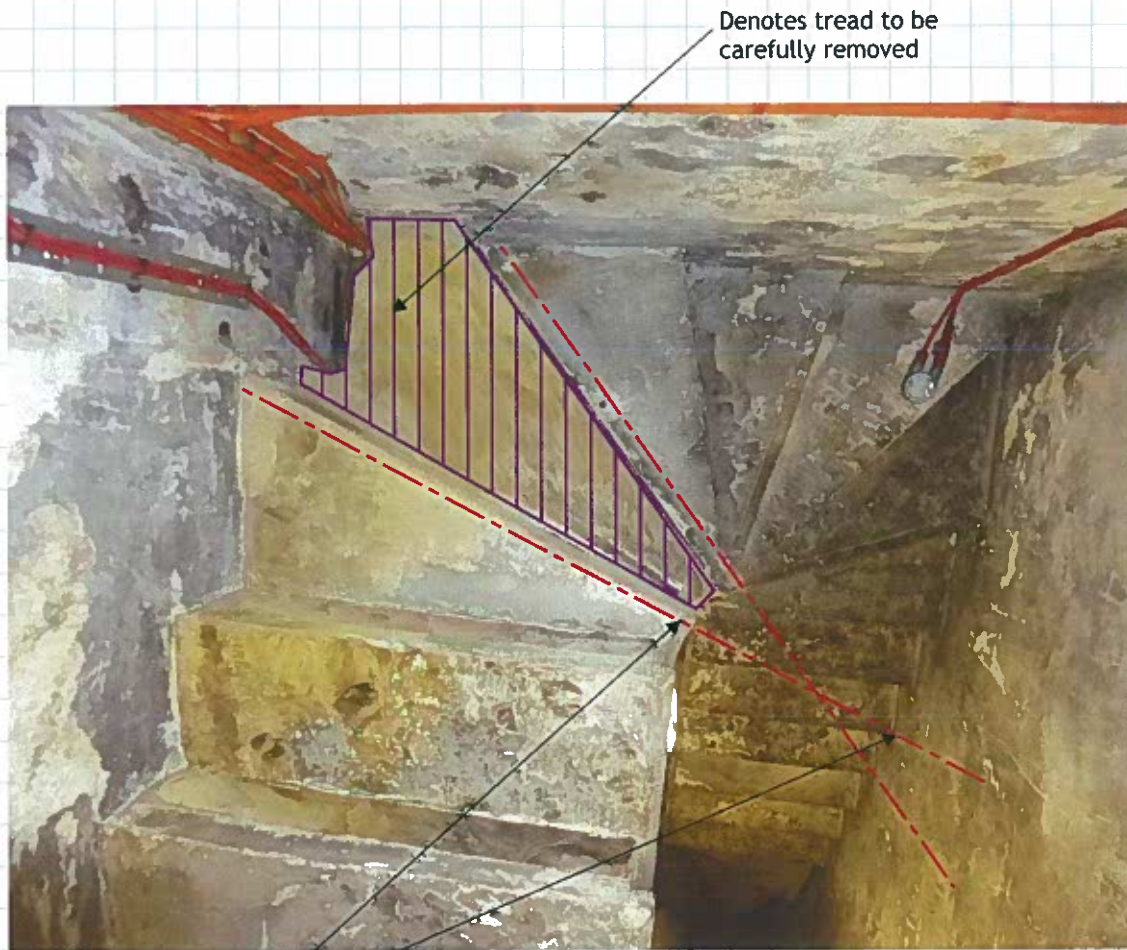
Structural engineer's sketch (SK01) illustrating the method of repairing the stone

2No. 152x89x16 UB temporary beams to support stairs above and below tread to be removed. Connection detail into wall shown to the right.

100x100x8 EA, 300mm long, bolted to existing wall using 2No. M16 resin anchors with Hilti HIT-HY 70 resin, 150mm embedment to manufacturers details

Bolt beam to angle using Lindapter F9 flange clamps (2No. per angle)

In order to replace the step, the stair will first be temporarily supported from below using two steel beams. Also, mansafe anchors will be fixed to the wall to provide fall restraint for the operatives carrying out the work.

The temporary support beams will allow the damaged stone to be carefully cut out and replaced with a new stone tread and riser. Following the works the temporary support and mansafe anchors will be removed and the wall will be made good.

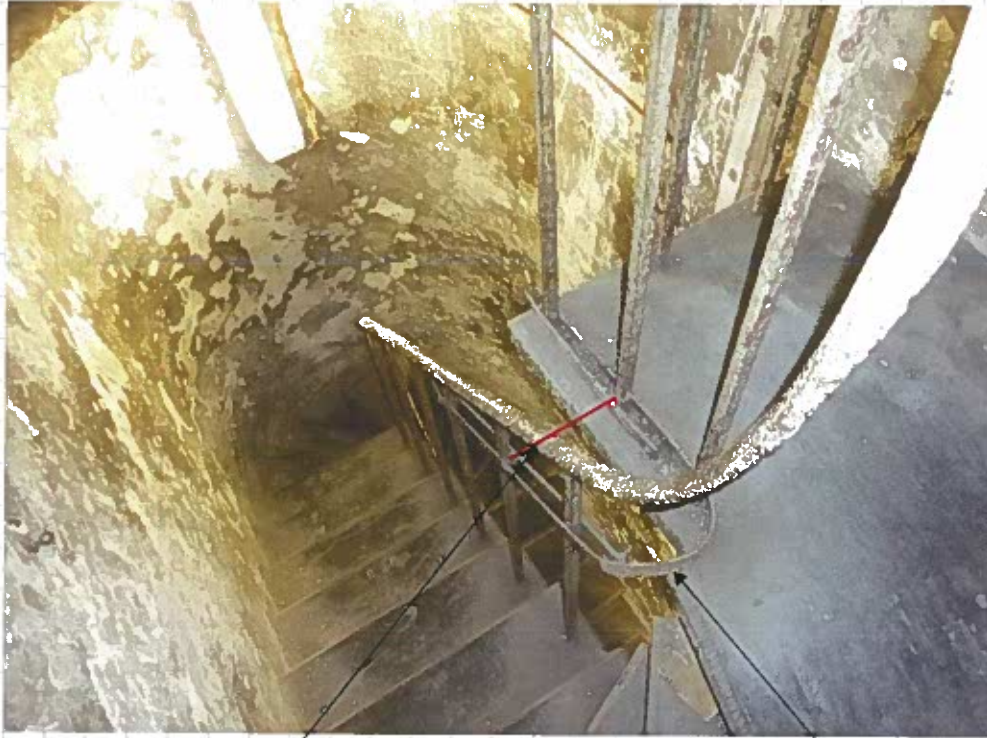
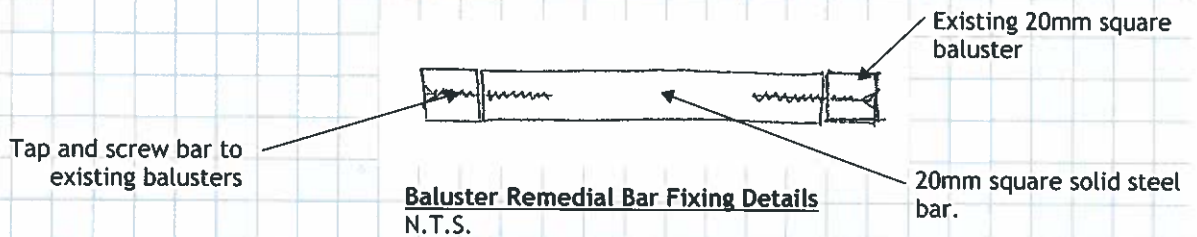
Structural engineer's sketch (SK02) illustrating the proposal to strengthen the balustrade

New 20mm square solid steel bar fixed to top of handrail and bottom of return to stiffen up lower handrail. Refer to fixing detail below.

Existing remedial steel strapping can be removed following installation of steel brace.

Remedial work is also required to strengthen the existing iron balustrade. Existing steel straps will be removed and new steel struts will be screwed in place through the steel balusters. This repair method will be used at the top landing as shown in the photograph above and elsewhere where the balustrade has been weakened. The number of locations where this repair method will be used will be confirmed once the stair has been fully assessed for damage

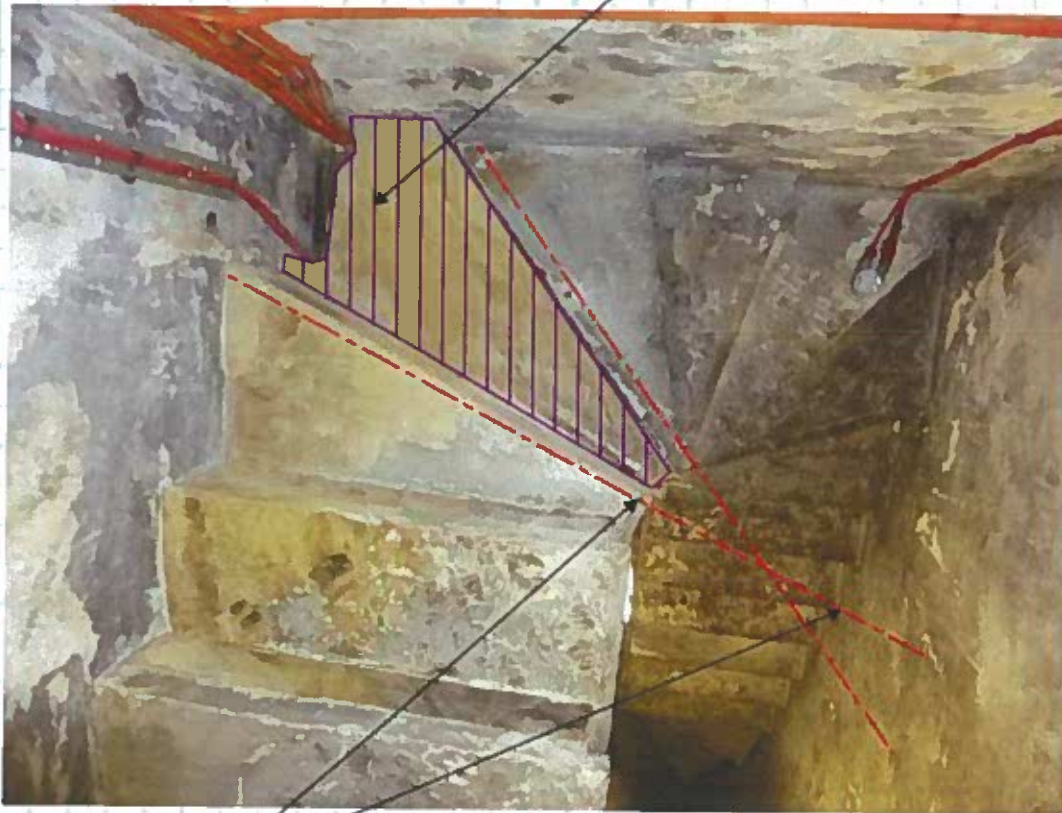
Proposed Stone Replacement Temporary Works Details

Denotes tread to be carefully removed

2No. 152x89x16 UB temporary beams to support stairs above and below tread to be removed. Connection detail into wall shown to the right.

100x100x8 EA, 300mm long, bolted to existing wall using 2No. M16 resin anchors with Hilti HIT-HY 70 resin, 150mm embedment to manufacturers details

Bolt beam to angle using Lindapter F9 flange clamps (2No. per angle)

1. Install angel supports for proposed temporary beams into wall using 2No. M16 resin anchors with Hilti HIT-HY 70 resin.
2. Allow for resin to cure for 24 hours.

3. Install both temporary 152x89x16 UB steel beams, as MNP sketch SK/01, as tight to the existing treads as possible.
4. Shim up between the steel beams and the underside of the existing treads using neoprene shims.

5. Carefully remove existing loose riser.
6. Carefully remove existing tread. Allow to saw cut along existing bearing to free stone from wall.
7. Carefully reform the original bearing of existing tread and riser.

8. Remove cables to allow for installation of new stonework (by specialist).
9. Carefully install new riser, using lime mortar to bed onto existing stone tread below.

10. Carefully install new tread, using lime mortar to bed onto new riser.
11. Re-route cables through new core through stone tread if necessary.
12. Allow mortar to cure for 7 days.

13. Remove temporary steel beams and angle supports.
14. Make good holes in masonry wall where angle supports were installed.

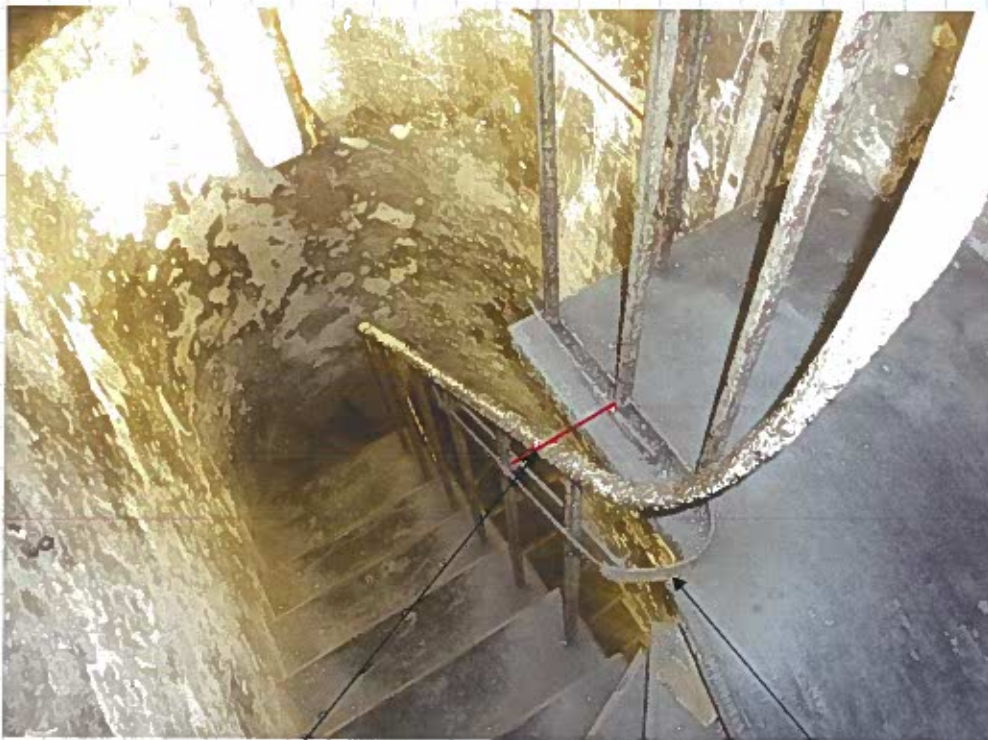
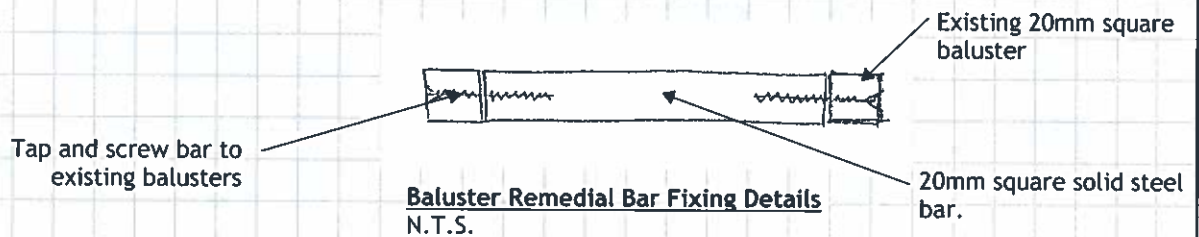
Proposed Remedial Works Details for Top Landing Balustrade

New 20mm square solid steel bar fixed to top of handrail and bottom of return to stiffen up lower handrail. Refer to fixing detail below.

Existing remedial steel strapping can be removed following installation of steel brace.
