Charlie Ratchford Resource Centre - Tree Survey, Implications Assessment & Constraints Plan

Issue/Revision:	Draft	Final
Date:	August 2014	May 2015
Comments:		
Prepared by:	Tom Luck	Tom Luck
Signature:

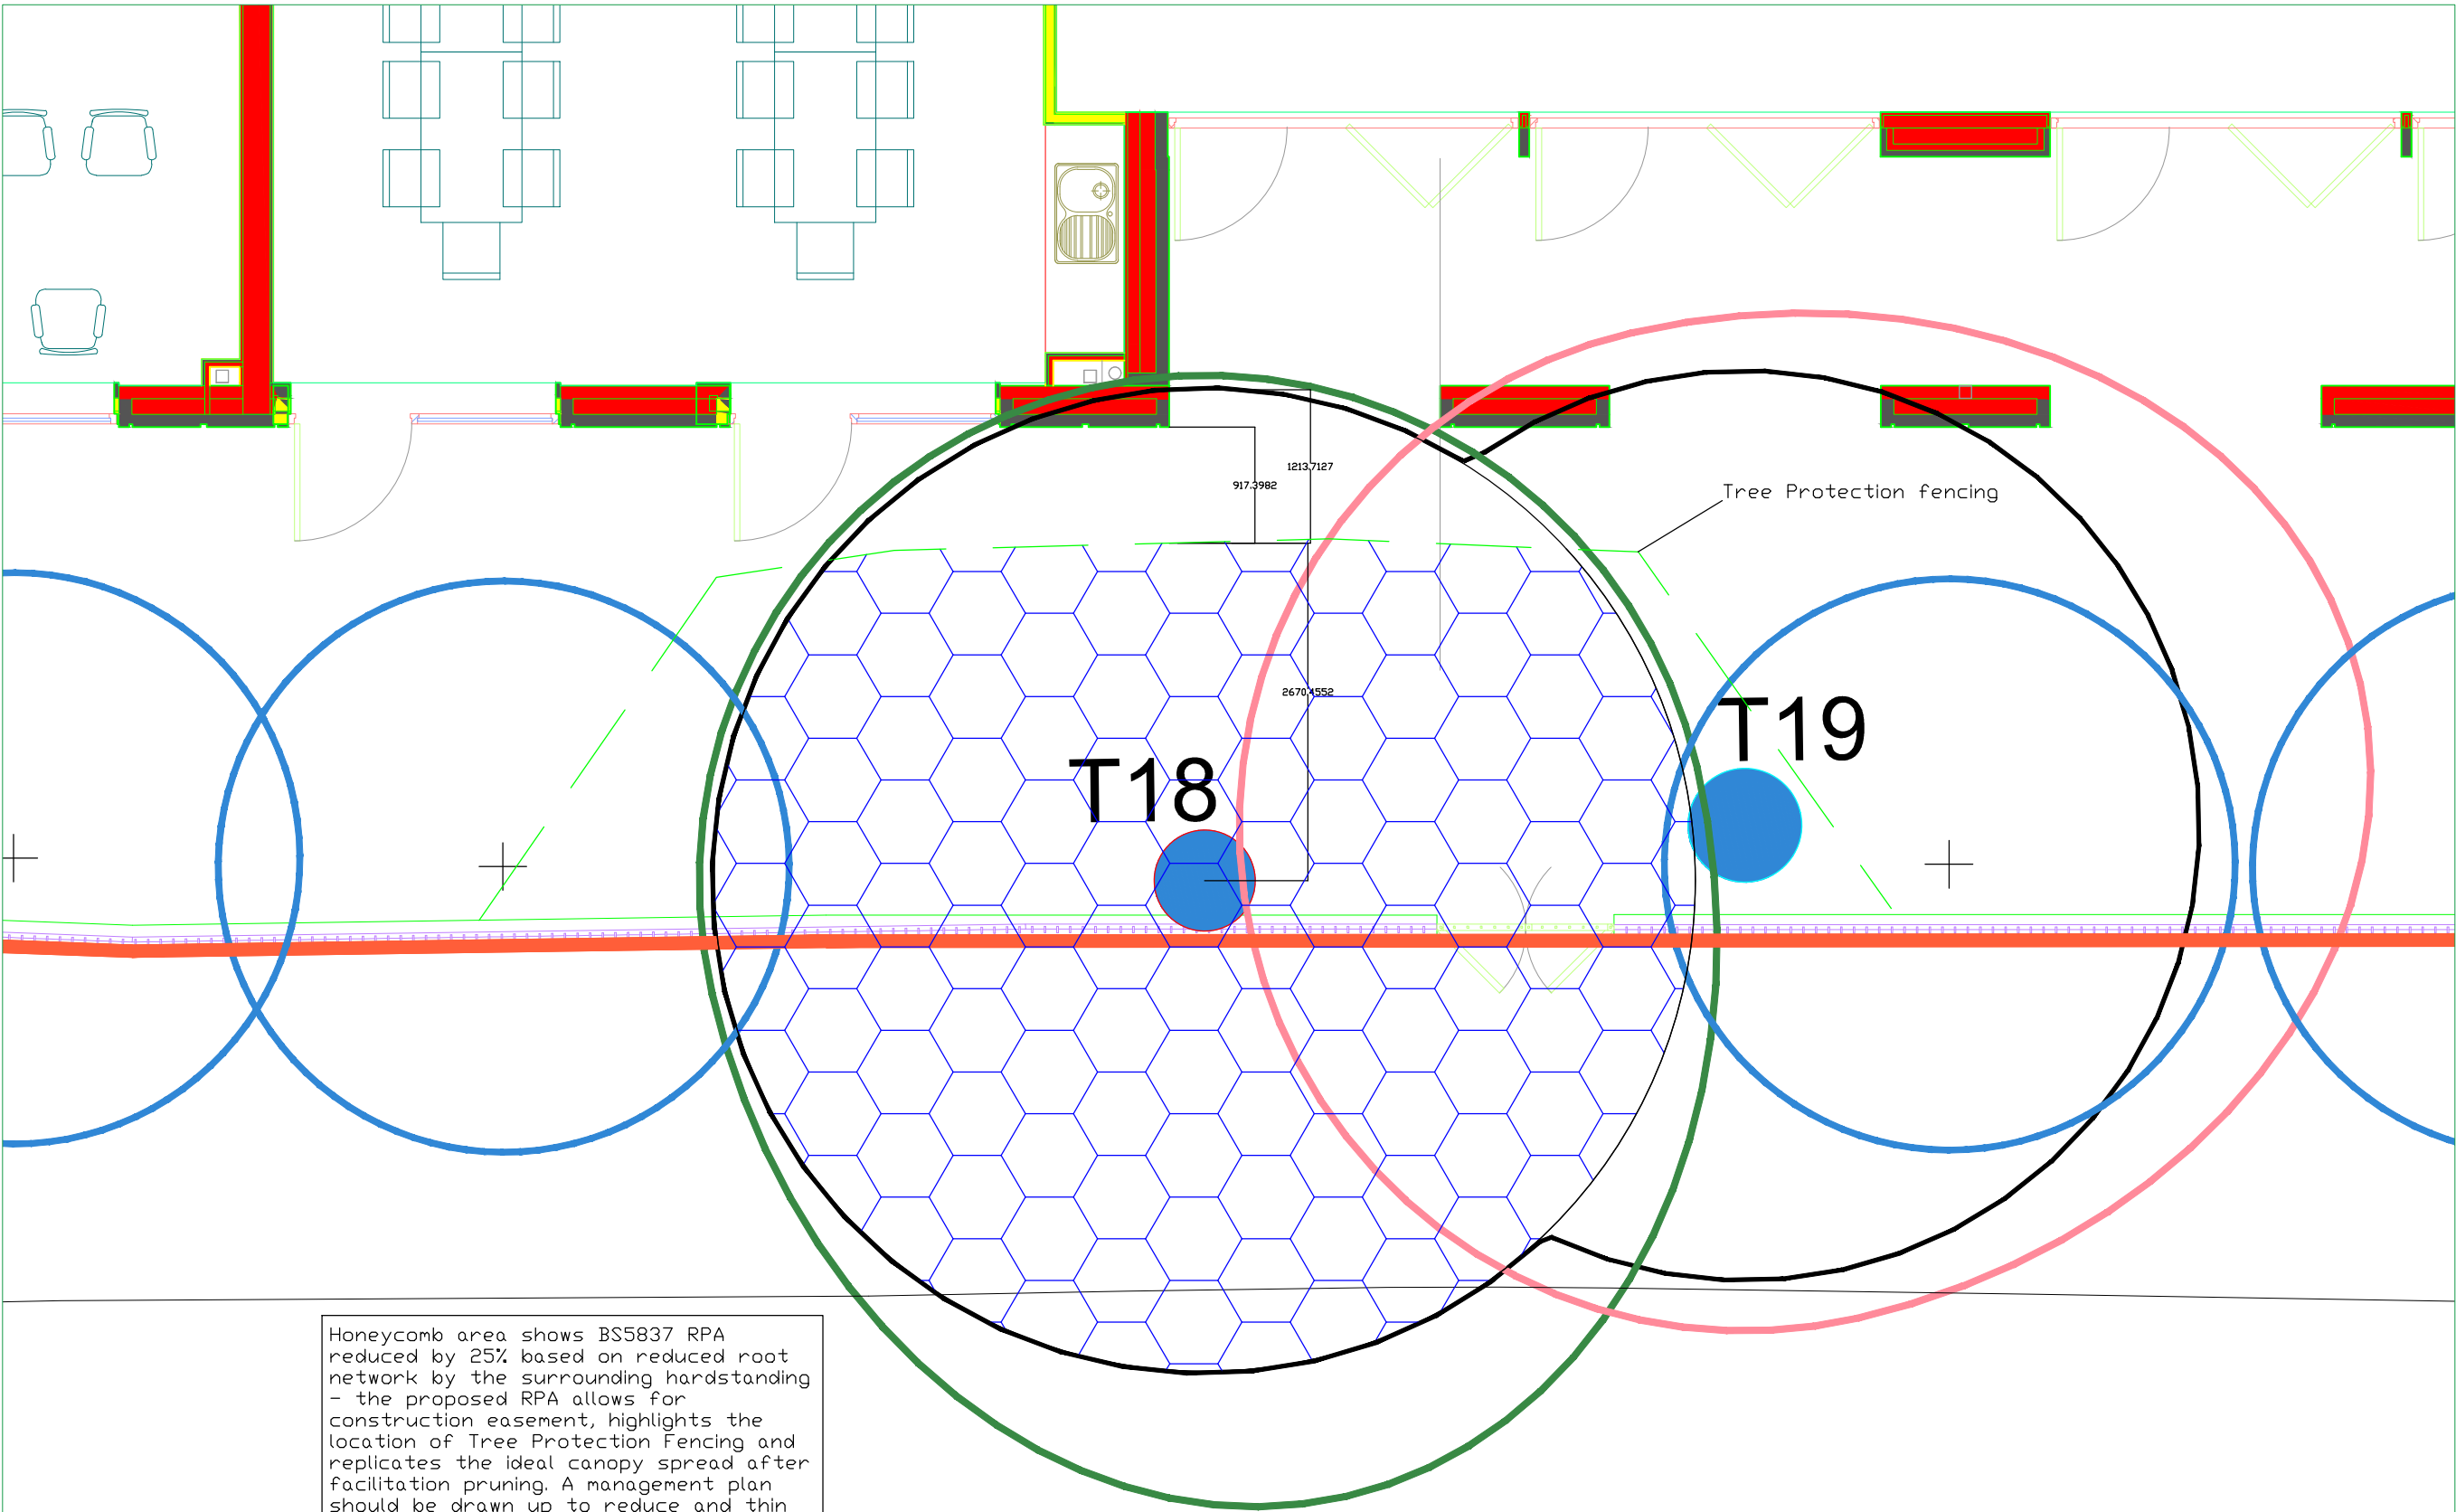
APPENDIX 4: T18

- 5.7 The Landscape Tree Removal Plan highlights a potential conflict between T18 and the proposals. T18 is located in the vacant section of the Crogsland Road site, surrounded by hardstanding. The hardstanding is likely to suppress root growth, reducing the potential for the construction process to damage the roots. Tree protection fencing placed inside the British Standard calculated RPA is likely to protect the tree and avoid root damage. The details of the distance on the tree protection fencing should be specified in an Arboricultural Method Statement.

- 5.8 An incursion of the RPA by the proposals has been discussed with James Remington dated 27th April 2015, who has requested further information regarding the amount of incursion into the RPA. The RPA for T18 is 3.9m radius from the stem which equates to 48m²; allowing a 1.2m incursion into the circular RPA radius equates to 5.6m² of the 48m² RPA. The 1.2m incursion will allow for tree protection fencing to shield 88.4% of the 48m² RPA. This is illustrated in appendix 4.0.

Honeycomb area shows BS5837 RPA reduced by 25% based on reduced root network by the surrounding hardstanding - the proposed RPA allows for construction easement, highlights the location of Tree Protection Fencing and replicates the ideal canopy spread after facilitation pruning. A management plan should be drawn up to reduce and thin the canopy on a regular basis to avoid intermittent heavy pruning operations. The distances are shown in mm.

- 5.9 The proposals also show conflict with the canopy of T18, which, will require facilitation pruning in the form of a crown reduction to avoid any branch damage during demolition and construction and to allow the erection of the tree protection fencing.
