## **TREE HEALTH AND STRUCTURAL INTEGRITY REPORT**

**OUR REF:** JM/3174R/sh

**DATE:** Monday 2<sup>nd</sup> June 2014

**SITE  
ADDRESS:** Seven London Plane trees at;  
Cartwright Gardens, and  
Woburn Square Gardens,  
Gordon Square Gardens, and  
Malet Street Gardens  
London, WC1.

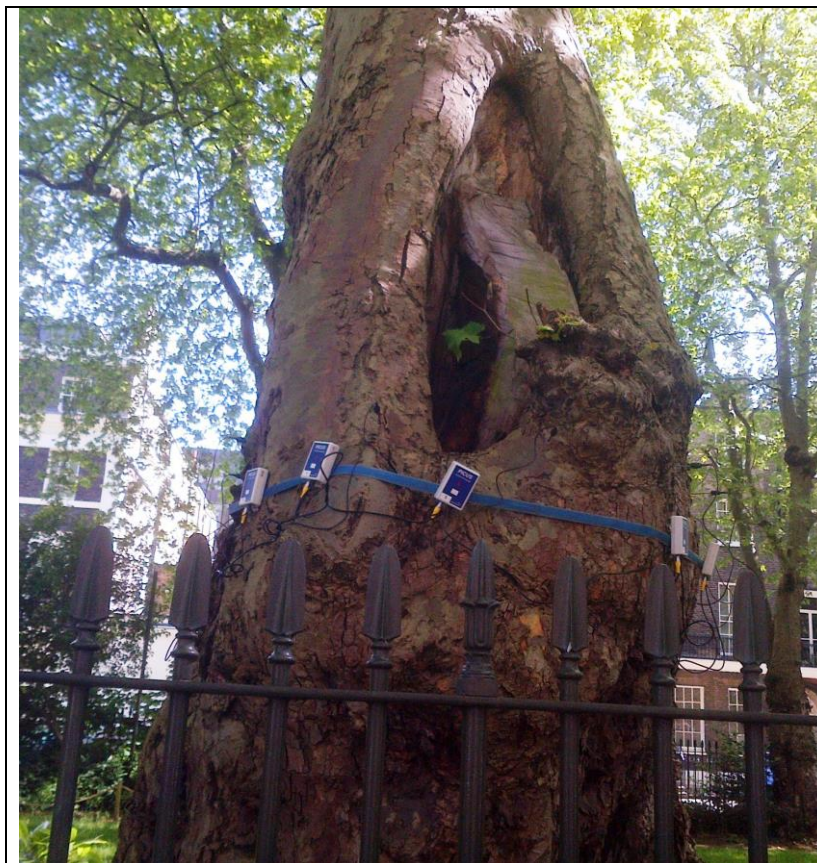
**Picture 1 – The photograph above shows the sensors attached to the main stem of tree No. 587 at 180 centimetres above ground level.**

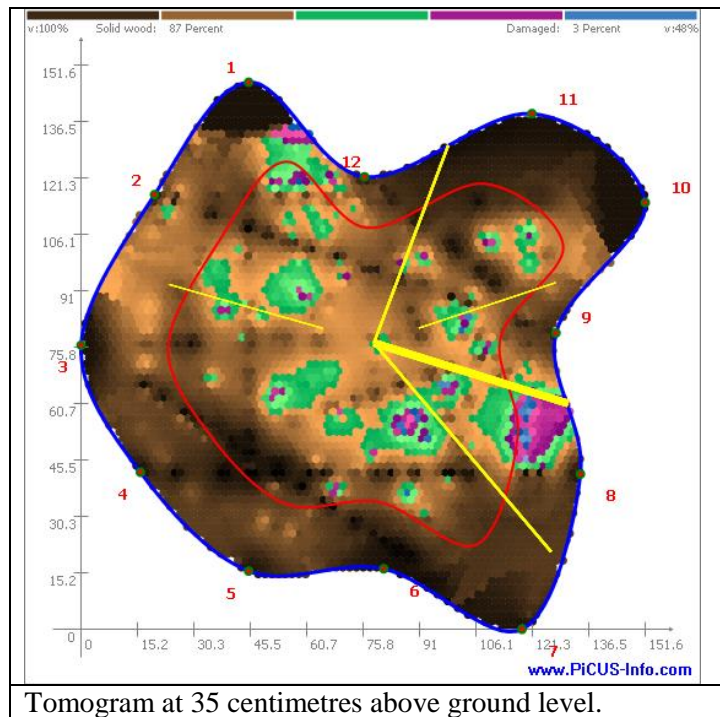
### TREE NO. 477 - LONDON PLANE

The sonic tomograph (Picus) test was conducted as close to ground level as was possible at the time, avoiding the flare of the buttressing and local obstruction. The results (Tomogram) show small mottled areas of damaged wood (Purple/Blue colours) and partially damaged wood/incipient decay (Green colour) within the central, northern and eastern areas of the main stem. Overall 87% of the cross-section is represented as solid wood, 10% as partially damaged wood and 3% damaged/decayed wood. The small areas of damaged and partially damaged wood possibly indicate isolated areas of softened wood. However the mottled pattern is indicative of infection, and has similarities with tomograms displaying infection by the soft rot fungus *Kretzschmaria deusta*.

The circumferential red line on the Tomogram indicates Mattheck's 't/R' ratio, (when the stem of a tree with a full crown is two thirds or more hollow the probability of failure is high). It can be seen that the small mottled areas are predominantly contained within the circumferential red line.

The yellow radial lines shown on the tomogram indicate possible cracks or barriers to the sound-waves in the wood. The thickness of the yellow lines displayed by the software is indicative of the relative size of the underlying crack. In this case there is a network of cracks on the eastern side of the main stem, the wider indicated crack between sensors 8 and 9 is considered to be in part influenced by included bark.

- ❑ In conclusion, we would advise that the structure of tree No. 477 is somewhat weakened by the presence of radial cracks, potentially further weakened by fungus colonization and is considered a moderate risk. It would therefore be prudent to reduce the crown by between 2.0 and 3.0 metres in height and lateral spread. This will remove the over-extended nature of the limb to the west and reduce weight over the weakened base. It will be important to keep the base of the tree clear of vegetation to allow on-going self-inspection for evidence of fungal colonization.

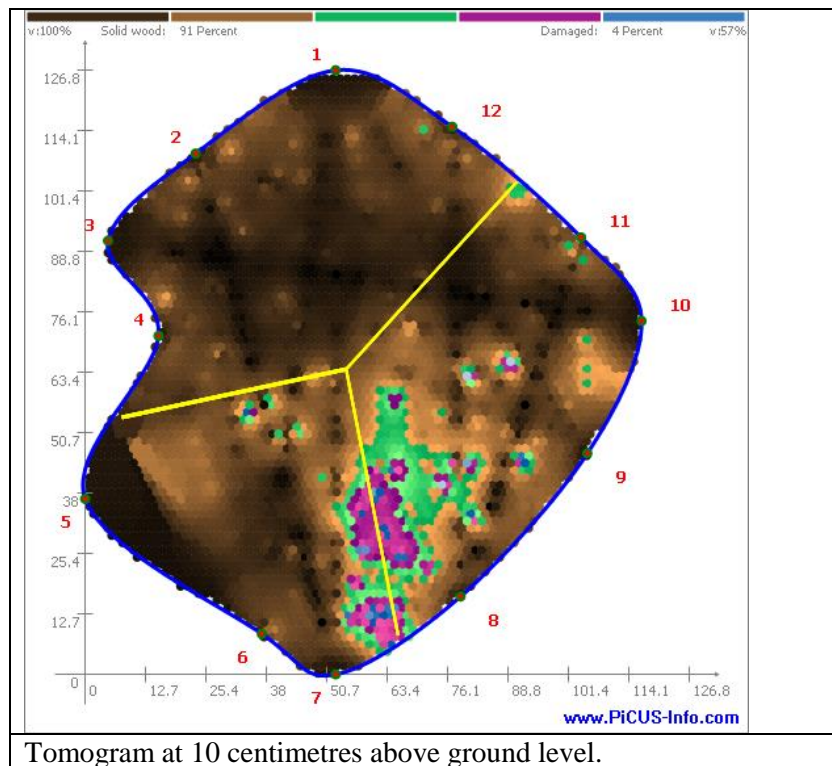
## TREE NO. 495 - LONDON PLANE

The sonic tomograph (Picus) test was conducted as close to ground level as was possible at the time, avoiding the flare of the buttressing. The results (Tomogram) show damaged wood (Purple/Blue colours) on the southern side of the main stem. Overall 91% of the cross-section is represented as solid wood, 5% as partially damaged wood and 4% as damaged/decayed wood. The relatively small areas of damaged wood likely indicate isolated areas of softened wood, possibly related to decay within central root zone, which may be expected for a tree of this maturity.

The yellow radial lines are considered to likely indicate the presence of radial cracking.

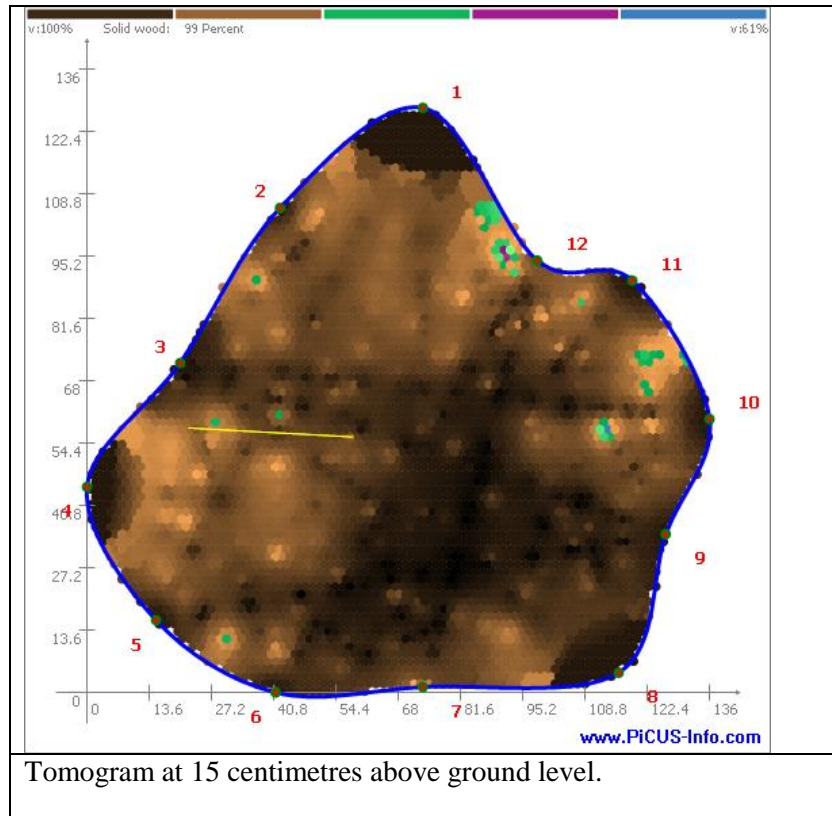
## TREE NO. 503 - LONDON PLANE

The sonic tomograph (Picus) test was conducted as close to ground level as was possible at the time, avoiding the flare of the buttressing and local obstruction. The results (tomogram) show some small areas of damaged wood (Purple/Blue colours) and partially damaged wood/ incipient decay (Green colour) on the north-eastern side of the main stem. Overall 99% of the cross-section is represented as solid wood, 1% as partially damaged wood and 0% damaged/decayed wood. The small areas of damaged and partially damaged wood possibly indicate isolated areas of softened wood are highly localised.

There is one narrow yellow radial line between sensors 3 and 4, which is considered likely in this case to indicate a minor, contained radial crack.

- ❑ Remove deadwood in crown at 18.0 metres.
- ❑ At the time of the deadwood removal, inspect the fusing branches at 24.0 metres above ground level and remove the smaller touching limb if in excess of 30% of the limb cross sections are damaged.

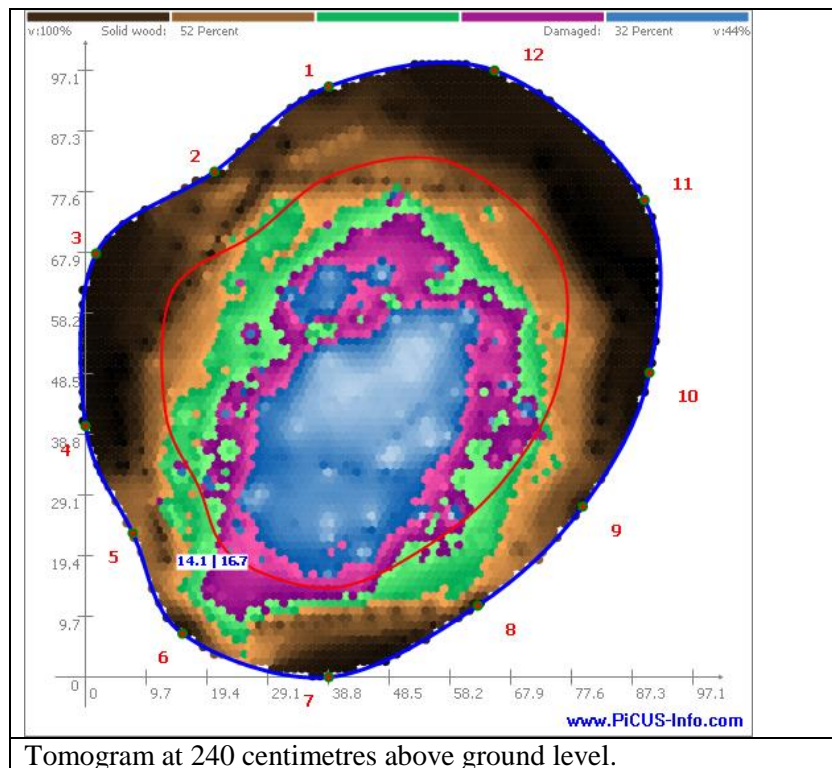
## TREE NO. 511 - LONDON PLANE

The sonic tomograph (Picus) test was conducted to assess the extent of decay at the base of the large cavity within the main stem at approximately 240 centimetres above ground level. The results (tomogram) show a central area of damaged/decayed wood (Purple/Blue colours), resulting from decay development at the point of a previously lost large limb/co-dominant stem. Overall 52% of the cross-section is represented as solid wood, 16% as partially damaged wood and 32% damaged/decayed wood.

The tomogram indicates the decay to have been well compartmentalised by the tree.

The area of decayed wood (illustrated in the tomogram image as blue) is suggested by the software to have lost approximately half of the strength of the solid wood shown in brown colours.

The circumferential red line on the Tomogram indicates Mattheck's 't/R' ratio, (when the main stem of a tree with a full crown is two thirds or more hollow the probability of failure is high). It can be seen that the sound wood is generally at the boundaries to satisfy the ratio. Above the testing level, the cavity opening is 12 centimetres wide, representing approximately 4% of the 300 centimetre circumference.

- ❑ The tree will require a further non-invasive PICUS test at the corresponding height within 3 years to assess the progression of decay.

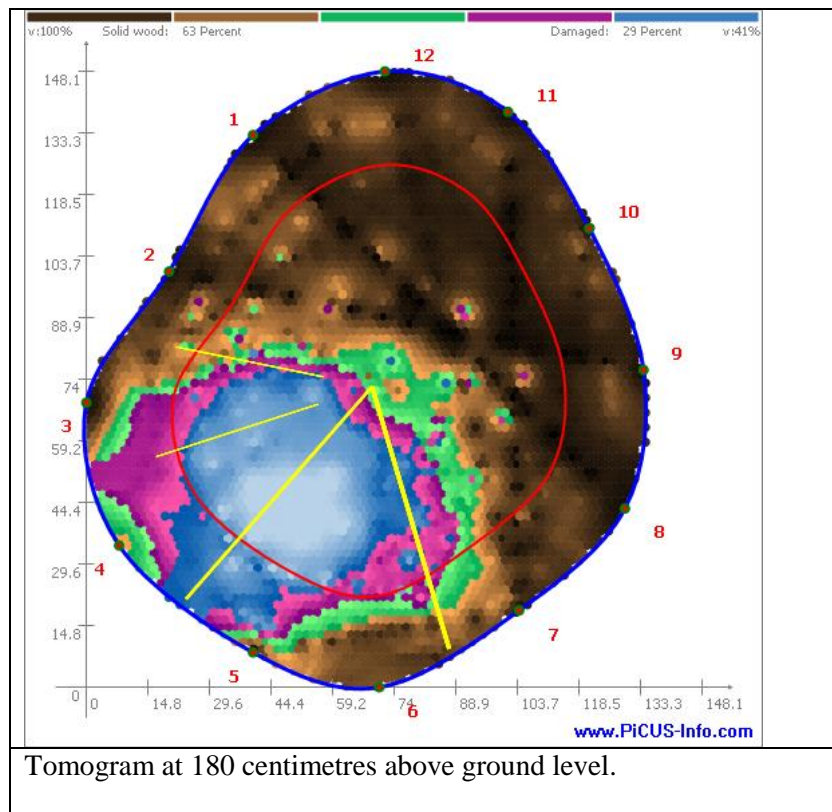
## TREE NO. 587 - LONDON PLANE

The sonic tomograph (Picus) test was conducted at the base of the large cavity within the main stem at approximately 180 centimetres above ground level, to assess the extent of decay. The results show an off-centre area of damaged/decayed wood (Purple/Blue colours) on the south-west side of the main stem, likely resulting from decay development at the point of a previously lost large limb/co-dominant stem. Overall 63% of the cross-section is represented as solid wood, 18% as partially damaged wood and 29% as damaged/decayed wood.

The tomogram indicates the decay to have been relatively effectively compartmentalised by the tree.

The area of decayed wood (illustrated in the tomogram image as blue) is suggested by the software to have lost in excess of half of the strength of the solid wood shown in brown colours.

The circumferential red line on the Tomogram indicates Mattheck's 't/R' ratio, (when the main stem of a tree with a full crown is two thirds or more hollow the probability of failure is high). It can be seen that the sound wood on the north side of the main stem is sufficient to satisfy the ratio. On the south side of the main stem the sound wood is insufficient to satisfy the ratio. However it should be noted that the software has exaggerated the extent of decay in this area, a visual assessment of the residual wall adjacent to sensor 4, indicates approximately 12 centimetres of sound wood. The cavity opening is 60 centimetres wide, representing approximately 14% of the 440 centimetre circumference.

- ❑ The tree will require a further non-invasive PICUS test at the corresponding height within 3 years to assess the progression of decay.

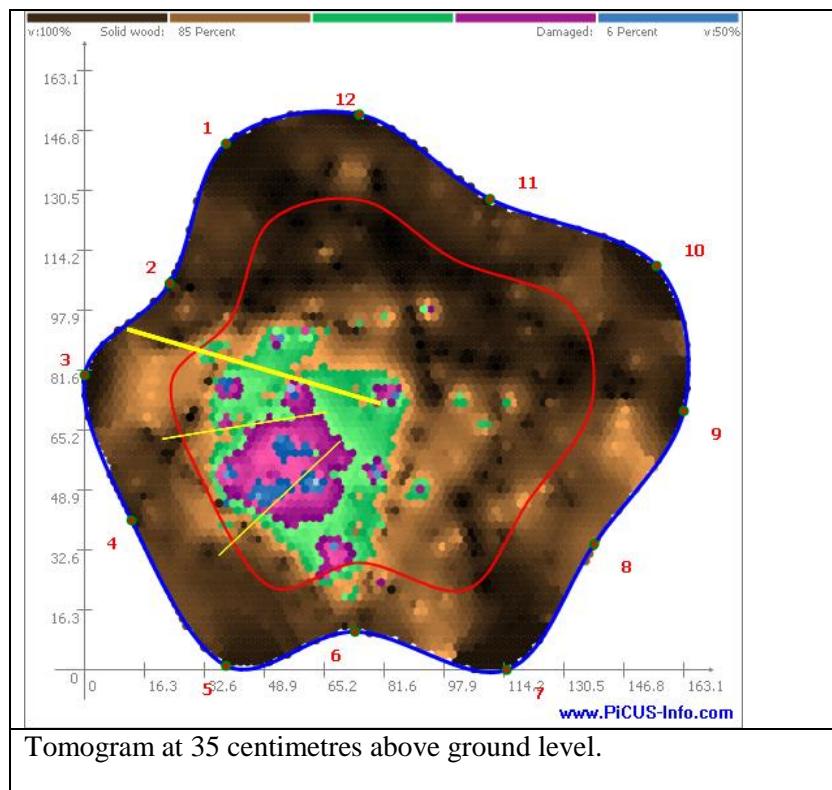
## TREE NO. 433 (622) - LONDON PLANE

The sonic tomograph (Picus) test was conducted as close to ground level as was possible at the time, avoiding the flare of the buttressing. The results show damaged wood (Purple/Blue colours) within the central area of the main stem. Overall 85% of the cross-section is represented as solid wood, 9% as partially damaged wood and 6% as damaged/decayed wood. The location of the damaged wood would suggest decay within the central root system, which may be expected for a tree of this maturity.

The yellow radial lines shown are considered in the case to be an anomaly and in fact indicate the edges of the decay.

The tomograph indicates the decay to be currently weakly invasive and has been effectively compartmentalised by the tree.

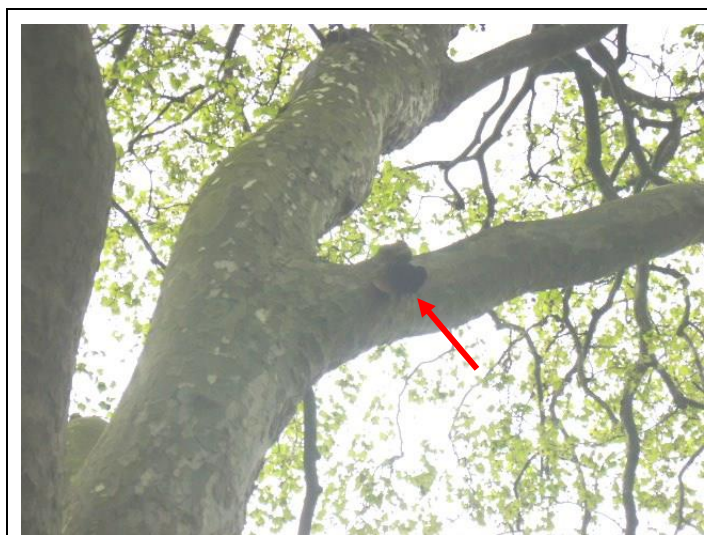
An old fungal fruiting body of *Inonotus hispidus* was observed attached to a scaffold limb on the western side of tree No. 477 at 12.0 metres above ground level. This species of fungus is reported to cause a simultaneous white rot affecting upper portions of the main stem and principal branches. London Plane is a common host of the fungus but is more resistant to failure even when a cavity has formed than other affected species such as Ash. (Green, T and Watson, G. 2011 'Fungi on Trees'. Arboricultural Association. Stonehouse, Gloucs).

Picture 2 – Showing tree No.477 and the *Inonotus hispidus* fruiting body at 12.0 metres.

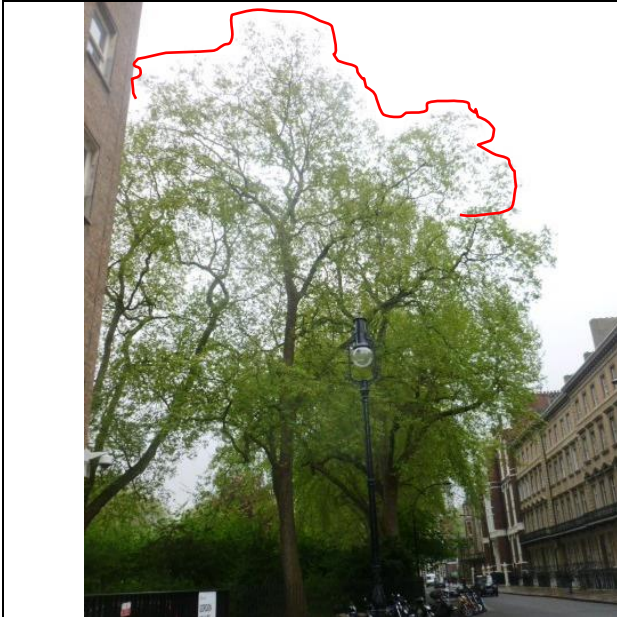
The tree's crown displays minor asymmetry and has below average vitality, it is sparse throughout with an estimated foliage density of 75% when compared to neighbouring London Plane trees of similar age. The crown contains less than 5% deadwood up to 30 millimetres in diameter, which overhangs the public footpath. The calculated live crown ratio (LCR) of the tree is 80%, which is acceptable.

Picture 3 – Tree No. 495 with sparse crown.

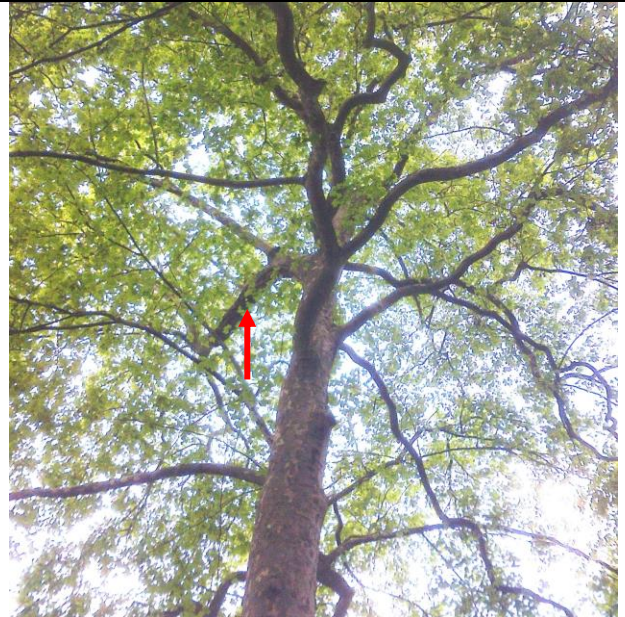
The bark at the underside of the lowest scaffold limb on the north-west side of the main stem at approximately 15.0 metres contains numerous cracks and loose bark, suggesting heavy loading; this is confirmed by the three vigorous vertical sprouts that have developed along the length of the scaffold limb, likely following historical storm damage.

Picture 4 – Tree No. 587 with splits and decay at underside of heavily weighted limb.

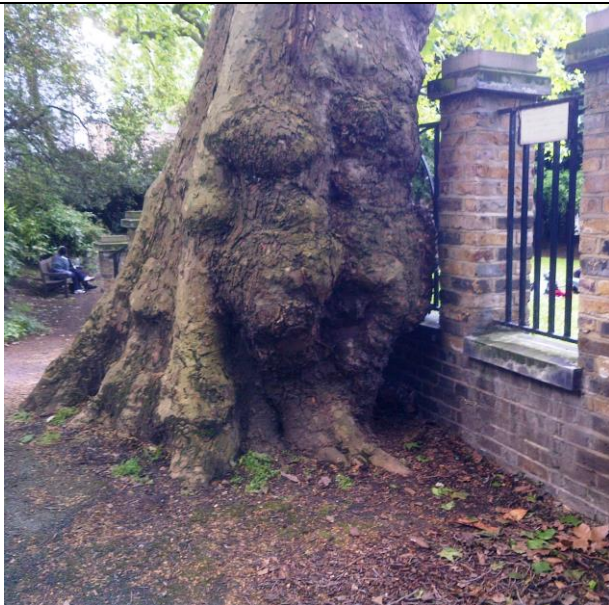
Tree No. 750 (361) has had a long-standing relationship with the adjacent brick retaining wall and there is a notable, but not extreme, bowing outwards of the structure opposite the stem of the tree. The wall shows signs of historical and recent repairs to remediate the likely direct damage caused by the tree. The aerial parts of the tree are not currently in contact with the wall, it is therefore probable that root contact with the brickwork coupled with the swaying motion of the tree to be causing on-going progressive movement.

Currently there is 1 centimetre gap between the burring on the north-west side of the main stem and the centre of the adjacent pillar within the wall. At the base of the tree the gap between the main stem and the wall is in the region of 12 centimetres. It is possible to carry out works to the structure of the wall and/or the tree to increase the gap between the main stem and the structure; however there is considered to be no recommended works to the tree to control a root system to prevent future direct damage.

Picture 5 – Tree No. 433 adjacent to brick retaining wall.

- The tree is located directly adjacent to a brick retaining wall; future direct and possibly mutual damage is inevitable. The length of time until damage occurs above ground will be improved by relocating the coping stone to the north of the stem by approximately 40 millimetres and by shaving off approximately 50 millimetres from the burr on the north-west side of the main stem extending from 0.5 to 1.2 metres.

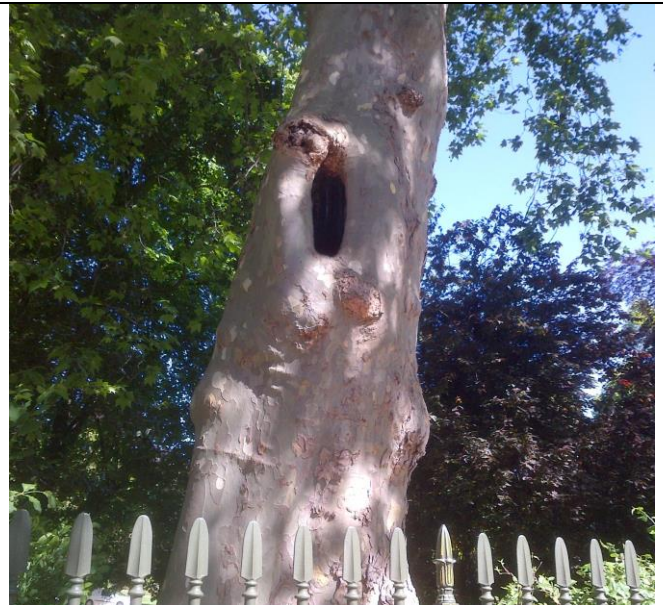
The tree stem is in degraded condition as it contains a cavity at the suspected point of previous major limb attachment, since removed/failed. The cavity extends from 2.5 to 2.9 metres above ground level and is 12 centimetres wide at the mouth opening. Probing with a metal spike reveals the cavity to extend 25 centimetres horizontally toward the centre of the main stem and at least 25 centimetres vertically downwards. There are strong ribs of reaction wood at the perimeter of the cavity opening. Tapping the main stem with a mallet produced hollow sounds beneath the cavity from 2.5 metres extending down to 1.9 metres above ground level on the south and south-east sides of the main stem.

Picture 6 – Tree No. 511, cavity at 2.4 metres above ground level.
