Bartlett Consulting

Date: 21st May 2015
Our Reference: JM/150261L/sh

Re: Boundary between Jockey's Fields and Raymond Buildings: Letter to accompany notification to carry out works to trees within a Conservation Area.

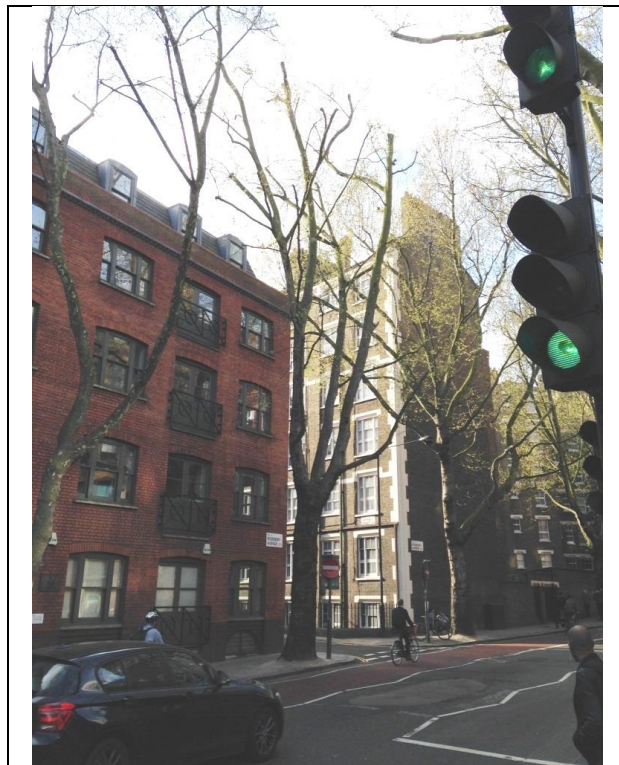
Photograph one – Showing high pollarded trees in the nearby Roseberry Avenue.

It is considered appropriate that the trees adjacent to the damaged boundary wall are now managed on a similar regime to those in the local street environment. Whilst high pollarding the trees will alter their appearance, it would allow the trees to be retained and reduce the future risk of direct damage to the Grade 2 listed boundary wall. Implementing a high pollarding regime would not be out of keeping with the London Plane trees located in the local street scene and the trees would remain with impressively large dimensions.

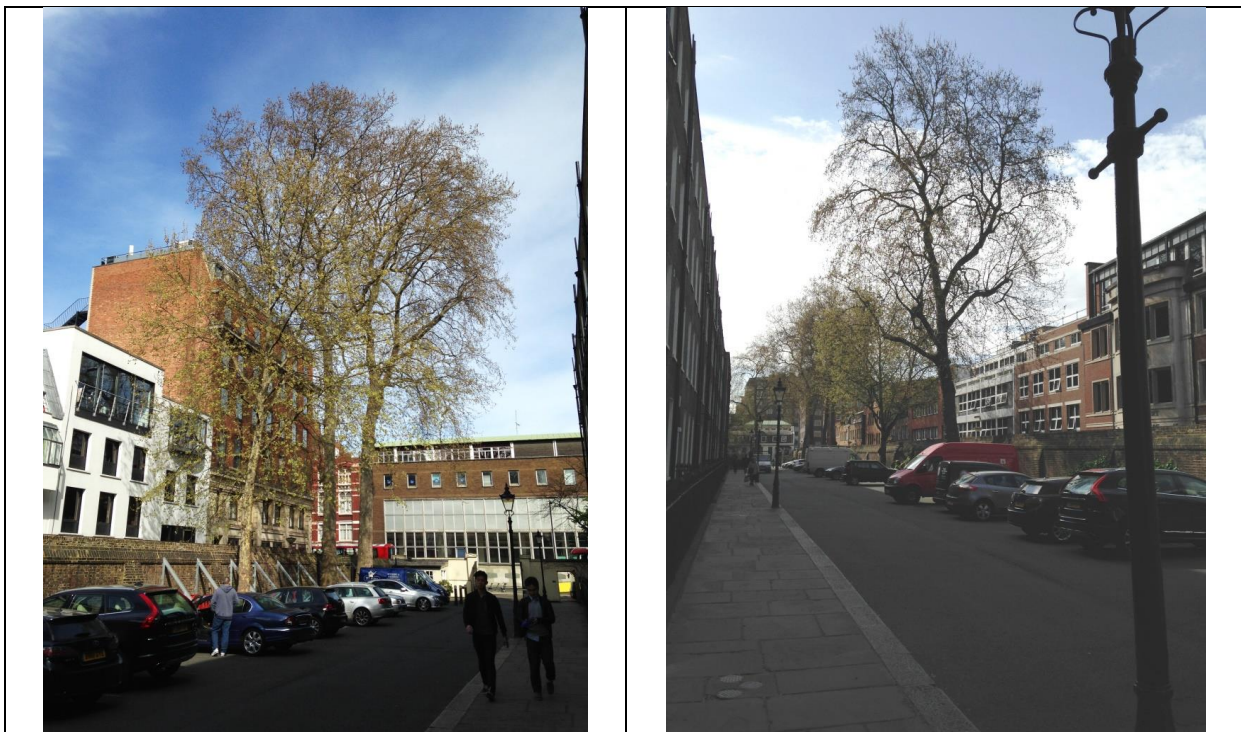
The trees T600 and T601 are mature specimens and located adjacent to the greatest extent of damage to the wall. T602, a younger replacement planting is currently of less concern due to its smaller dimensions. It would appear prudent at this stage to high pollard T600 and T601 to reduce future risk of damage to the boundary.

T606, T608, T609 and T610 are located adjacent to the two wall sections that are subject to outward leans in the direction of Jockey's Fields so will require repair in the form of rebuilding. Whilst the Structural Engineer has not attributed damage to these sections of wall with the adjacent trees, high pollarding would reduce future risk for the reasons detailed above for T600 and T601. Managing T606, T608, T609, T610 and T611 as high pollards as for T600 and T601 would also maintain a more cohesive group. The recommendations for the trees differ slightly as a result of the variance in their heights and the effort to maintain a cohesive tree group.

T602 and T607 are younger specimens with smaller dimensions and therefore it is not considered expedient at this time to conduct high pollarding.

Photograph two – Showing the trees adjacent to the northern section of the wall; T602 is at the front and T601 and T600 behind.

Photograph two – Showing the T606 in the foreground and T607 – T611 behind.

| Tree Number | Species | Schedule of works |
|---|---|--|
| T600 | London Plane | High pollard by reduction in height by approximately 5.0 metres and reduction in lateral spread by approximately 3.0 metres to balance. Re-reduce back to pruning points on a three year cycle. |
| T601 | London Plane | High pollard by reduction in height by approximately 5.0 metres and reduction in lateral spread by approximately 3.0 metres to balance. Re-reduce back to pruning points on a three year cycle. |
| T602 | London Plane | No works presently required. |
| T606 | London Plane | High pollard by reduction in height by approximately 5.0 metres and reduction in lateral spread by approximately 3.0 metres to balance. Re-reduce back to pruning points on a three year cycle. |
| T607 | London Plane | No works presently required. |
| T608 | London Plane | High pollard by reduction in height by approximately 3.0 metres and reduction in lateral spread by approximately 2.0 metres to balance. Re-reduce back to pruning points on a three year cycle. |
| T609 | London Plane | High pollard by reduction in height by approximately 3.0 metres and reduction in lateral spread by approximately 2.0 metres to balance. Re-reduce back to pruning points on a three year cycle. |
| T610 | London Plane | High pollard by reduction in height by approximately 3.0 metres and reduction in lateral spread by approximately 2.0 metres to balance. Re-reduce back to pruning points on a three year cycle. |
| T611 | London Plane | High pollard by reduction in height by approximately 3.0 metres and reduction in lateral spread by approximately 1.5 metres to balance. Re-reduce back to pruning points on a three year cycle. |
