6. Desk Study and Walkover Survey

Walk over Survey

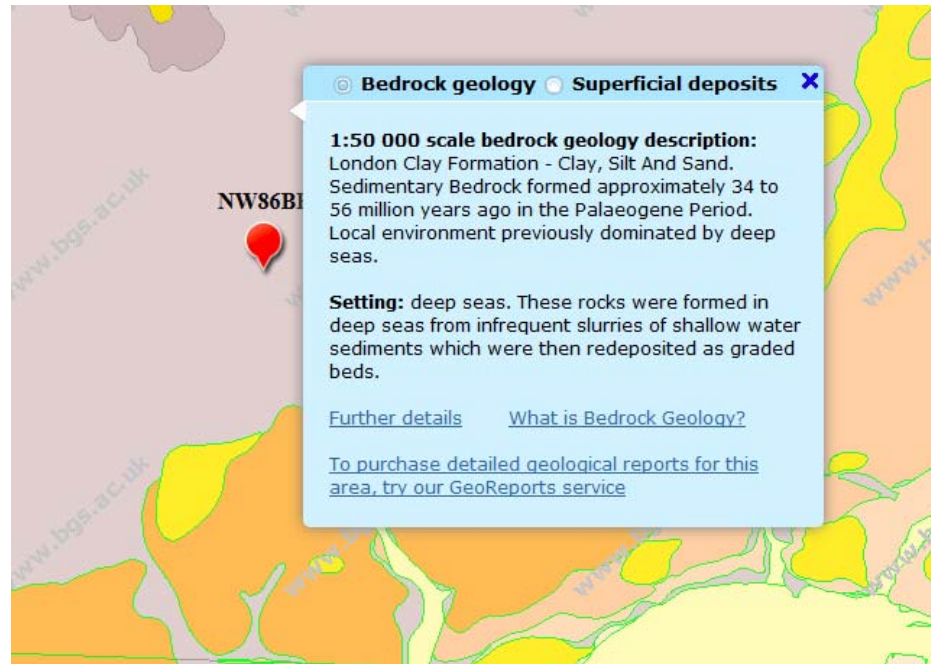
Accordingly to the Geology of Britain viewer, the site is located on London Clay Formation. This is as expected in the area.

Figure 27 14f Avenue Road on geology of Britain viewer

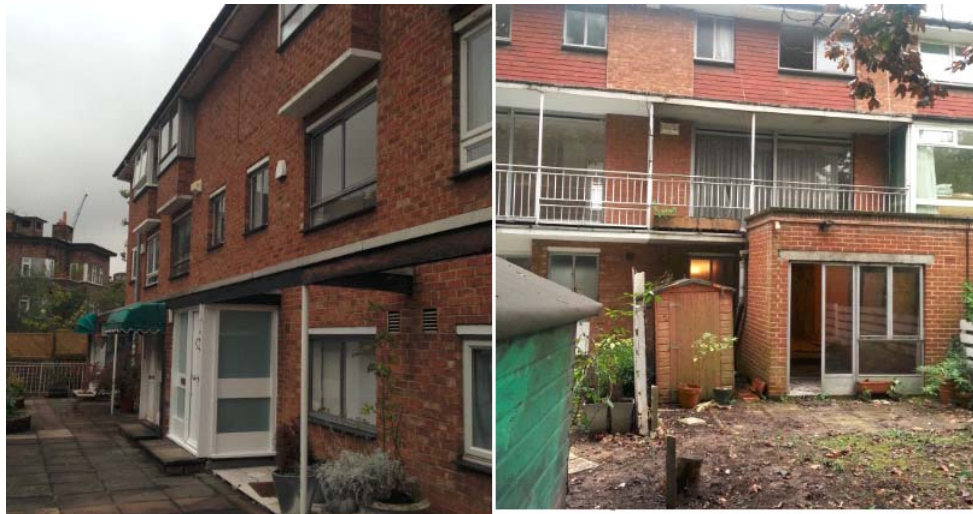
Figure 28 Rear and front of 14 Avenue Road

The existing building did not exhibit any signs of subsidence nor movement. The building is part of a terrace and the effects of the development on the adjacent properties will need to be considered.

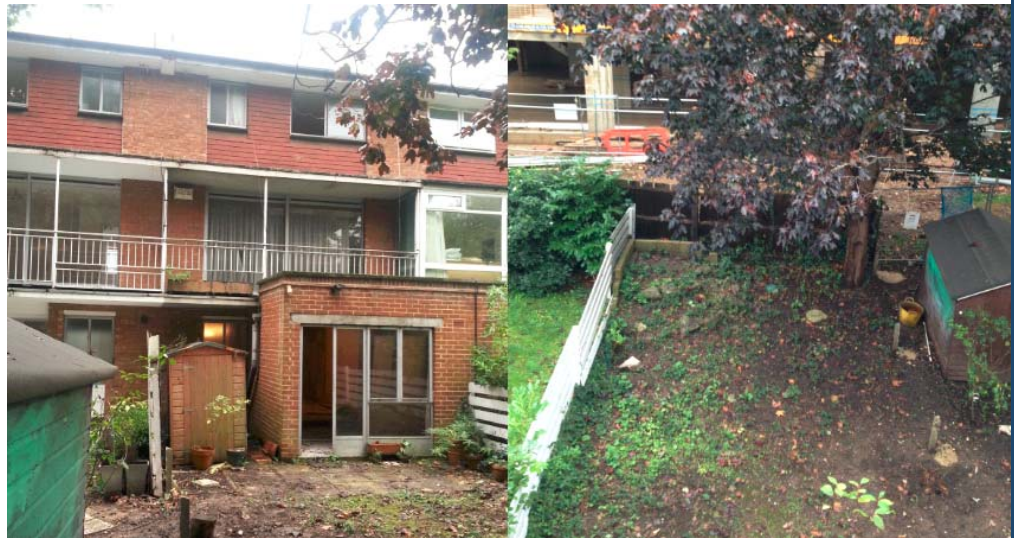
Figure 29 Large tree at the back of the garden. Boundary lines with the Neighbours as timber fences and solid wall between two extensions.

Two big Maple trees were noted at the back of the properties (one, on Neighbour's side). The trees are not going to be cut down due to basement works. Root barrier protection can be required to protect new basement walls. The base of foundation excavations must extend at least 300mm into non-root penetrated soils.

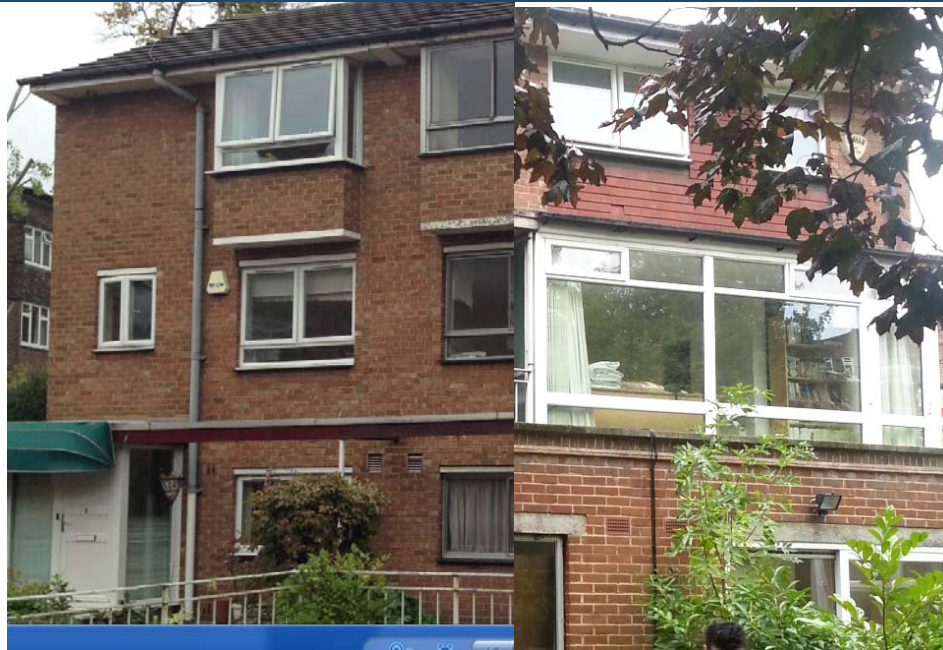
Figure 30 14f Avenue road front /rear of the building

No. I and G are attached properties. Based on visual inspection undertaken on 14th October 2014 for the property and the neighbours, no signs of cracking / movement were noted to the front and rear elevation of the properties. The water course was noted on the site at the time of the inspection.

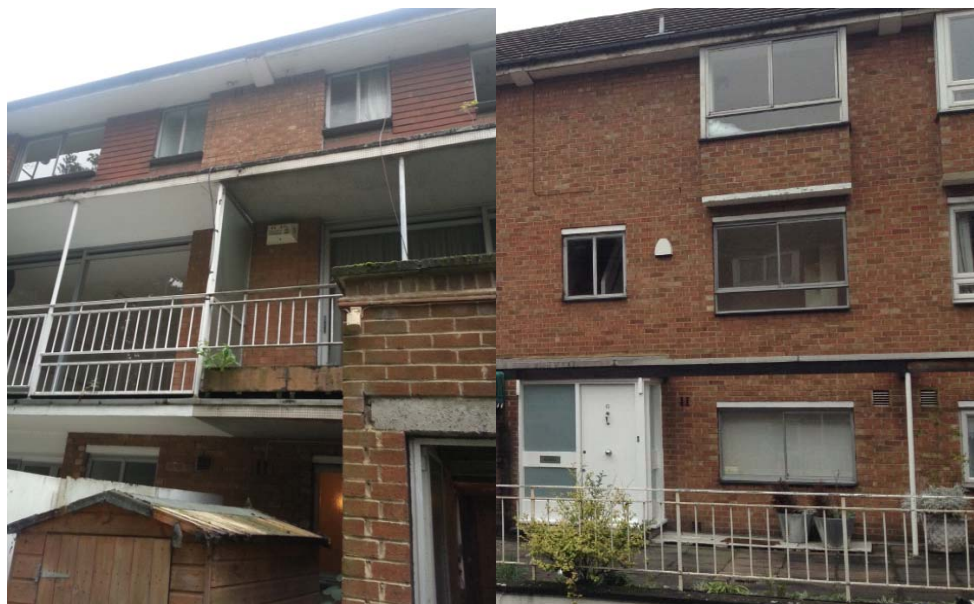
Figure 31 14g Avenue road front /rear of the building
