# ADDENDUM TECHNICAL REPORT

**Crawford Reference: SU1300377**

**Mr Gonzalez Ramirez  
9 Rosslyn Hill  
London  
NW3 5UL**

**SUBSIDENCE CLAIM**

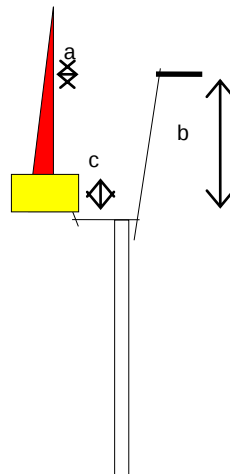
Foundation Details

A trial hole was excavated to expose the foundations - see site plan for location and the diagram below for details. Trial Hole 1 revealed a concrete strip footing founded at a depth of 0.77 m below ground level which bears onto very compact dark brown gravelly silty sand with brick and concrete fragments and clinker (made ground).

Root activity of live appearance was noted to the underside of the foundations.
