SECOND ADDENDUM REPORT

Crawford Reference: SU1300377

9 Rosslyn Hill
London
NW3 5UL

SUBSIDENCE CLAIM

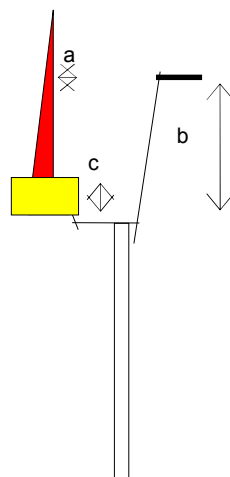
Foundation Details

Trial pit 2 carried out internally to the front left of the garage was excavated to expose the foundations. This revealed a concrete strip footing founded at a depth of 0.90 m below ground level which bears onto medium compact mid to dark brown, sandy, silty clay with occasional gravel, brick, concrete pieces and clinker fragments (made ground) Roots up to 5mm in diameter were observed to the underside of the foundation.

Trial pit 3 carried out internally to the rear left of the garage was excavated to expose the foundations. This revealed a concrete strip footing founded at a depth of 0.75 m below ground level which bears onto medium compact mid brown, sandy, very silty clay with occasional gravel, brick, concrete pieces and clinker fragments (made ground) Roots up to 2mm in diameter were observed to the underside of the foundation.

Root activity of live appearance was noted to the underside of the foundations.

No.	Borehole Depth	Footing (a)	Underside (b)	Thickness (c)
TH2	3.00 m.	200 mm.	900 mm.	500 mm.
TH3	3.00 m.	300 mm.	750 mm.	350 mm.
