# **TECHNICAL REPORT ON A SUBSIDENCE CLAIM**

**Crawford Reference: SU1300377**

**9 Rosslyn Hill  
London  
NW3 5UL**

## **SUBSIDENCE CLAIM**

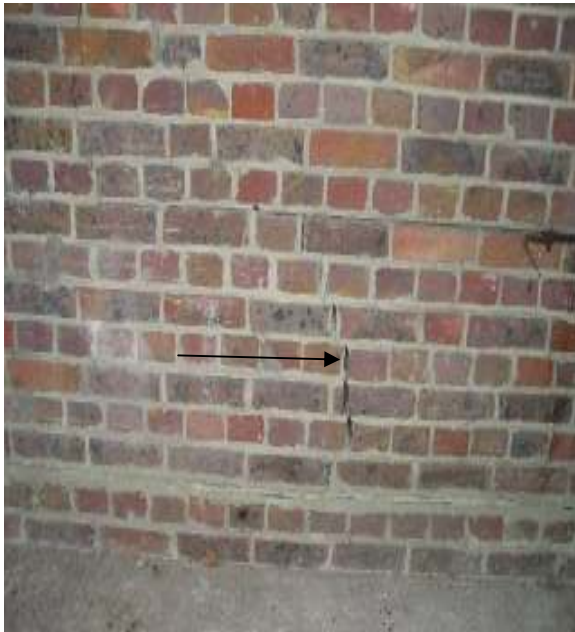
Cracking to left hand flank

**Garage** - Various stepped tapering and horizontal cracks were noted to the left hand flank ranging up to 10mm in width, mastic repairs were evident to some of the cracks, 10mm vertical tapering crack to the rear wall at midpoint with mastic repair evident, 12mm gap evident between the concrete floor slab and right hand party wall.

In structural terms the damage falls into Category 3 of Table 1, Building Research Establishment<sup>8</sup> Digest 251, which describes it as "moderate".

The pattern and nature of the cracks is indicative of an episode of subsidence. The cause of movement appears to be clay shrinkage however we cannot rule out that some physical damage caused by the root growth to the garage has occurred due to the proximity of the third party vegetation.

The cause of the movement needs to be dealt with first. Our Mitigation Unit will liaise with your neighbours in this respect.

Provided the tree management works are completed expeditiously, consideration may then be given to carrying out the appropriate repairs to the property.

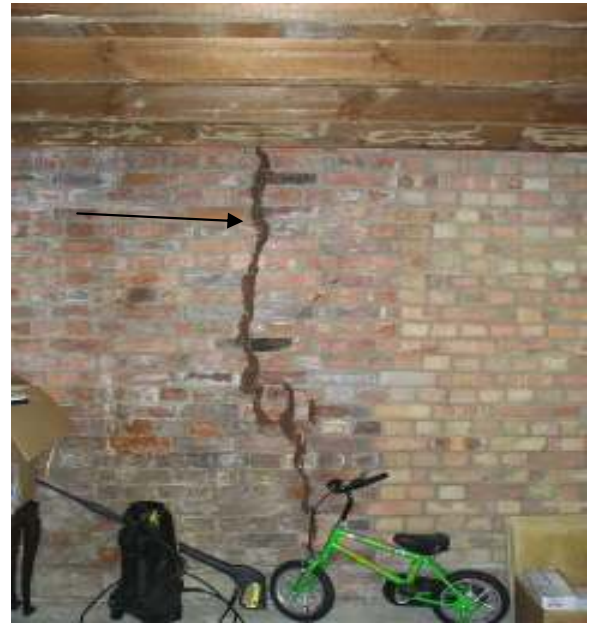
Cracking to rear wall (mastic repair evident)

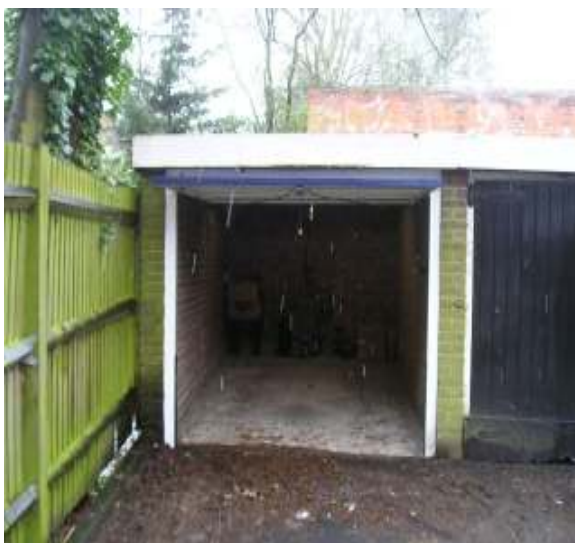
View of garage

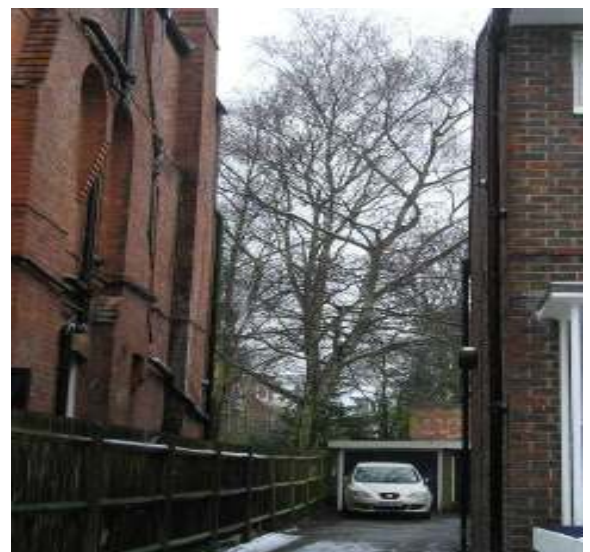
View of third party trees

The presence of shrinkable clay beneath the foundations and the proximity of vegetation where there is damage indicates the shrinkage to be root induced. This is a commonly encountered problem and probably accounts for around 70% of subsidence claims notified to insurers.

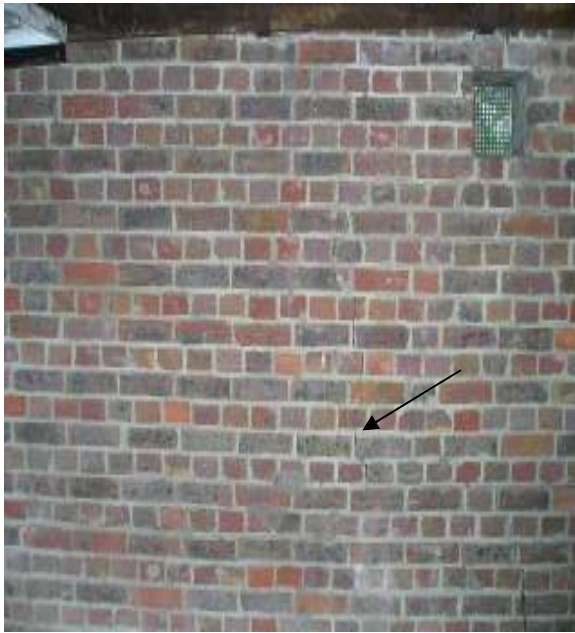
Cracking to left hand flank

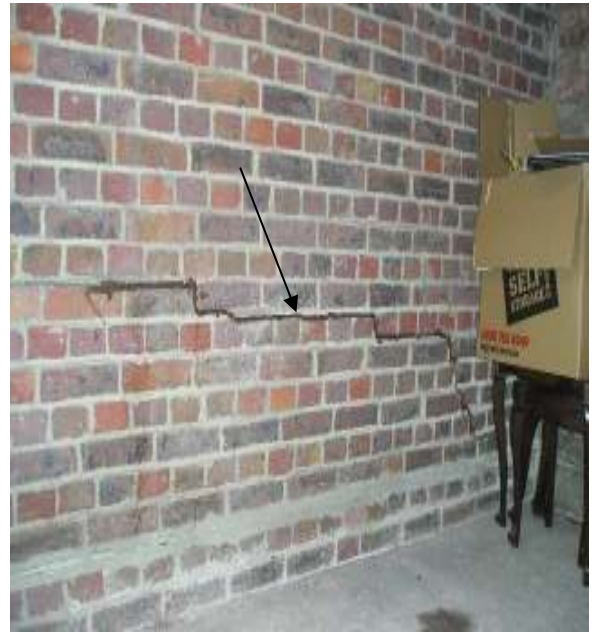
Cracking to left hand flank

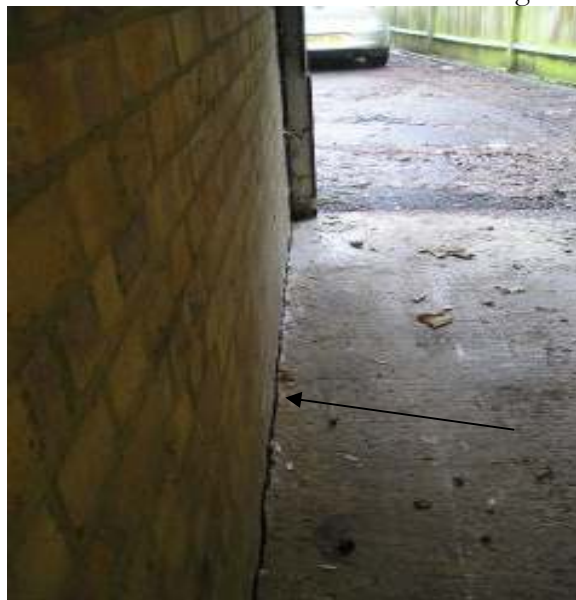
View of movement between slab and right hand party wall
