Arboricultural Appraisal Report

Subsidence Damage Investigation at:

9 Rosslyn Hill
London
NW3 5UL

CLIENT:	Crawford & Company
CLIENT REF:	SU1300377
MWA REF:	NW160413.03
MWA CONSULTANT:	David Mahon B.Sc. (Hons) MICFor MArborA
REPORT DATE:	19 May 2015

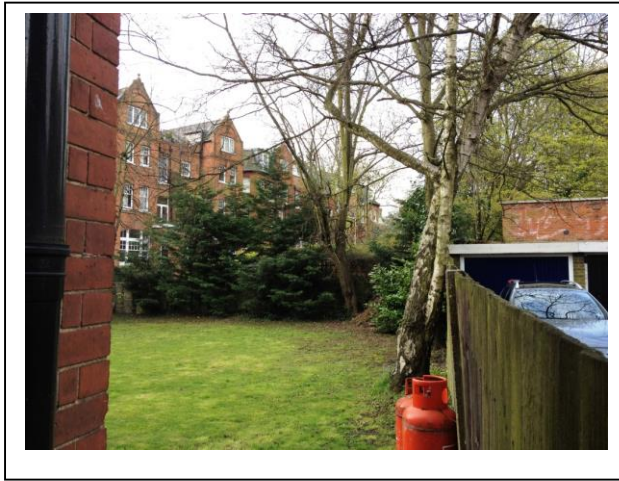
View of T2 & T4

Tree No.	Species	Ht (m)	Dia (cm)	Crown Spread (m)	Dist. to building (m)	Age Classification	Ownership
T1	Sycamore	15	25* 25*	9	1.05	Younger than property	3 rd Party:- 7 Rosslyn Hill
Recommendation		Remove and treat stump to inhibit regrowth					
T2	Birch	15	25* 30*	14	4.70	Younger than property	3 rd Party:- 7 Rosslyn Hill
Recommendation		Remove and treat stump to inhibit regrowth					
T6	Ash	18	500*	12	15.8	Younger than property	3 rd Party:- 7 Rosslyn Hill
Recommendation		Remove and treat stump to inhibit regrowth					
T3	Lime	15	370*	12	4.0*	Younger than property	3 rd Party:- 7 Rosslyn Hill
Recommendation		Remove and treat stump to inhibit regrowth					
T5	Laburnum	7	22	5	1.0*	Younger than property	3 rd Party:- 2 Belsize Lane
Recommendation		Tree has been removed (September 2013)

Tree No.	Species	Ht (m)	Dia (cm)	Crown Spread (m)	Dist. to building (m)	Age Classification	Ownership
T4	Cypress	4	12	2	1.0	Younger than property	3 rd Party:- 7 Rosslyn Hill
Recommendation		Remove and treat stump to inhibit regrowth

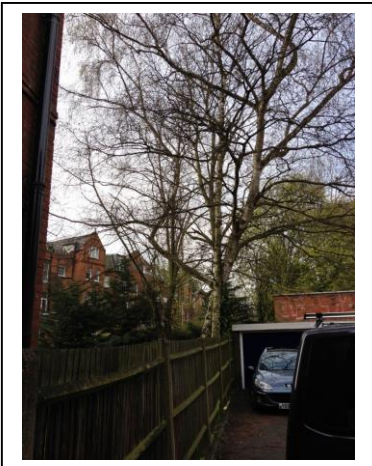
Roots were observed to 3.0m bgl in both BH2 & BH3 and recovered samples have been positively identified (using anatomical analysis) as ash, sycamore and lime the origin of which will be trees T6, T1 and T3 respectively confirming the influence of these trees on the soils below the foundations. Whilst no roots from the birch T2 have been formally identified given the proximity of the tree to the garage it is inconceivable that roots from this tree are not present and as such it is considered to be exerting an influence on soil moisture and volumes.

View of T1 & T2

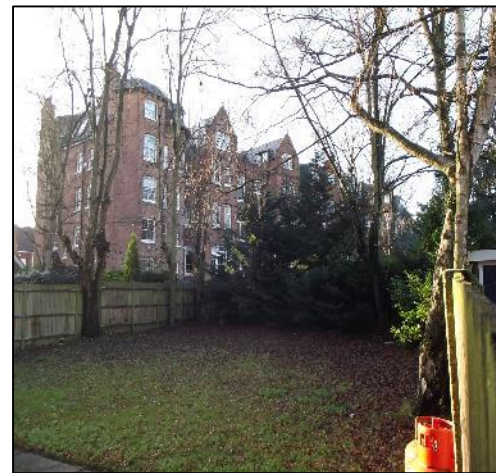
View of T6

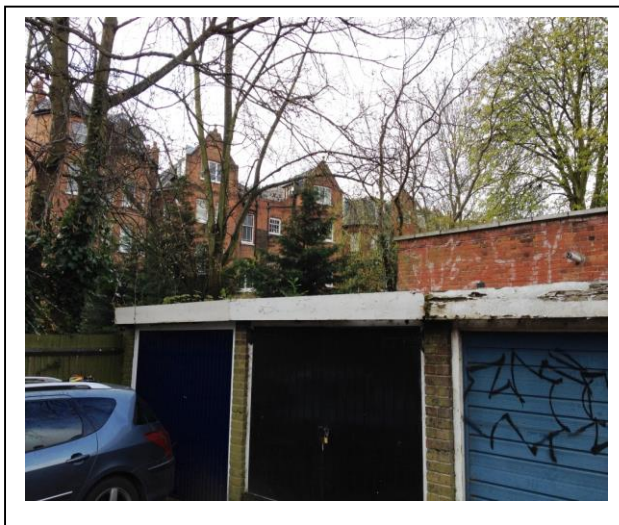
The damage presents as various stepped tapering and horizontal cracks were noted to the left hand flank ranging up to 10mm in width; mastic repairs were evident to some of the cracks, 10mm vertical tapering crack to the rear wall at midpoint with mastic repair evident, 12mm gap evident between the concrete floor slab and right hand party wall.

View of Garage
