## Tree Survey, Condition Management Report

**Client Name:** University of London

**Site Address:** 10 Sites around London

**Date:** 15<sup>th</sup> January 2015

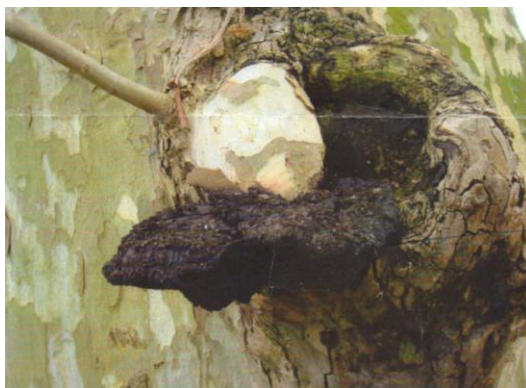
The most common fungal occurrence within the sites of Area 1 was the presence of *Inonotus hispidus* on the London Plane trees – especially within Gordon Square and Malet Street on trees T477; T479; T510; and T742. The decay fungi was present on old pruning wounds along the tree trunks or on scaffold branching.

*Inonotus hispidus* normally enters London Plane trees at an open pruning wound, as a white-rot which initially attacks the lignin and degrades the cellulose more slowly. London Plane however has the ability to defend and compartmentalise against this decay at initial infection. It is at this time that the decay switches to a soft-rot and degrades the cellulose. It has been determined that the ‘switch’ often occurs when the tree is dormant in the winter.

Because of London Plane’s ability to defend against this decay, failure usually only occurs at late stages of decay after many seasons when extensive cavity formation has occurred.

**Figure 01: Desiccated *Inonotus hispidus* bracket at Pruning Wound on London Plane**

The trees with *Inonotus hispidus* will require annual monitoring and further assessments of the level and spread of decay where the limbs and trunks are affected by the decay.

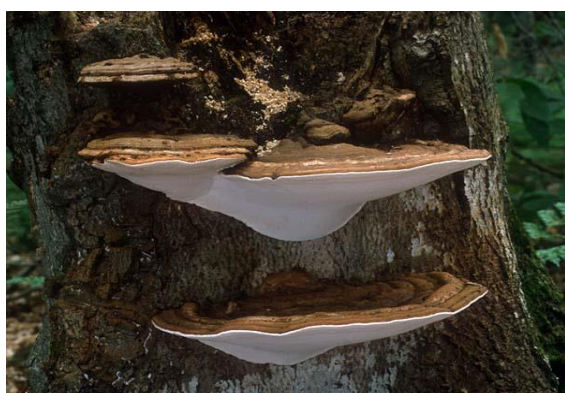
Hornbeam T415 was identified with *Ganoderma applanatum* which is a 'white-rot' that selectively degrades the lignin within the tree. In advance stages of decay, the lignin can be almost totally degraded while the cellulose remains. As the tree retains its tensile strength, even in advanced stages of decay the tree may not be considered a hazard as the tree will naturally put down compensatory growth around the trunk to compensate for the movement.

**Figure 02: *Ganoderma* spp on Hornbeam**

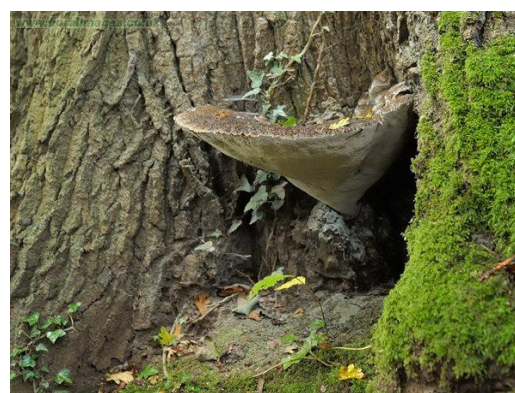
Oak T845 was identified with several large and mature *Inonotus dryadeus* fungal brackets. This is actually a root rot which then colonises the base of the tree and lower sections of the trunk. The decay is a 'white-rot' that selectively degrades the lignin. In advanced stages of decay the tree will put down compensatory growth around the buttress and trunk to address the excessive movement. However as the decay starts below ground in the root system, only excavations around the base of the tree can fully determine and understand the extent of decay.

**Figure 03: *Inonotus dryadeus* on Oak**
