# ARBORICULTURAL ASSESSMENT REPORT

<b>For:</b>	<b>Client:</b>	Oriel Services Limited
	<b>Insurer:</b>	[REDACTED]
<b>Site:</b>	<b>Policyholder:</b>	[REDACTED]
	<b>Risk Address:</b>	70-72, Crediton Hill, London, NW6 1HR
<b>Refs:</b>	<b>OCA Ref:</b>	58265
	<b>Client Ref:</b>	7891572
	<b>Insurer Ref:</b>	[REDACTED]

<b>Report By:</b>	James Allnutt		
<b>Title:</b>	Arborist	<b>Date:</b>	10 <sup>th</sup> March 2015

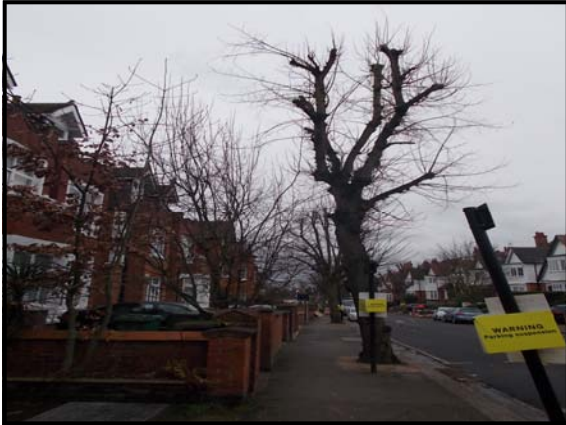
1. T2 Lime

Tree No:	Species	Works Required
T1	Willow	Fell and treat stump.
T2	Lime	Fell and grind stump (pending further evidence)

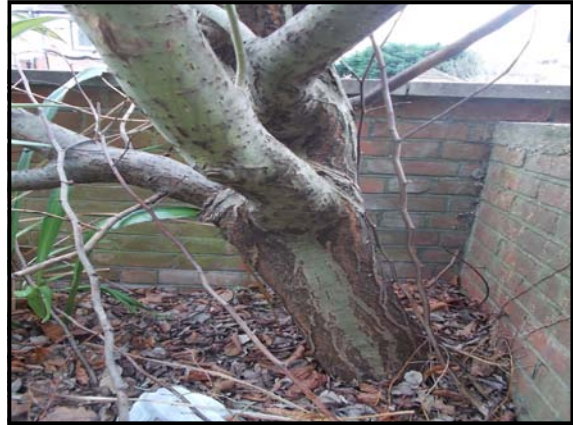
2. T1 Willow

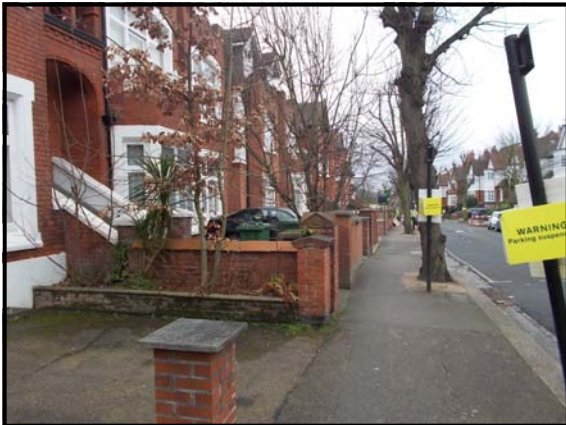
3. T1 Willow, T2 Lime, T3 Ash, T4 English Oak, T5 Cordyline and T6 Sycamore

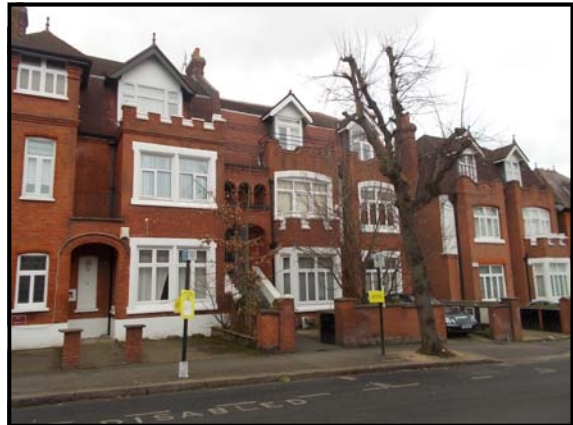
4. T1 Willow, T2 Lime, T3 Ash, T4 English Oak, T5 Cordyline and T6 Sycamore

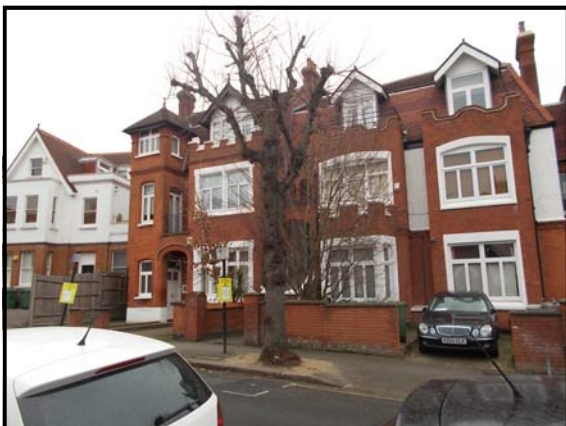
5. T2 Lime with T1 Willow behind

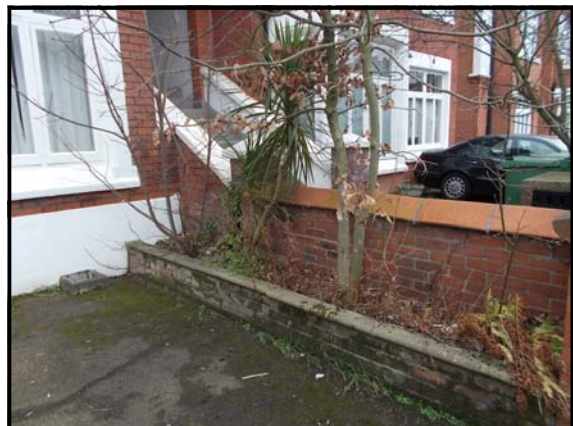
In relation to T3, T4 and T6 these trees all pose a future risk due to their proximity to the affected area and high growth potentials, they are likely to contribute to the damage at some point, whether now or in the future as they are adjacent and very close to the area affected.

6. T4 English Oak T5 Cordyline and T6 Sycamore

Tree No:	Species	Works Required
T3	Ash	Fell and treat stump.
T4	Oak	Fell and treat stump.
T6	Sycamore	Fell and treat stump.
