SITE INVESTIGATION FACTUAL REPORT

Report No: 246131
Client: Cunningham Lindsey - Maidstone
Site: 70-72, 70-72, Crediton Hill
London
Client Ref: XXXXXXXXXX
Date of Visit: 07/01/2015

Investigation Layout Plan

Trial Pit No: 1

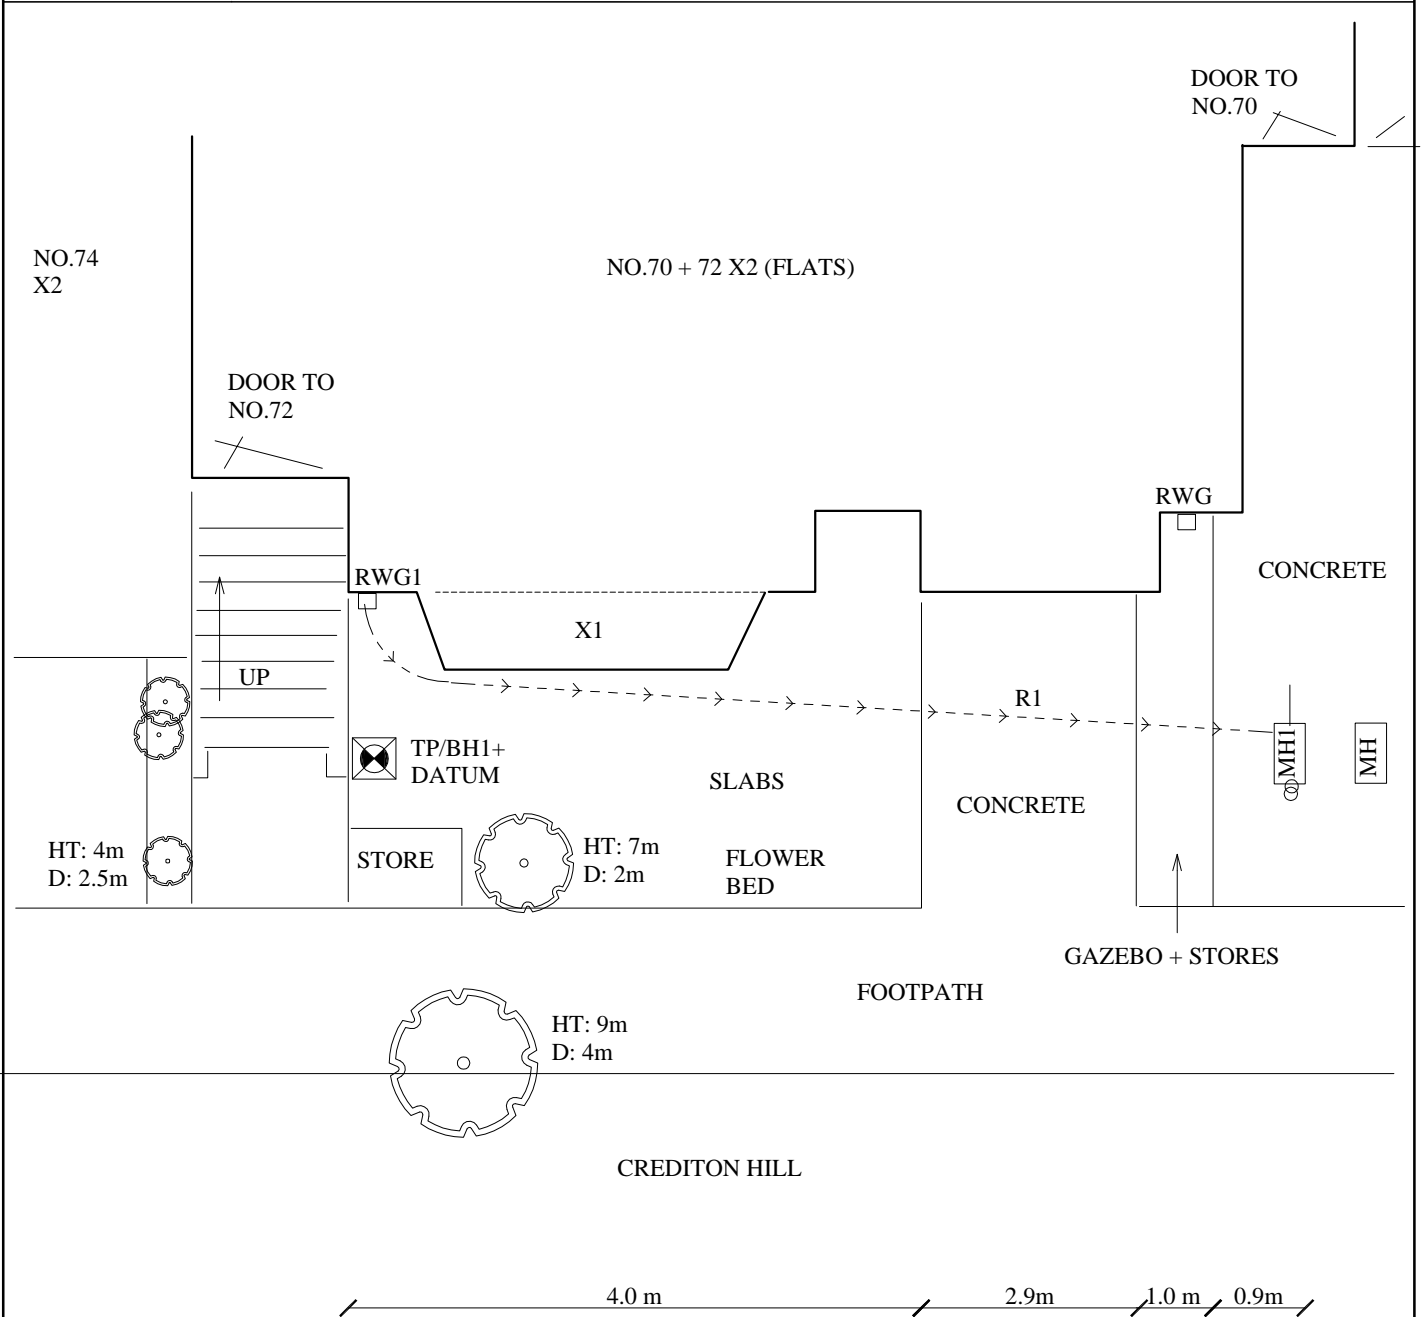
ON SITE TREE IDENTIFICATION FOR GUIDANCE ONLY. NOT AUTHENTICATED.

Parking - permit
 Water supply - in house.
 Site access - good.
 Power - internal

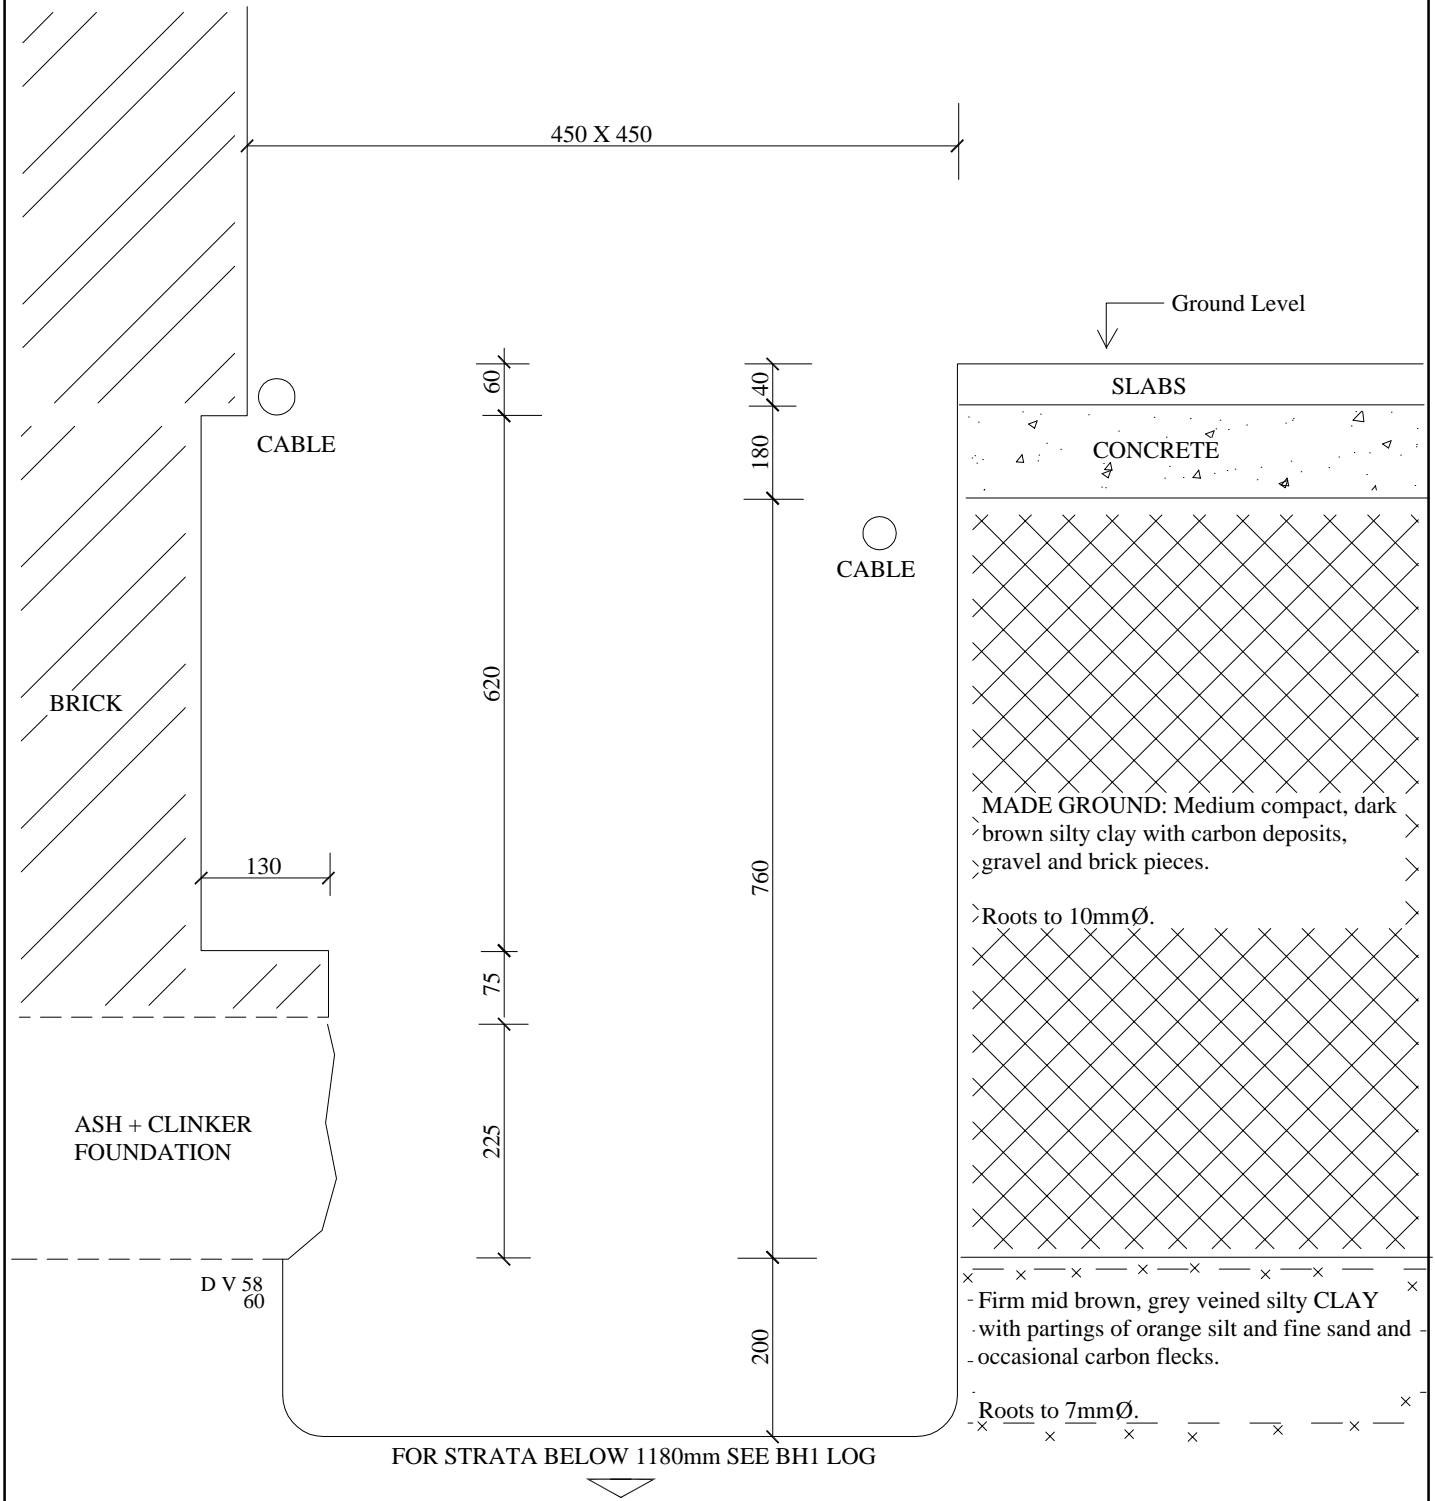
Remarks: All measurements in millimetres.

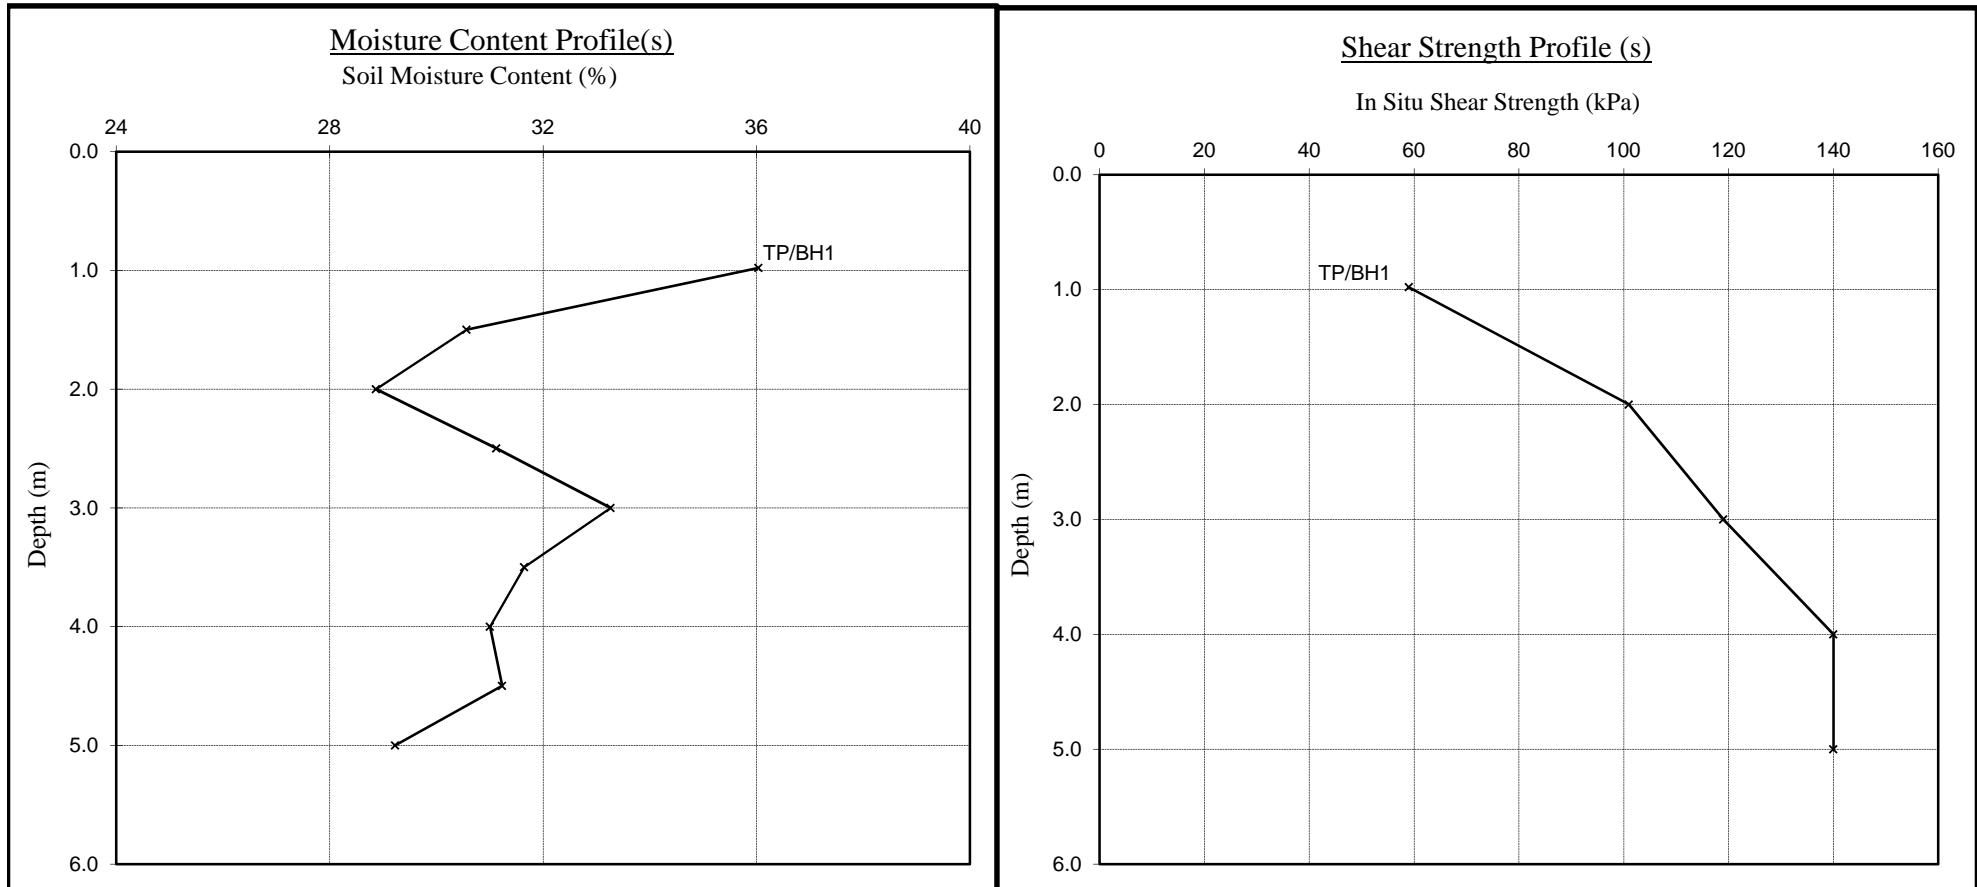
Moisture Content and Shear Strength Profiles

Unless otherwise stated, values of Shear Strength were determined in situ by CET using a Pilcon Hand Vane the calibration of which is limited to a maximum reading of 140 kPa.

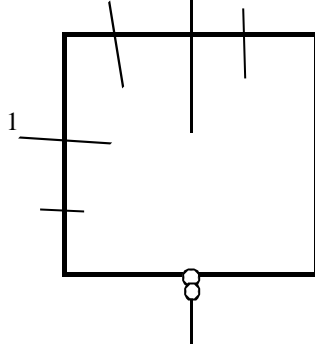
M/H: 1 Depth: 2170mm

Chamber Dimension (mm): 1200 X 700

As built
