ARBORICULTURAL ASSESSMENT REPORT

For:	Client:	GAB Robins UK Ltd
	Insurer:	[REDACTED]
Site:	Policyholder:	[REDACTED]
	Risk Address:	Studio House Hampstead Hill Gardens, London, NW3 2PH
Refs:	OCA Ref:	55953
	Client Ref:	B1330768
	Insurer Ref:

Report By:	Sue Lawson		
Title:	Arborist	Date:	31 December 2014

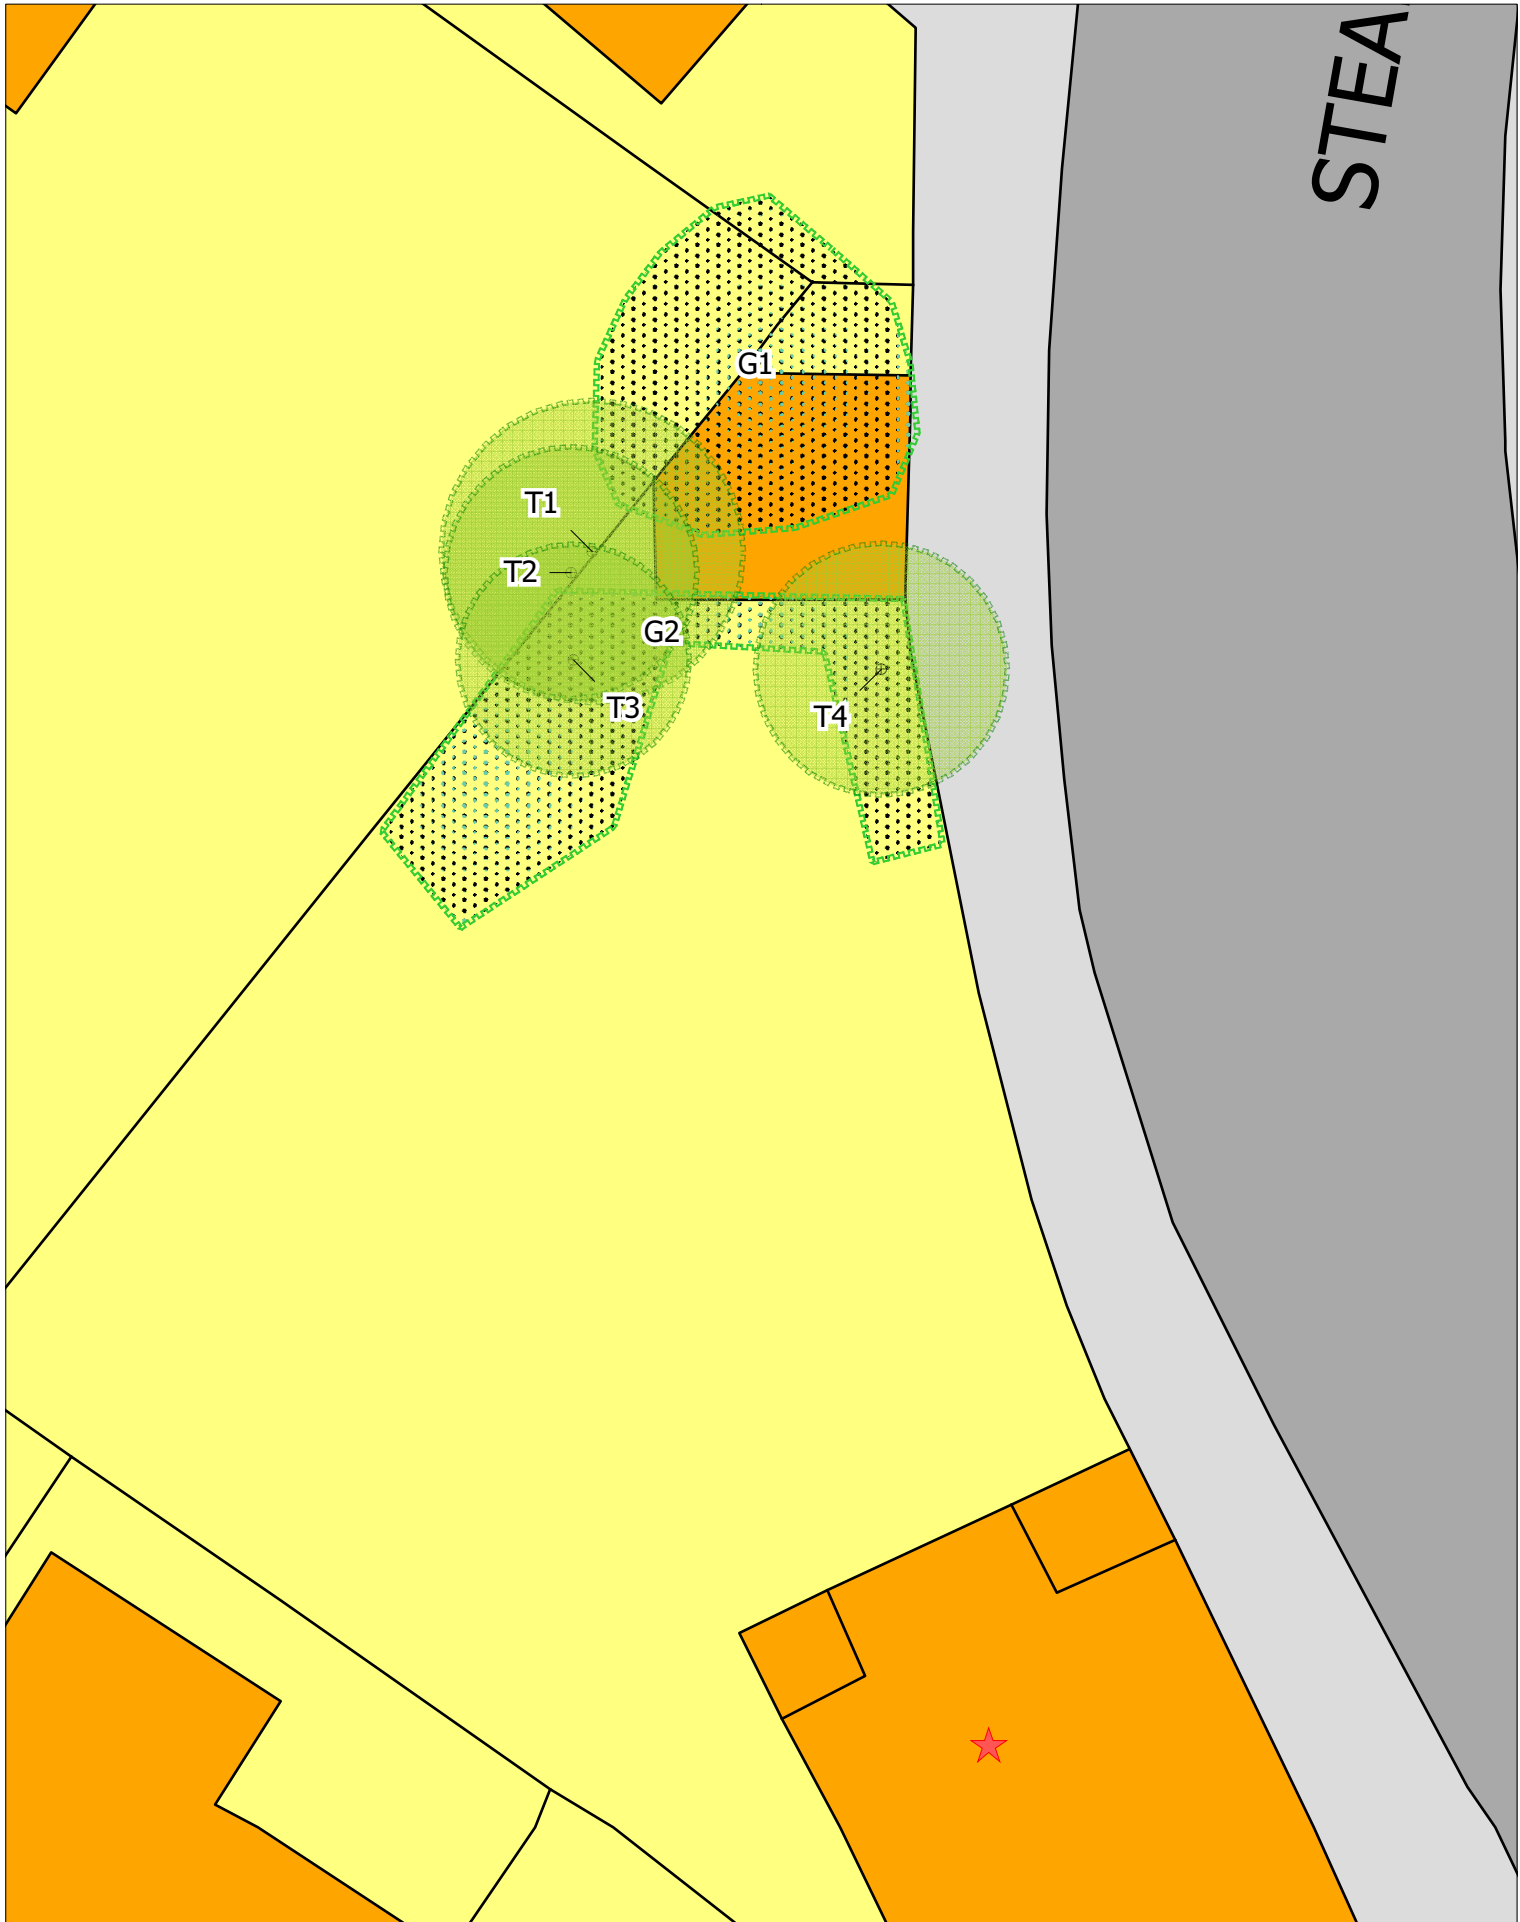
Location: STUDIO HOUSE, Hampstead Hill Gardens, London, NW3 2PH
Job Ref.: 55953
Survey Date: 28/04/2014
Scale: 1:150 @ A4

There are a large number of shrubs and trees situated adjacent the garage however at this stage, we consider that G1, T1 and T3 are the most significant vegetation in relation to the current damage.

Tree No:	Species	Works Required
G1	3x Lawson Cypress	Fell all trees.
T1	English Oak	Fell and treat stump.
T3	Eucalyptus	Fell and treat stump.

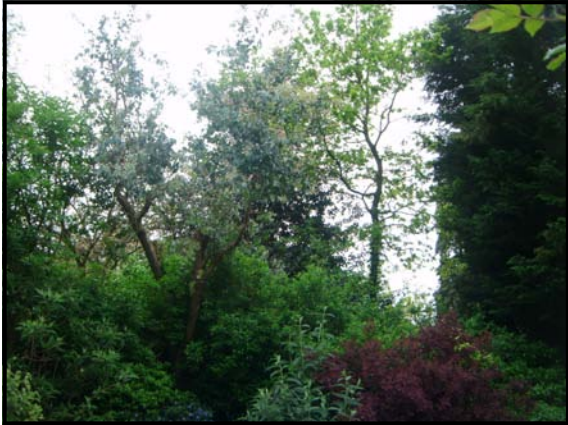
1. PH Eucalyptus

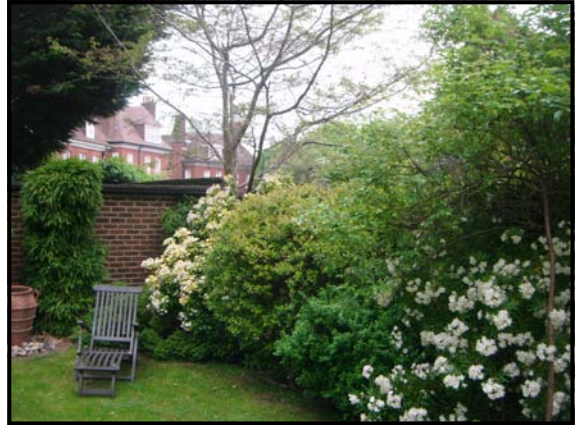
2. PH vegetation

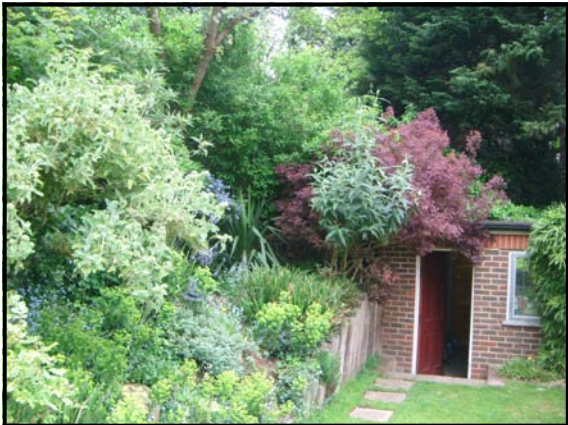
3. PH vegetation
