SITE INVESTIGATION

STUDIO HOUSE

HAMPSTEAD HILL GARDENS

Trial Hole Log No. 1 Location : INSIDE GARAGE REAR RIGHT SIDE

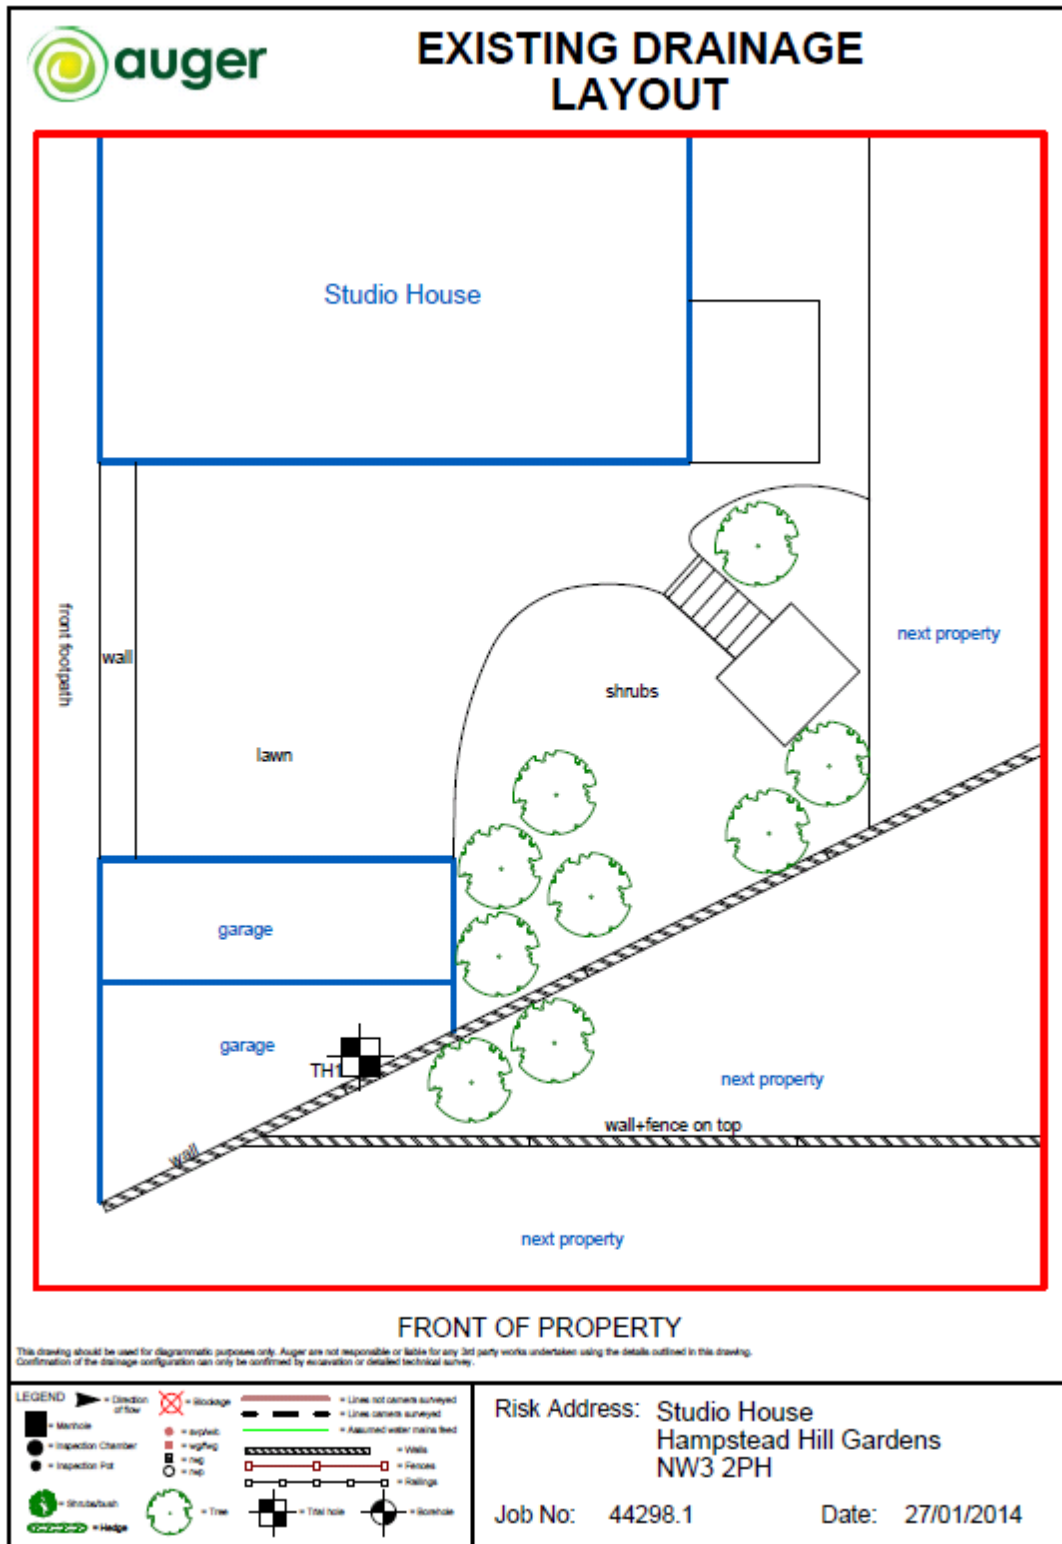
DEPTH METRES	SYMBOLIC LOG	STRATA DESCRIPTION	INSITU TESTS		Soil Sample	Root Sample	Water / Stability
			Type	Result			
0.0		Ground Level					
		Concrete					
		Brickwork					
		Concrete (Possible raft construction)	sv(19)	60kpa	@0.6m	@0.6m	
1.0		Moist stiff brown CLAY	sv(19)	60kpa	@1.1m		
			sv(19)	62kpa	@1.6m		
2.0			sv(19)	65kpa	@2.1m		
			sv(19)	66kpa	@2.6m		
3.0		TRIAL HOLE TERMINATED	sv(19)	68kpa

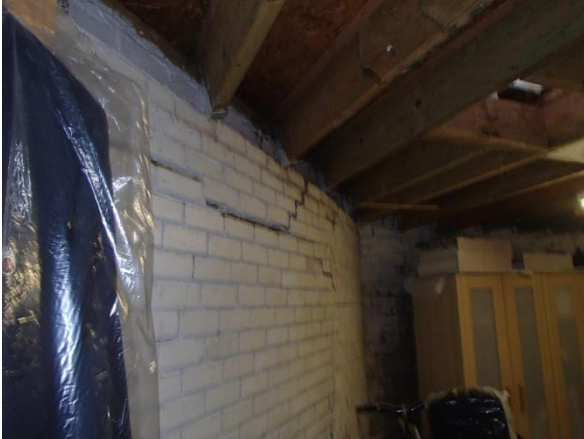
Fig 1.1 – Cracking in garage

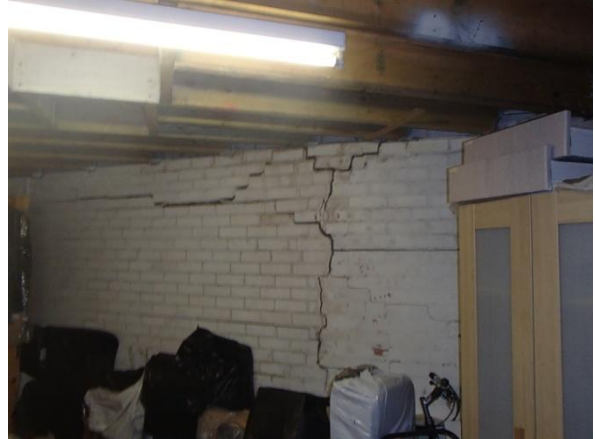
Fig 1.2 – Cracking in garage
