**PLAN OF TREES AT NO 117 PRIORY ROAD, LONDON
NW6**

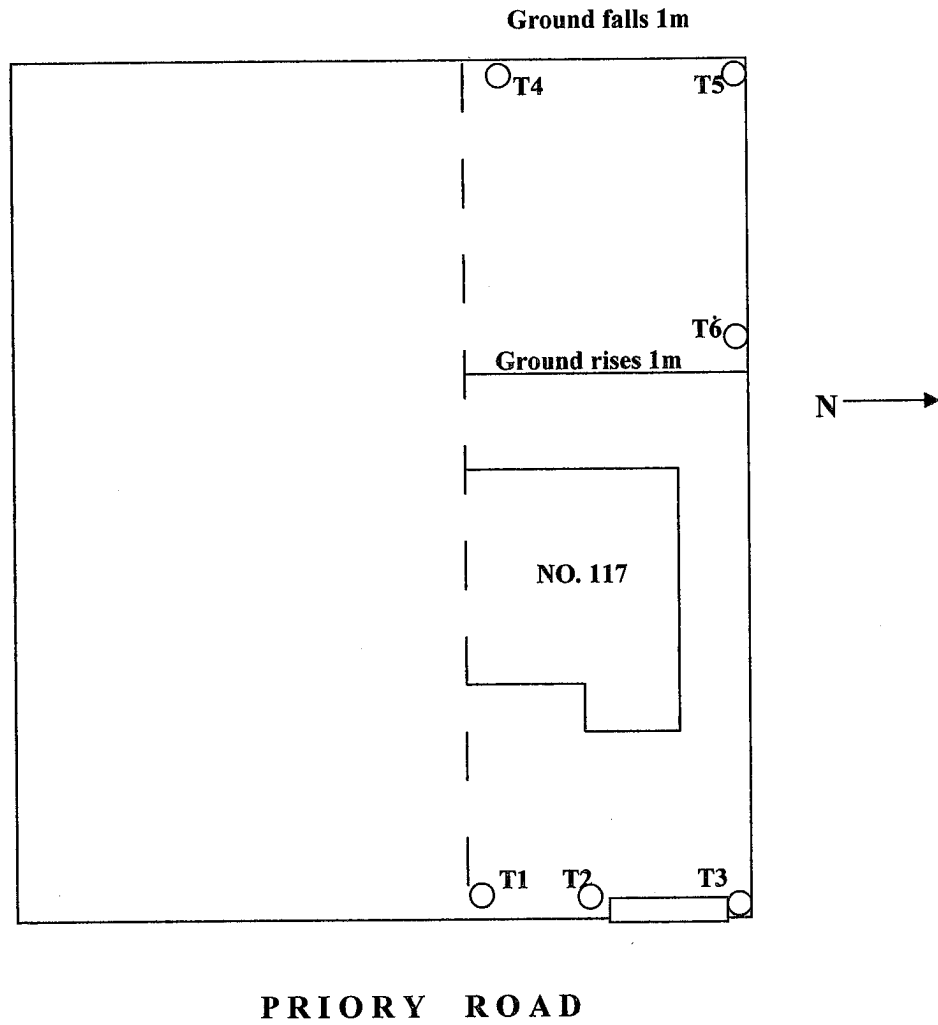
Tree No.	Species	Distance	Height	Trunk Diameter	Estimated Age	Comments and Recommendations
T1	Lime	5m	3m	250-300mm	40	Pollarded tree rooted 5m from building and less than 0.5m from front boundary wall
T2	Lime	5m	3m	250-300mm	40	Pollarded tree rooted 5m from building and less than 0.5m from front boundary wall
T3	Privet	5m	4.5m	200-250mm	30	Unusually for a privet T3 has developed into a small tree, unlikely to affect building though may damage adjacent wall
T4	Horse Chestnut	25m <2.5m	20m	750-800mm	70+	Large mature tree, one sided growing strongly to the south. Rooted 25m from the rear of No. 117 and should not affect this structure at that distance. It is however rooted in close proximity to the building located to the rear. Raised ground levels have buried the root collar and lower stem
T5	Lime	25m <0.5m	18m	450-500mm	50+	A tree of poor form which is growing strongly to the east away from the adjacent building. It should not prove harmful to No. 117 but is capable of causing both direct and indirect damage to the flank wall of the building behind as stem diameter increases.

T6	Pear	8m	6m	300-320mm	50+	A small though mature tree which is biased towards the south. It is rooted at a comfortable 8m from the rear elevation of No. 117 and located circa 1m above dpc level, has potential to grow much larger and may damage boundary wall located to north side.
