16 ETON VILLAS

LONDON, NW3

**Report on Structural Defects
and Repairs**

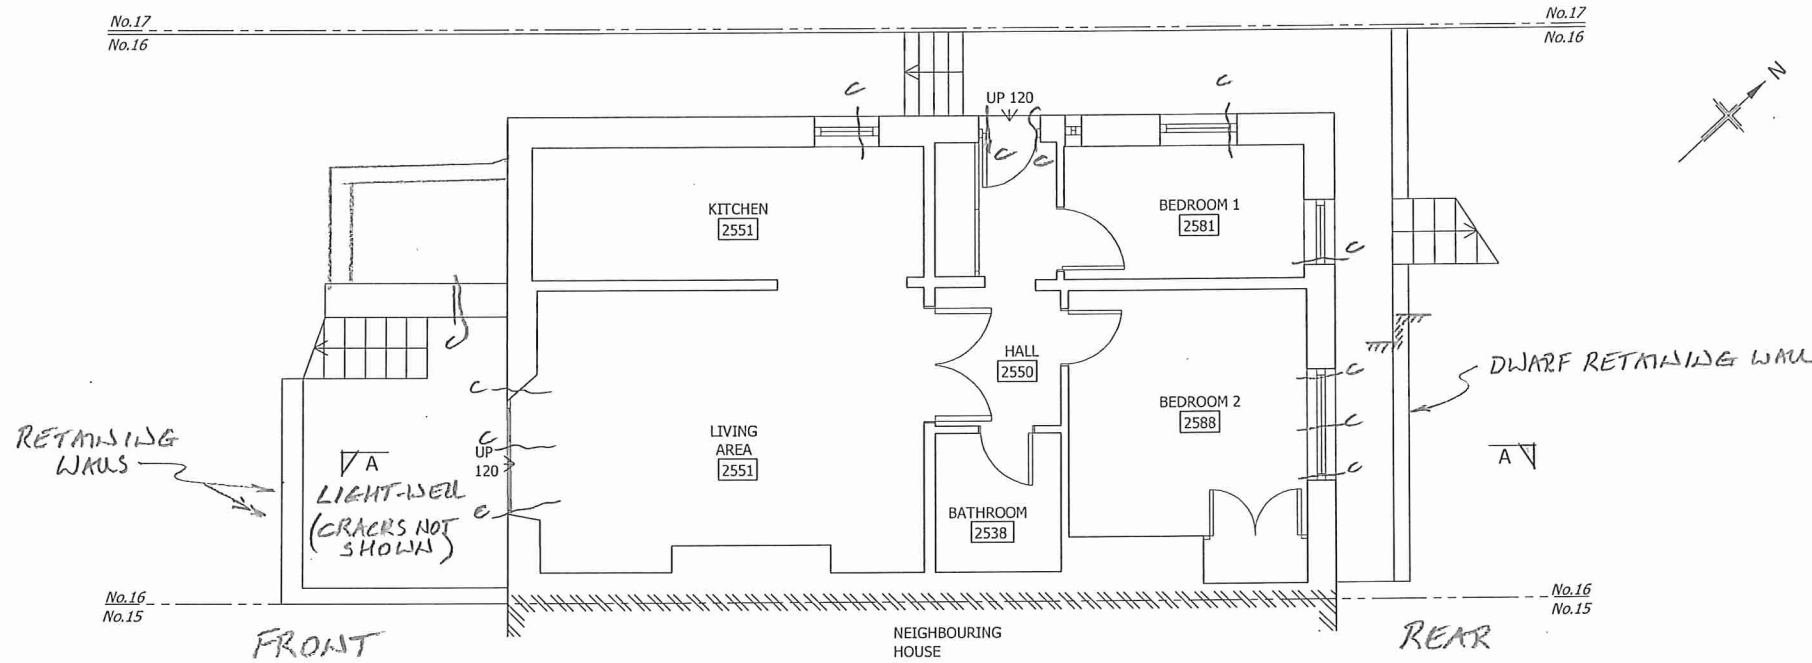
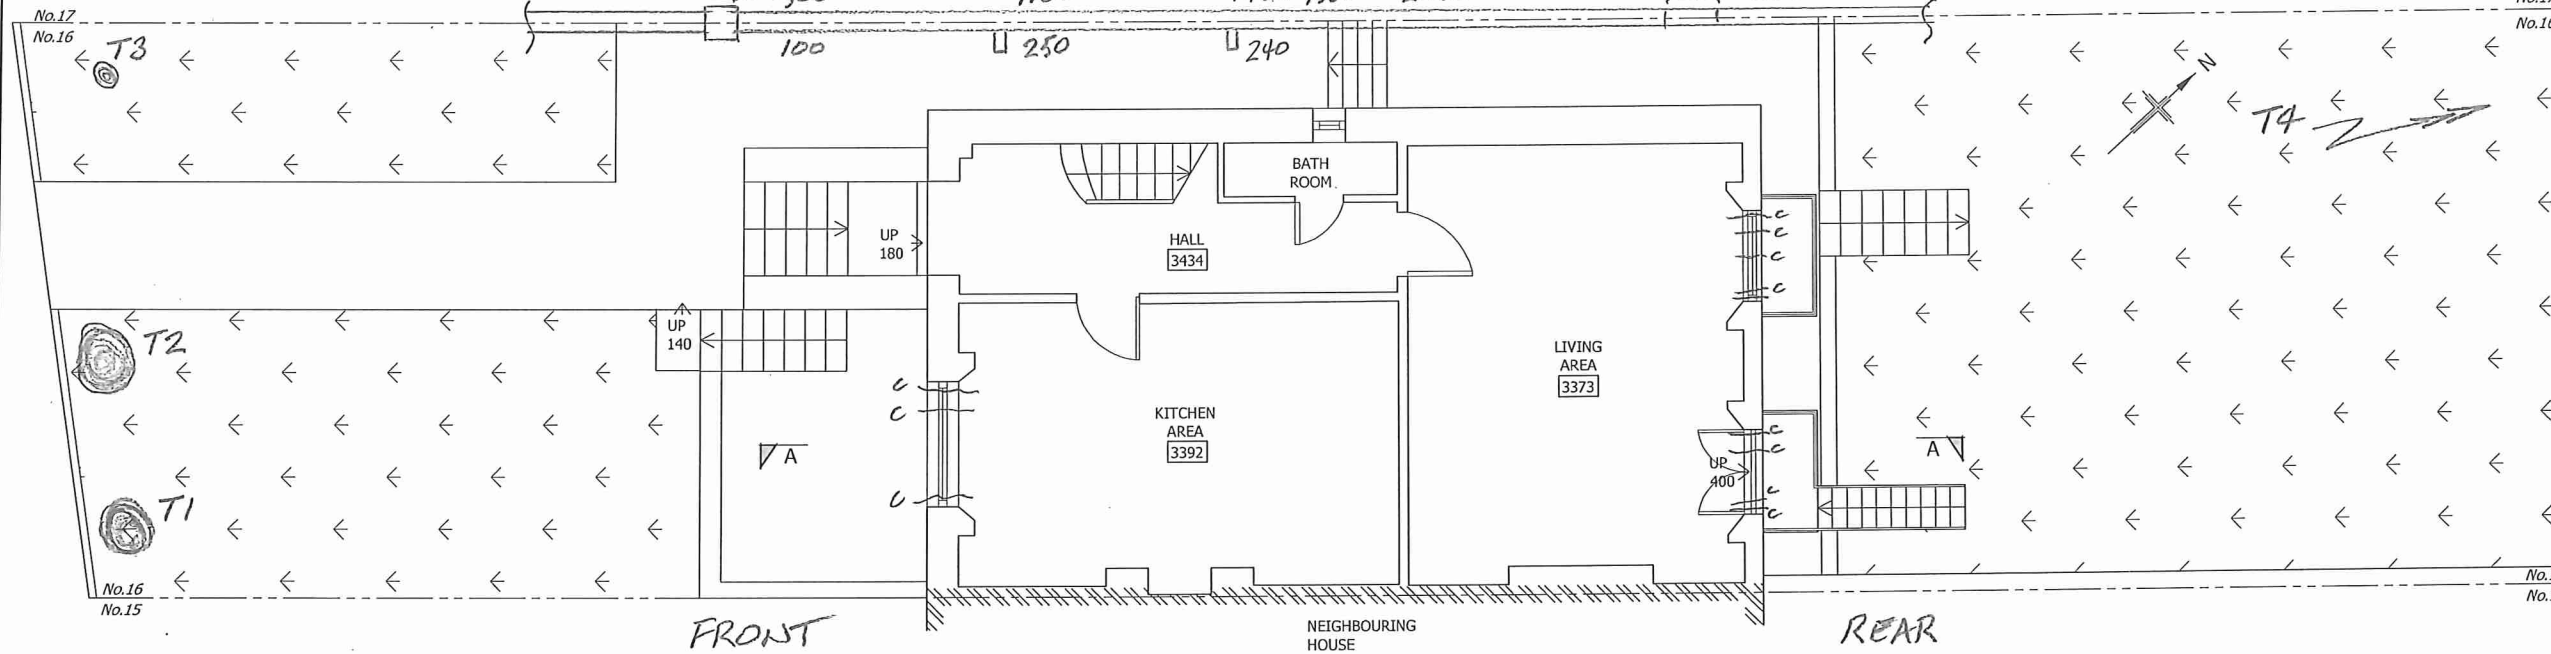
RECORD OF FACADE CRACKS			
AS AT 12/3/2015			
4289/SK/01	03/15	BN

A walk-over inspection shows that there are a number of cracks in the front façade, flank wall, and rear façade. The front entrance steps and porch are also cracked and steel beams have been recently installed below the entrance steps

The front light-well is of recent (re) construction, and its walls have a number of cracks. The left hand free-standing boundary wall is severely out of plumb, and attempts to arrest on-going movement have been carried out, with vertical steel posts installed at intervals.

- CRACK OVER WINDOW/DOOR
- HEIGHT OF BOUNDARY WALL, mm
- OUT OF PLUMB (APPROX), mm
- T1-T4 DECIDUOUS TREE

1. Repair the below-ground drains.
2. Ensure incoming water supply is intact.
3. Reduce size of the trees' canopies.
4. Resin-inject cracks; replace cracked bricks; install either stitch-lintels or Helibar reinforcement across cracks.

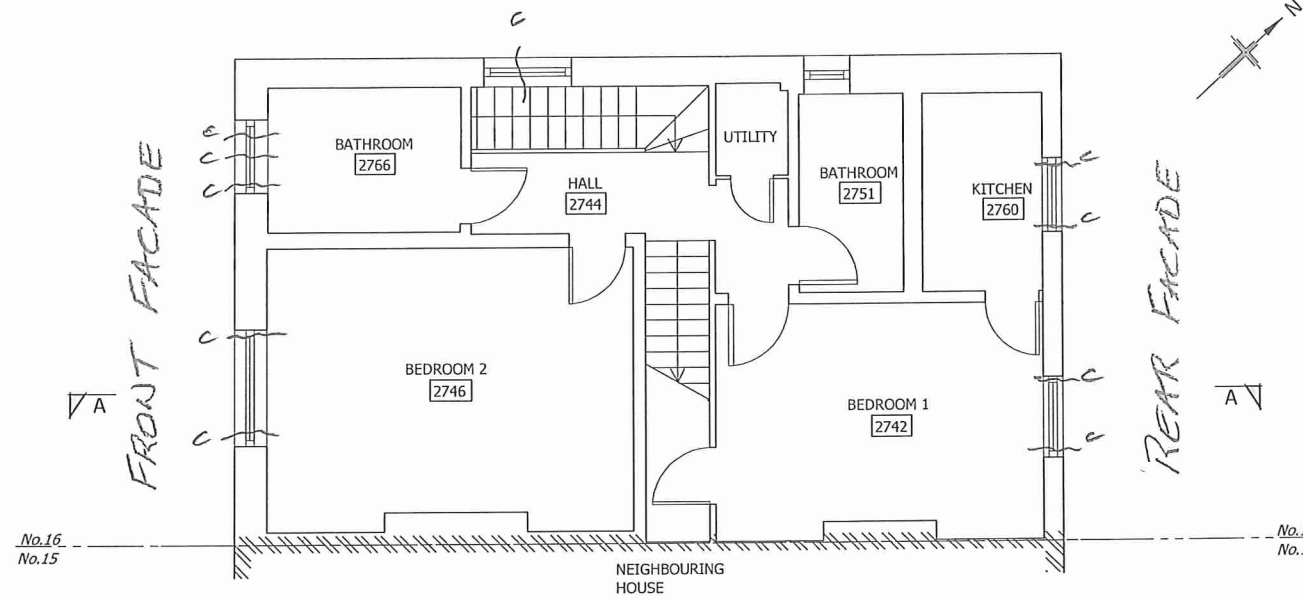
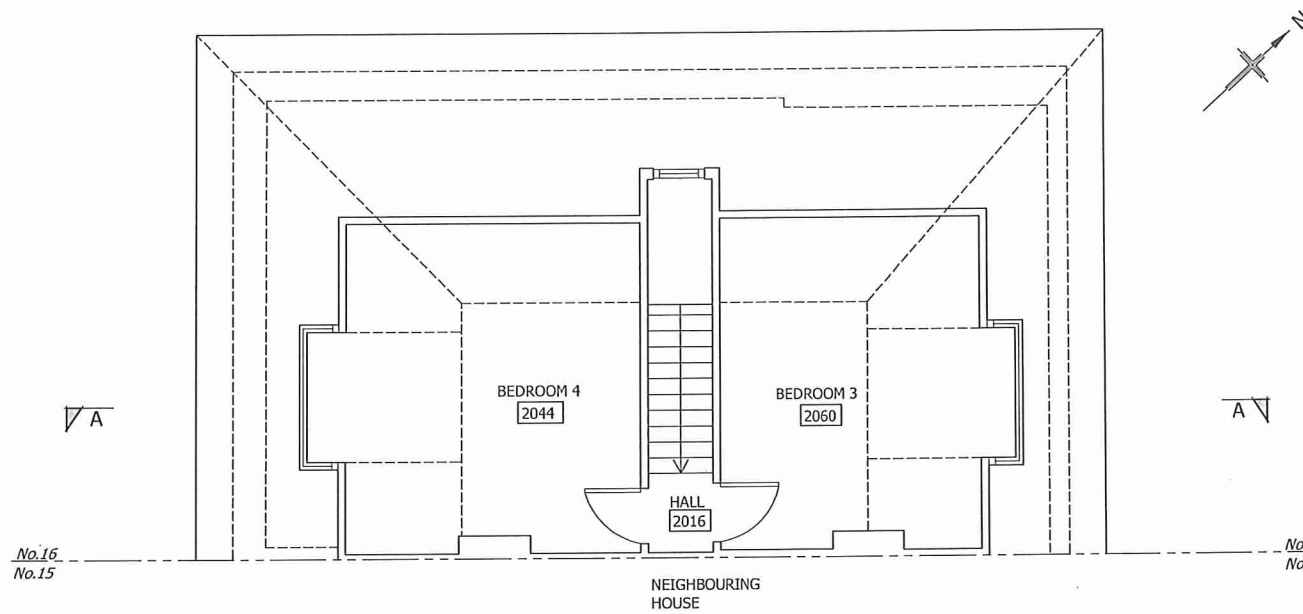
RECORD OF FACADE CRACKS			
AS AT 12/3/2015			
4289/SR/02	03/15	BJ

Internal Stud Walls and Joisted Floors: uneven floor (slopes) and cracks at the corners of rooms, between stud walls and external walls were noted.

CRACK, ABOVE WINDOW

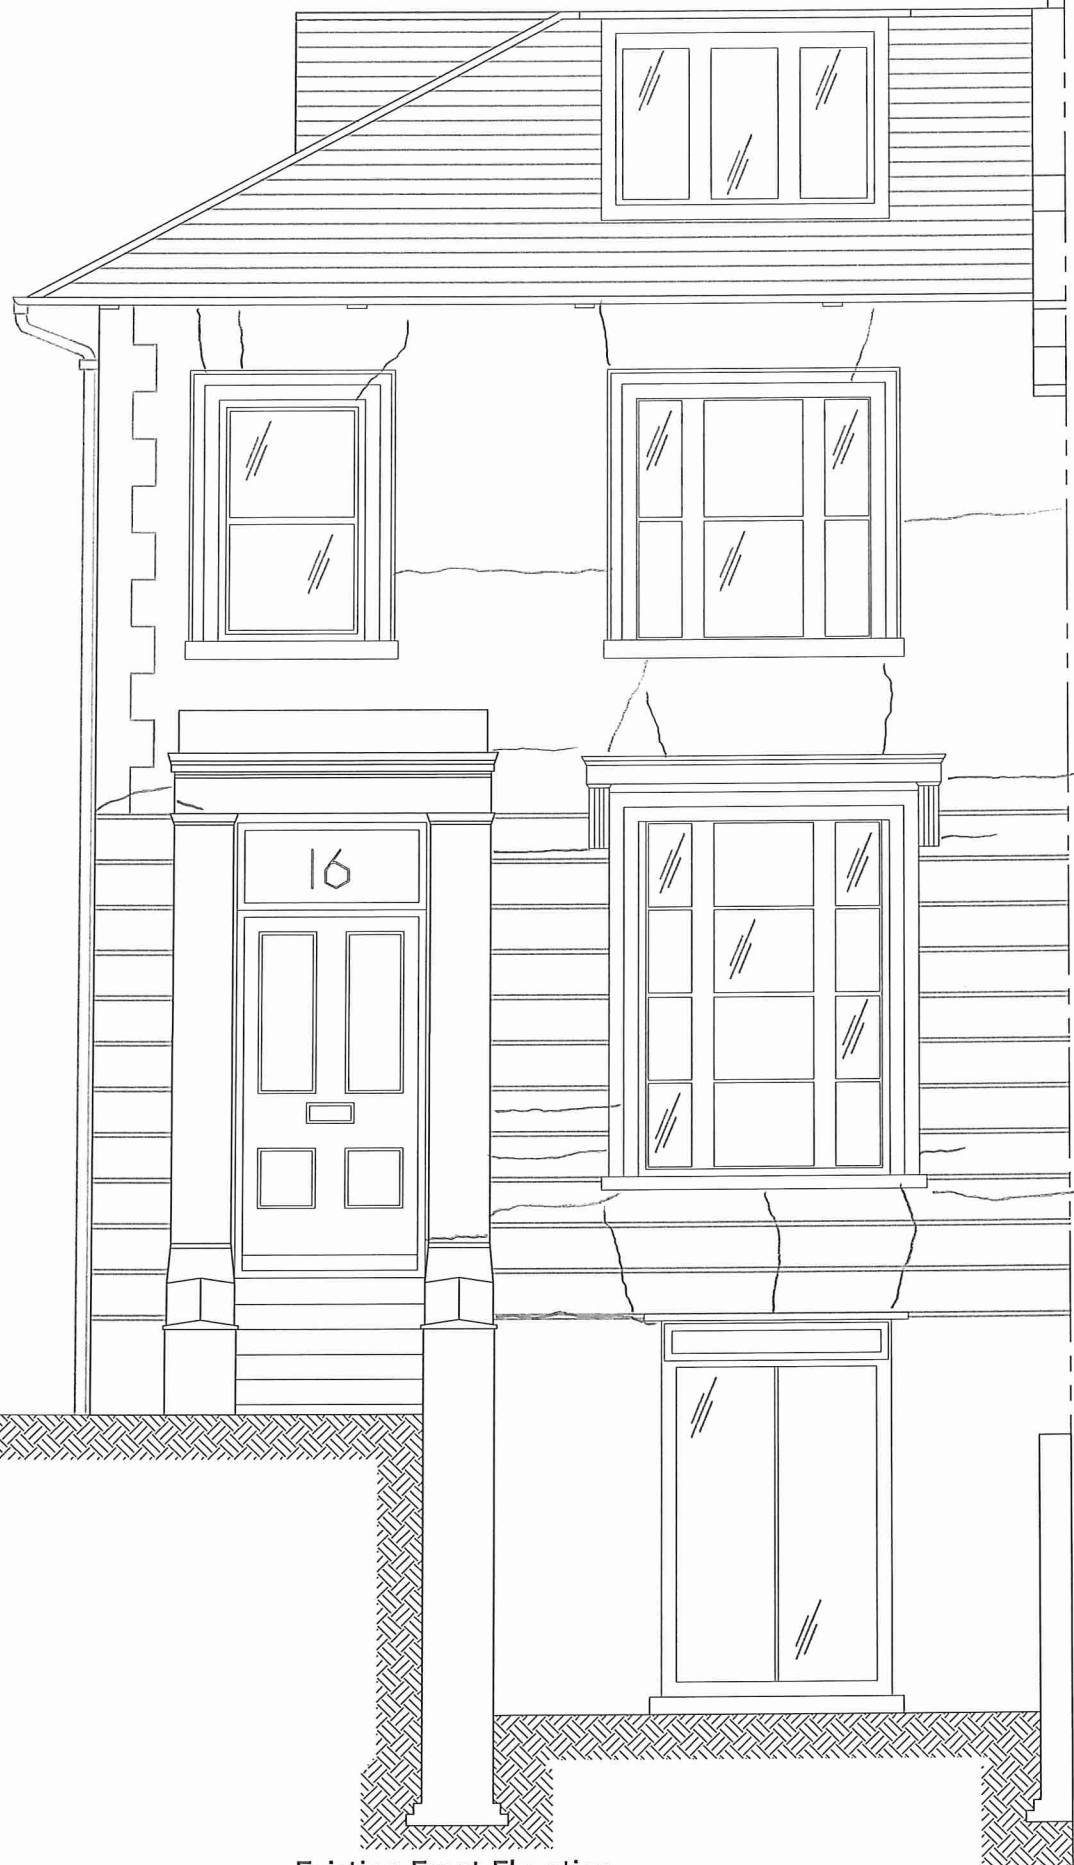
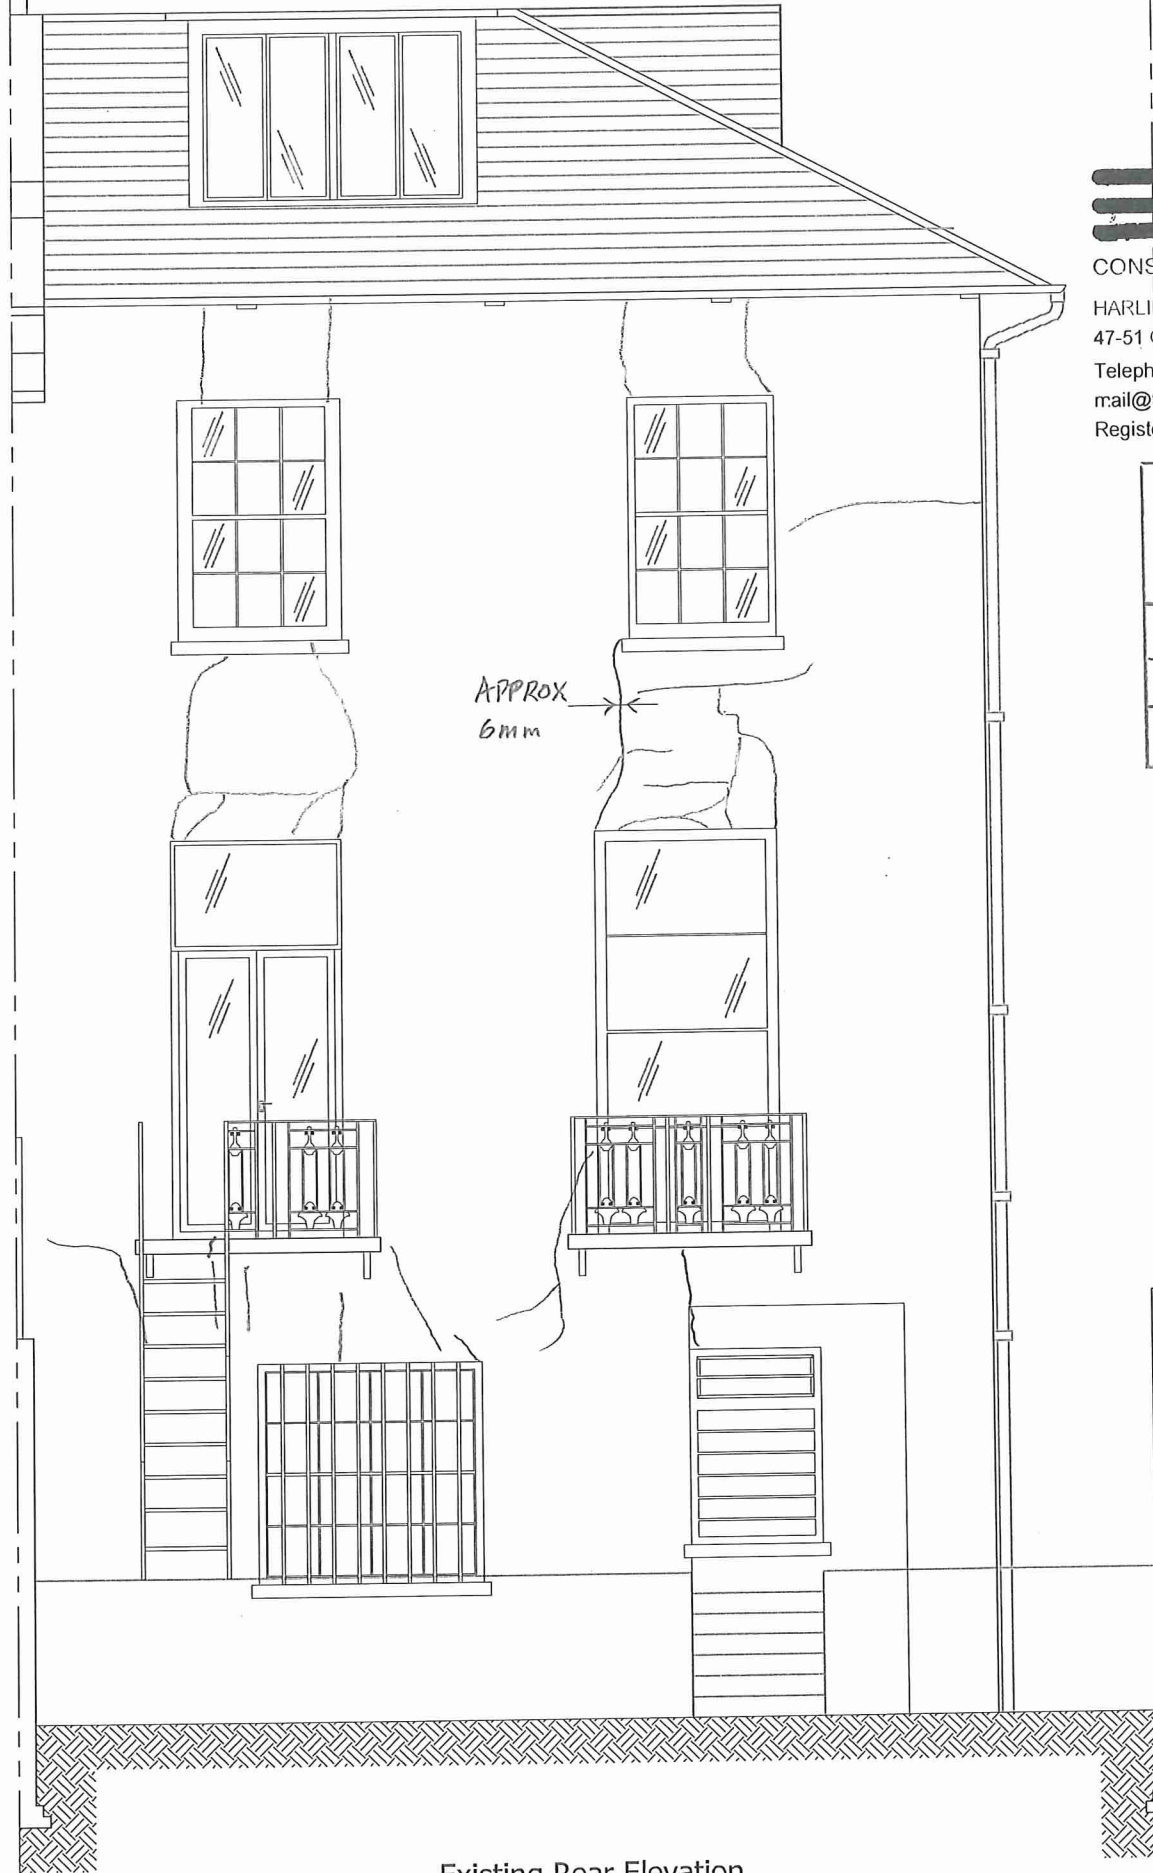
RECORD OF FACADE CRACKS			
AS AT 12/3/2015			
4289	/SK/03	03/15	TCH

Facades: extensive cracking of the fully-rendered walls at all levels. Some areas of previous repair were noted to have been poorly executed. The cracking was considered to be historic with no signs of ongoing movement. Cracking of the masonry walls, and loss of bond of the render, was anticipated.

Water leaking from the cracked pipes within the footprint of the house would tend to flow along the trench of the principle sewer passing parallel to the flank wall, and under the house entrance steps and front façade. Softening of the clay would reduce the clay's capacity and thus may be the cause of foundation settlement and thus cracking of the facades. Repair of all leaking drains would terminate this action.

CRACK IN RENDER

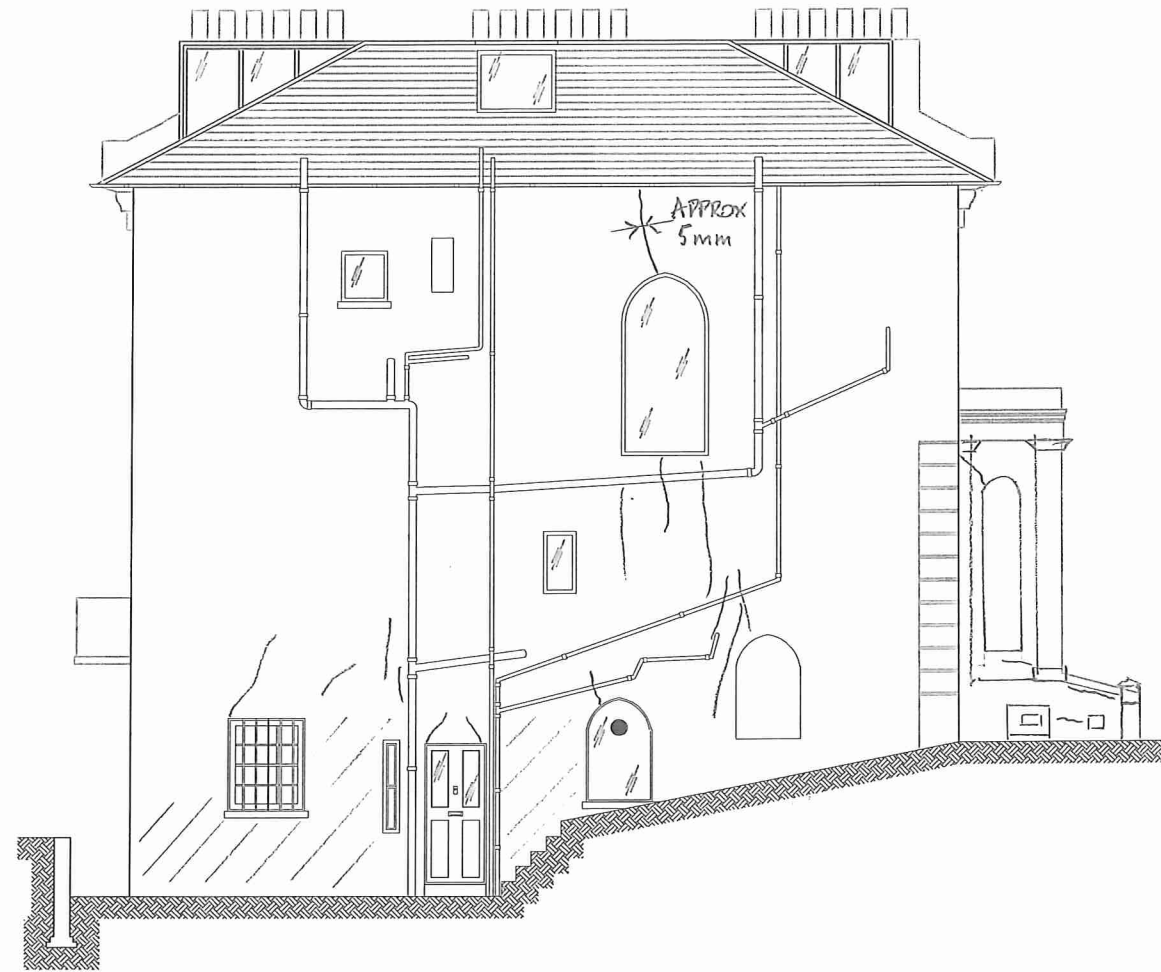
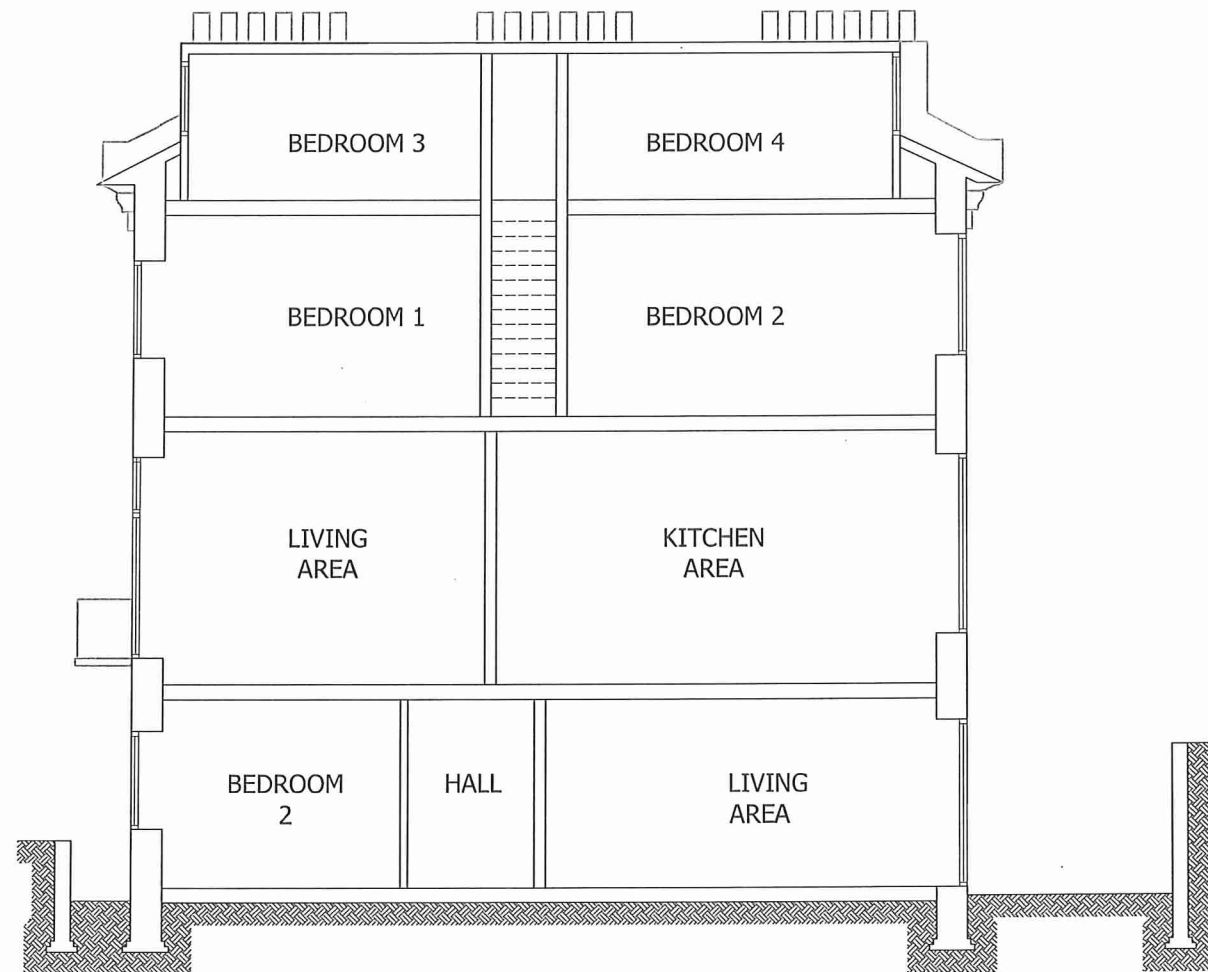
RECORD OF FACADE CRACKS			
AS AT 12/3/2015			
4209/SK/04	03/15	DL

- CRACK
- ZONE OF REPAIRED RENDER

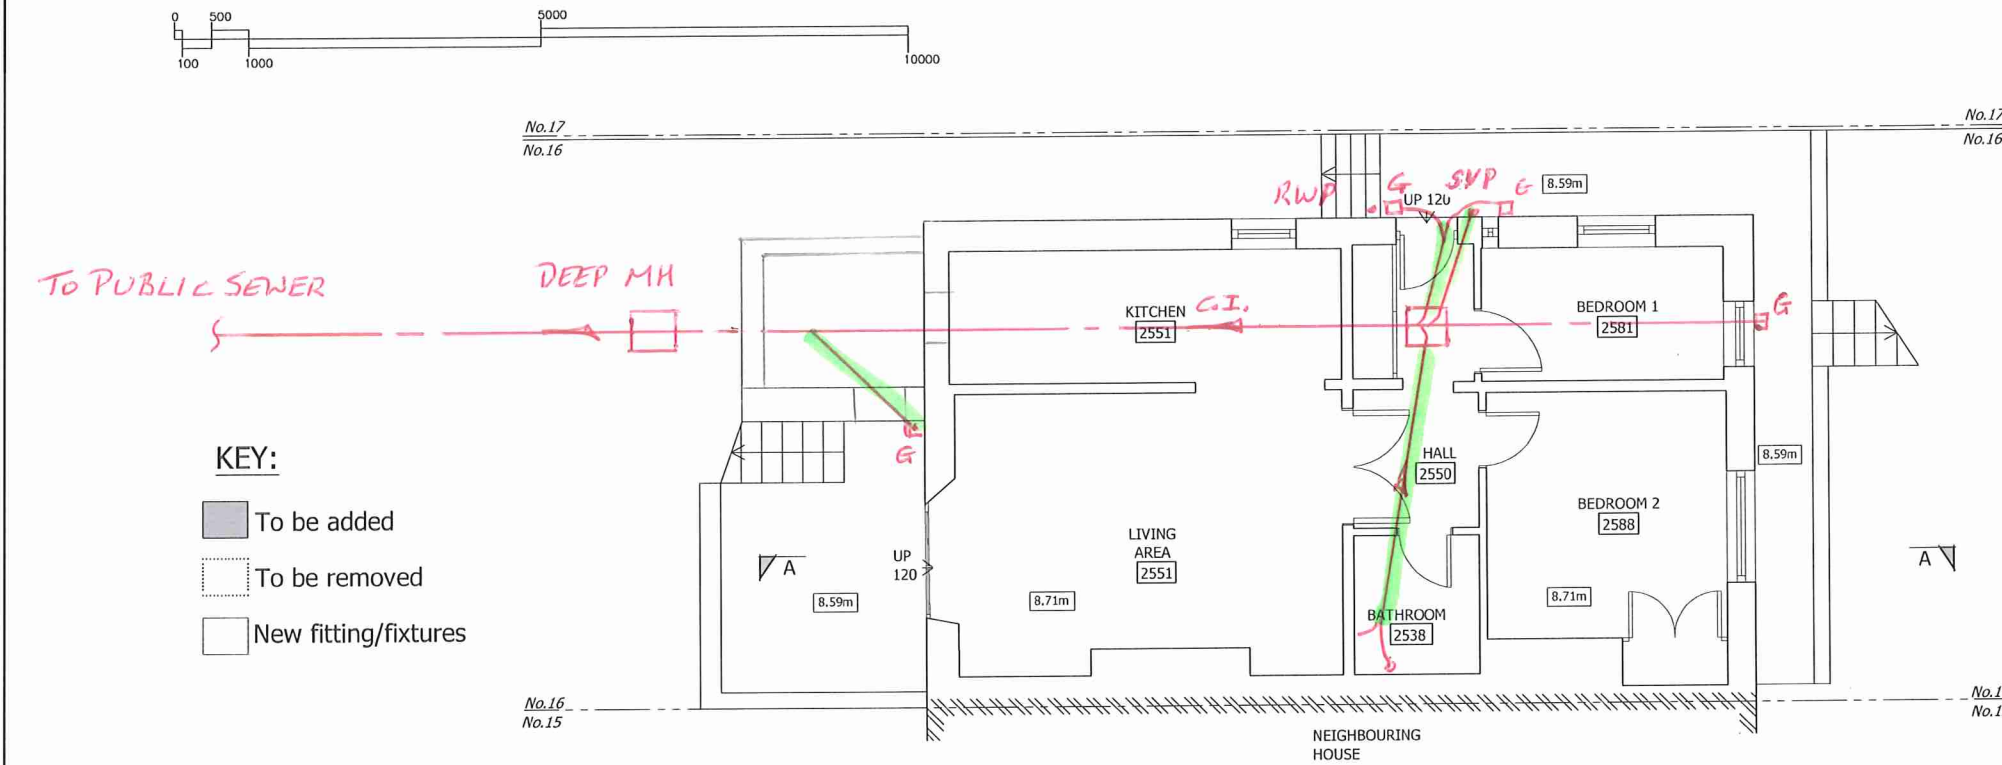
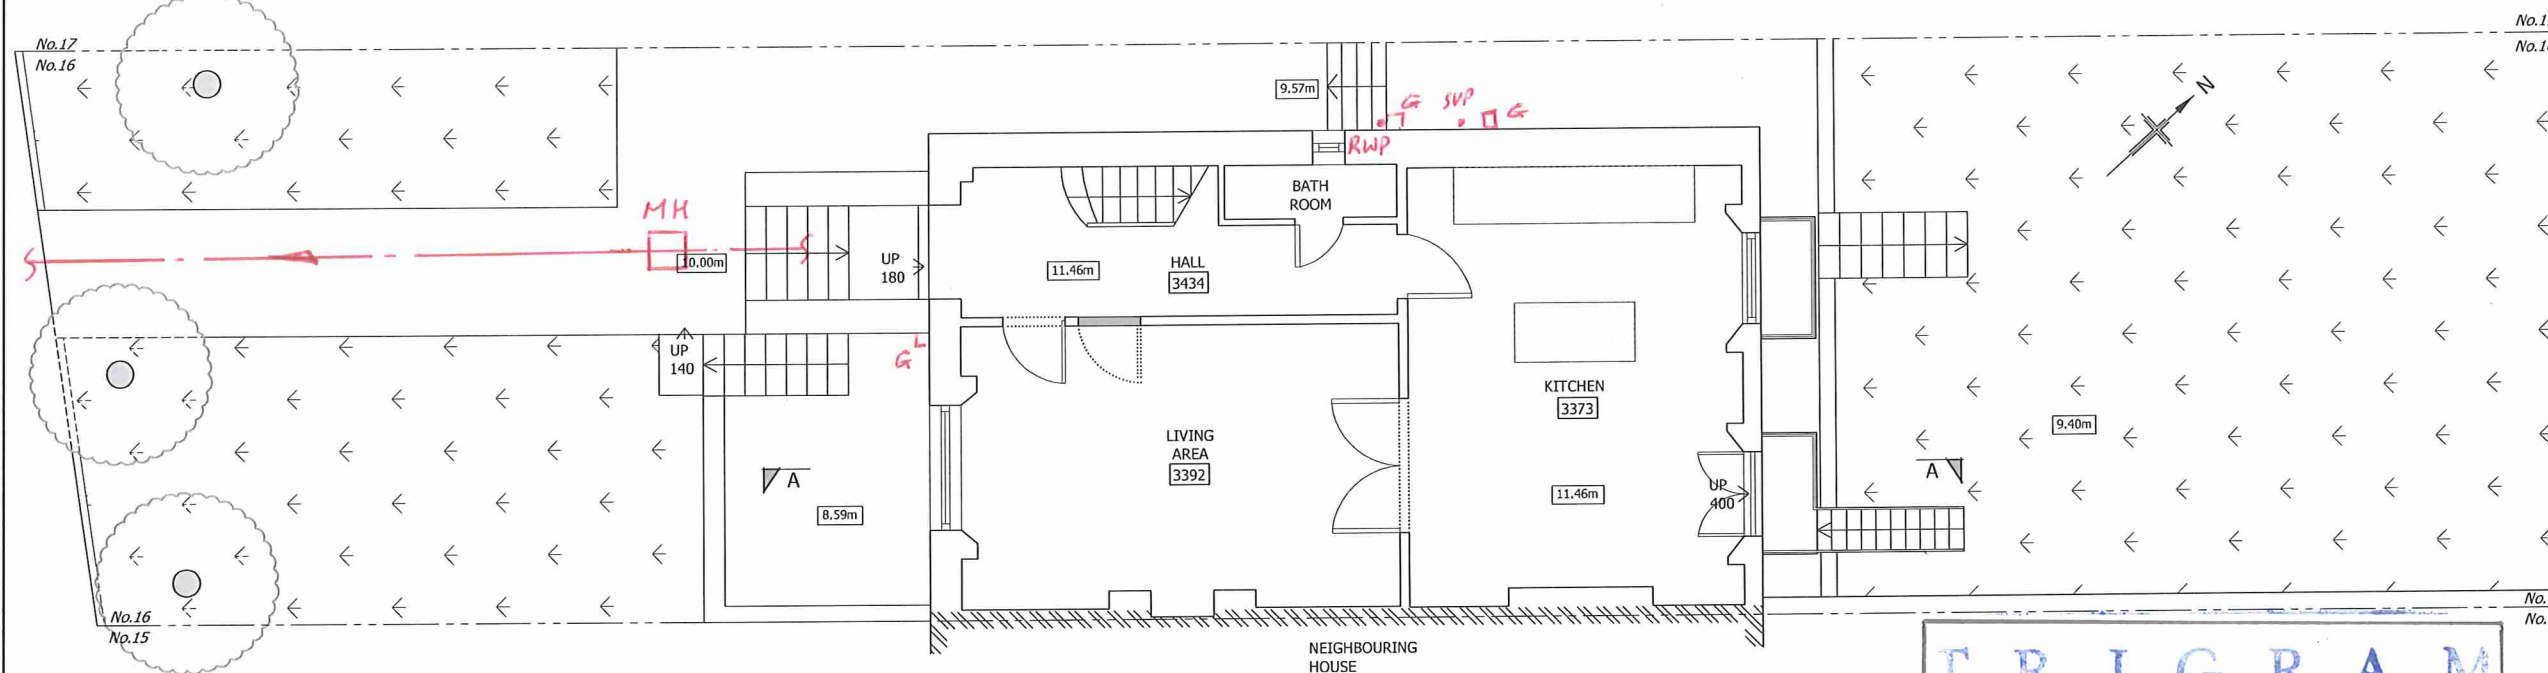
TRIGRAM PARTNERSHIP
16 ETON VILLAS, NW3
DRAINAGE DEFECTS
4209/SK/05 06/15 TSK

A CCTV survey of the below-ground drainage was carried out. The internal man-hole and clay-ware pipes are believed to have been constructed when the house was sub-divided. The CCTV inspection confirmed that many pipes are cracked and some joints are displaced. Therefore, water will have been leaking into the surrounding soils. A layout of the drains, and the locations for defects, is shown in Appendix B.
