# Existing Property

section 3

*Note: Section 3.0 is based on visual surveys carried out by Pollard Thomas Edwards architects on 14 January and 12 February 2013 while the properties were in occupation.*

## 3.1 14 Great James Street

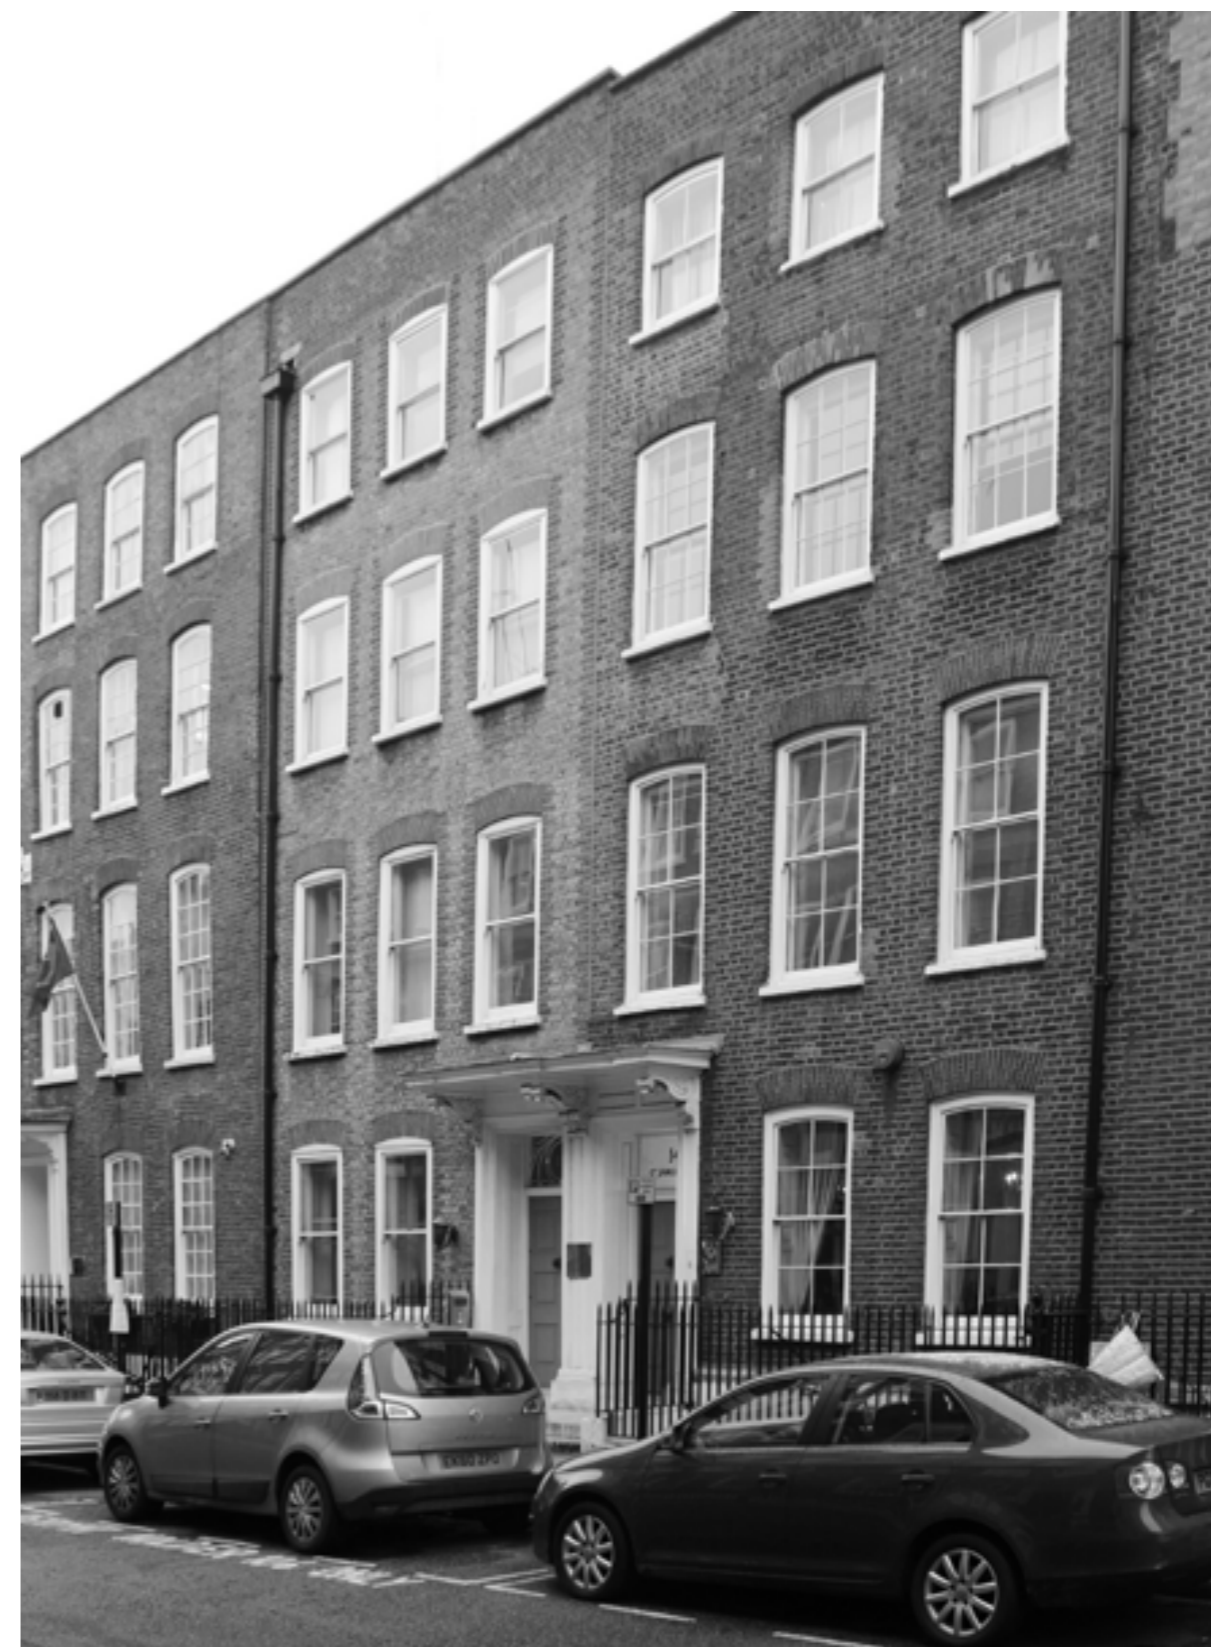
The adjoining front elevation to No.15 was rebuilt in the mid 20th century using yellow London stock brick, rather than match the original plum coloured brick at No.14 (Ref: AHP Building Report). The yellow brick extends as far as the panels between adjacent window heads and cills at No.14. The gauged arches and quoined jambs to windows at No.15 have been rebuilt to match the original red brick at No.14. The rebuilt brickwork at No.15 extends to the basement, but at No.14 the basement brickwork is rendered. The other properties in the street are a mixture of render and white painted brickwork at basement level. The party wall line between Nos. 14 and 15 is defined by a straight vertical joint and red brick quoining on one side, which is also replicated elsewhere in the street. The adjacent third floor brickwork at No.13 has also been rebuilt in yellow stocks, but the junction with No.14 brickwork has been block bonded. The elevations appear to be in a reasonably good state of repair for the age of the properties (fig. 22).

FIG 22. 2013 PHOTOGRAPH OF FRONT ELEVATIONS TO NOS. 14 AND 15 (REFER TO FIG.18 1965 PHOTOGRAPH)

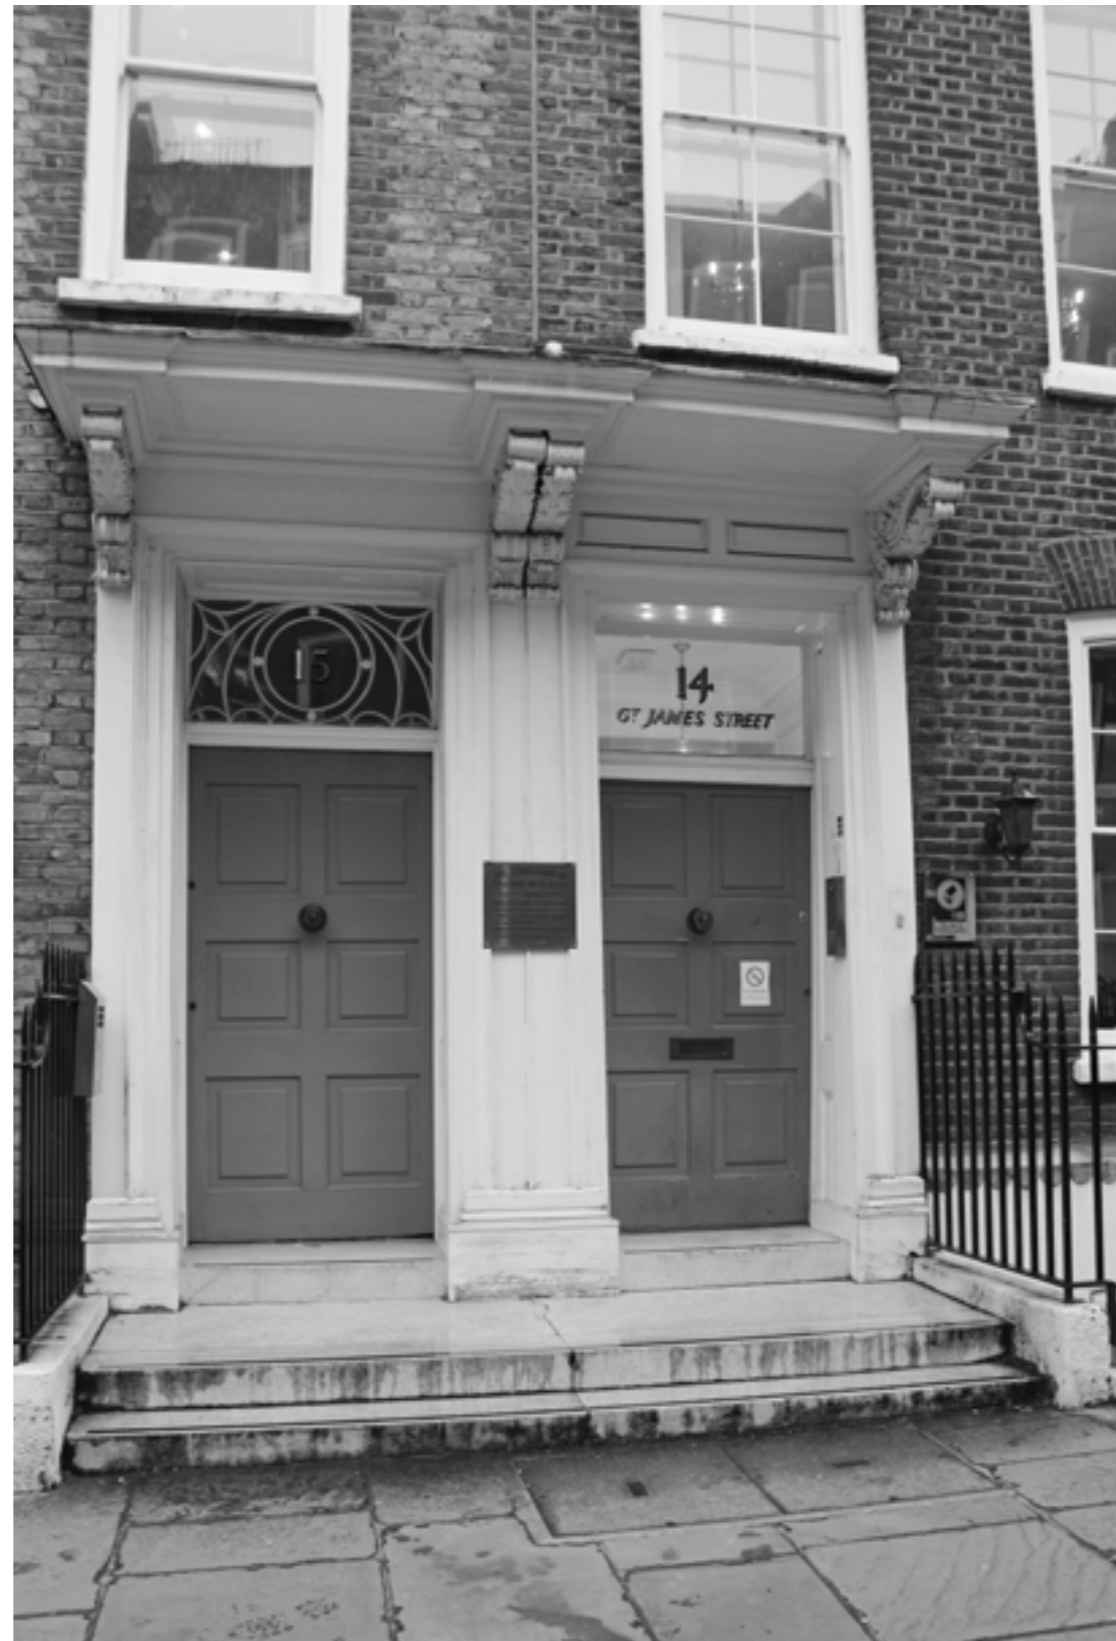
The cantilevered canopies are original with carved brackets to form a matching pair set at the same height. The other properties in the street display similar examples which are also consistent for the period. The roof of the canopies is covered in lead. The height of the doors and doorcases is uneven, with a decorative fanlight at No.15 and a plain fanlight at No.14. The plain fanlight is the larger of the two and may be the original size, based on other examples in the street, suggesting that the decorative fanlight could be an early addition. The pair of panels above the fanlight at No.14 also suggests it may be at the original height. The doors are not original, with different panel proportions to others in the street. The original pattern appears to have smaller panels at mid height, which still exist in several of the other properties. The doorcase returns are panelled and deeper than the majority of examples in the street, although No.16 is a similar depth (fig.23).

FIG 23. 2013 PHOTOGRAPH OF FRONT DOORCASES TO NOS. 14 AND 15 (REFER TO FIG.19 1960 PHOTOGRAPH)

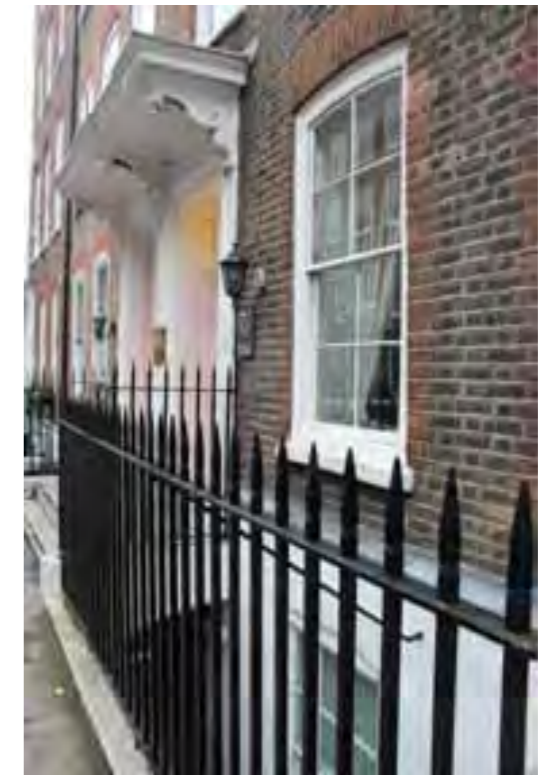
The railings and gates are modern additions. The original pattern can be seen at other properties in the street. The metal stairs down to the basement areas and rainwater downpipes and hoppers are also modern additions. The metalwork generally appears to be in reasonably good condition. The ornamental carriage lamps are modern (fig.24).

FIG 24. STREET FRONTAGE TO NO.14

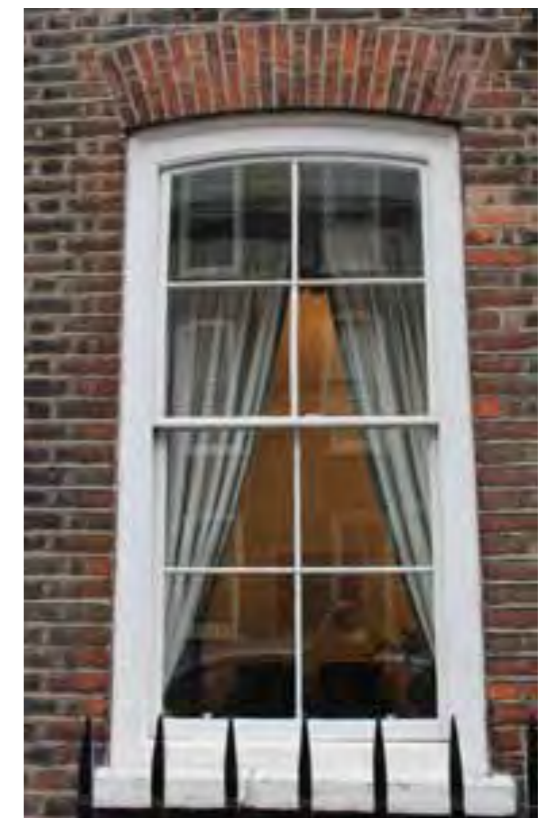
The window sashes have nearly all been replaced at some point during the life of the properties, but whether all sash boxes have been similarly replaced is unclear. These match the original pattern of exposed sash boxes appropriate to the period of the properties. The sash boxes at No.15 all appear to be new, having a straight bottom edge to the frame at the head, whereas No.14 sash boxes retain the curved bottom edge common to other properties in the street. None of the sash boxes at No.14 display the fluted design that appears to be the original pattern, which can be seen at Nos. 13 and 16 and elsewhere in the street (fig.25).

FIG 25. FRONT GROUND FLOOR WINDOW TO NO.14

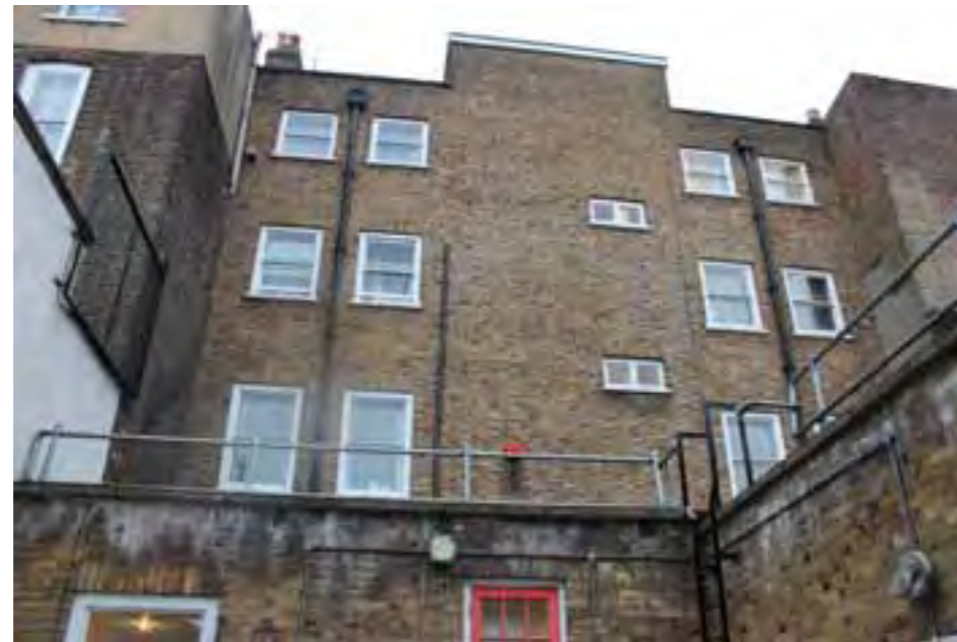
The main rear elevation is a later addition to the original property and was constructed in 1965 (Ref: AHP Building Report) with Flemish bond smooth yellow-pink multi-stock brickwork and flat soldier brick arches. The survey drawings and brick bond suggest a solid 1½ brick wall without a cavity (fig.27).

FIG 27. REAR ELEVATIONS TO NOS.14 AND 15

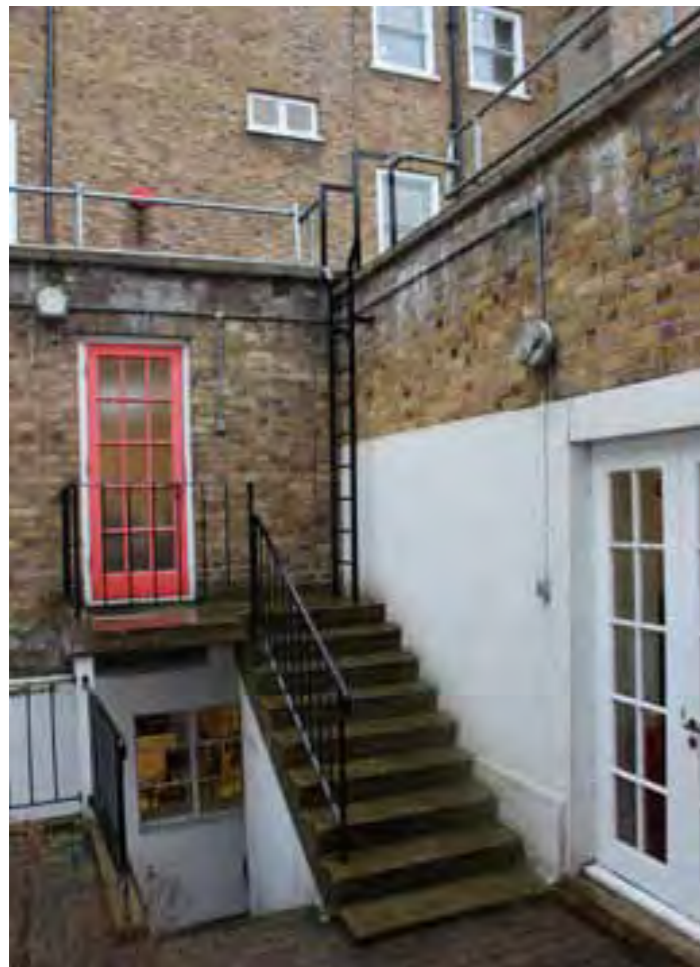
The windows are all modern sliding sashes or top hung casements. The external doors are similarly modern (fig.26).

FIG 26. REAR EXTENSION ELEVATIONS TO NOS.14 AND 15

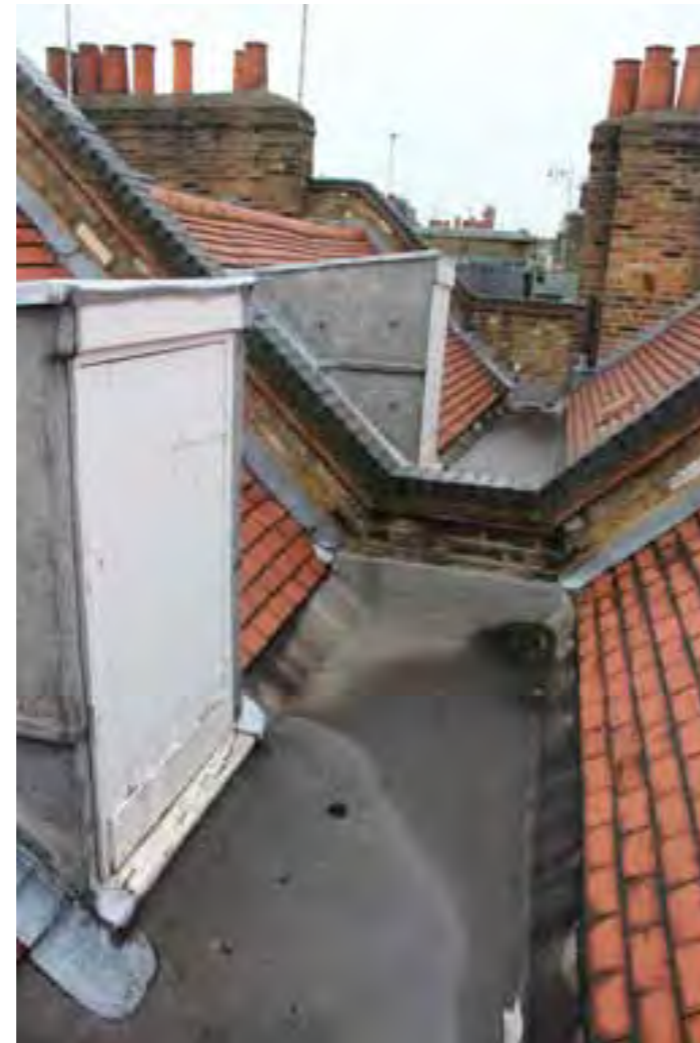
The original 'M' shaped roofs survive in each of the properties. These comprise a pair of duo-pitch roofs divided by parapets with a ridge running between party walls. The party wall parapets have modern engineering brick copings and creasing tiles (fig.30).

FIG 30. MAIN ROOF AND VALLEY GUTTER TO NOS. 14 AND 15.

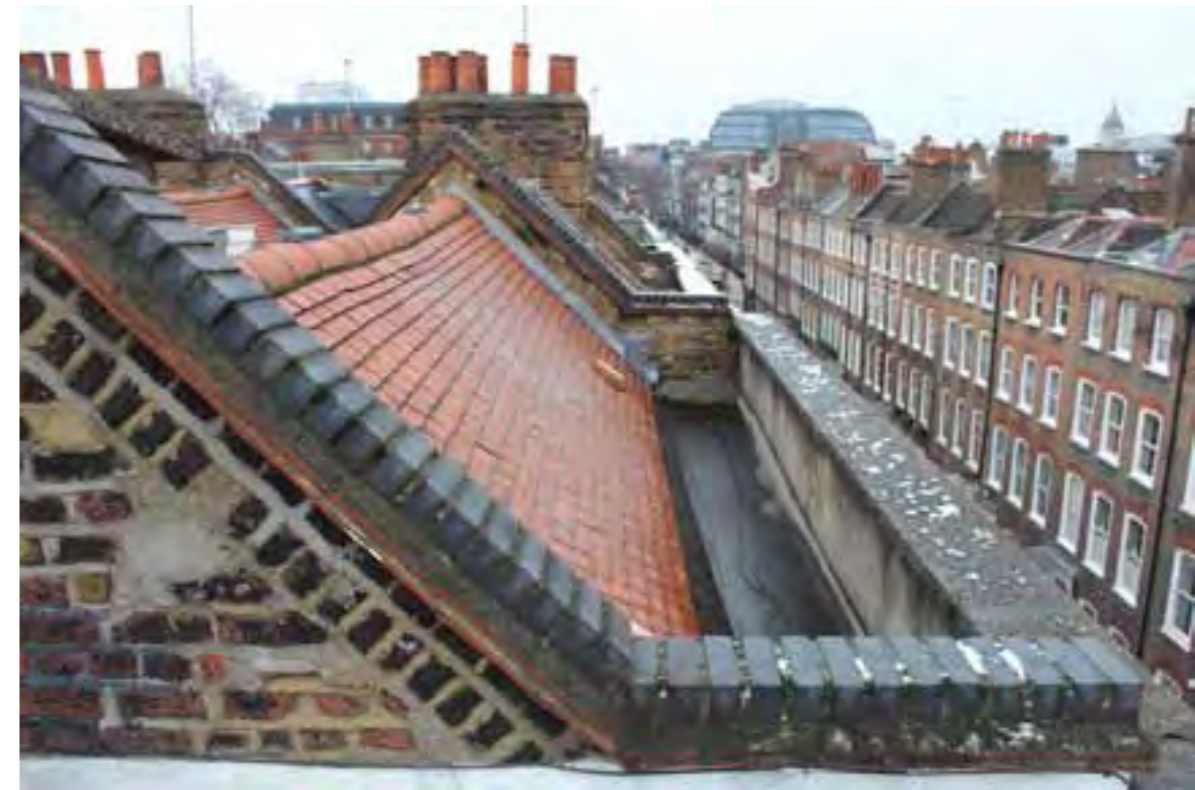
There are parapet gutters at the front and a valley gutter in the middle over the spine wall. The front parapet is rendered on the inside and has a modern concrete coping (fig.31).

There are roof dormers with lead cladding and timber boarded doors which originally provided access to the valley gutters. These are unused and sealed shut, as access is at present via the adjoining roof (fig.31).

FIG 31. MAIN ROOF AND FRONT PARAPET GUTTER TO NOS.14 AND 15

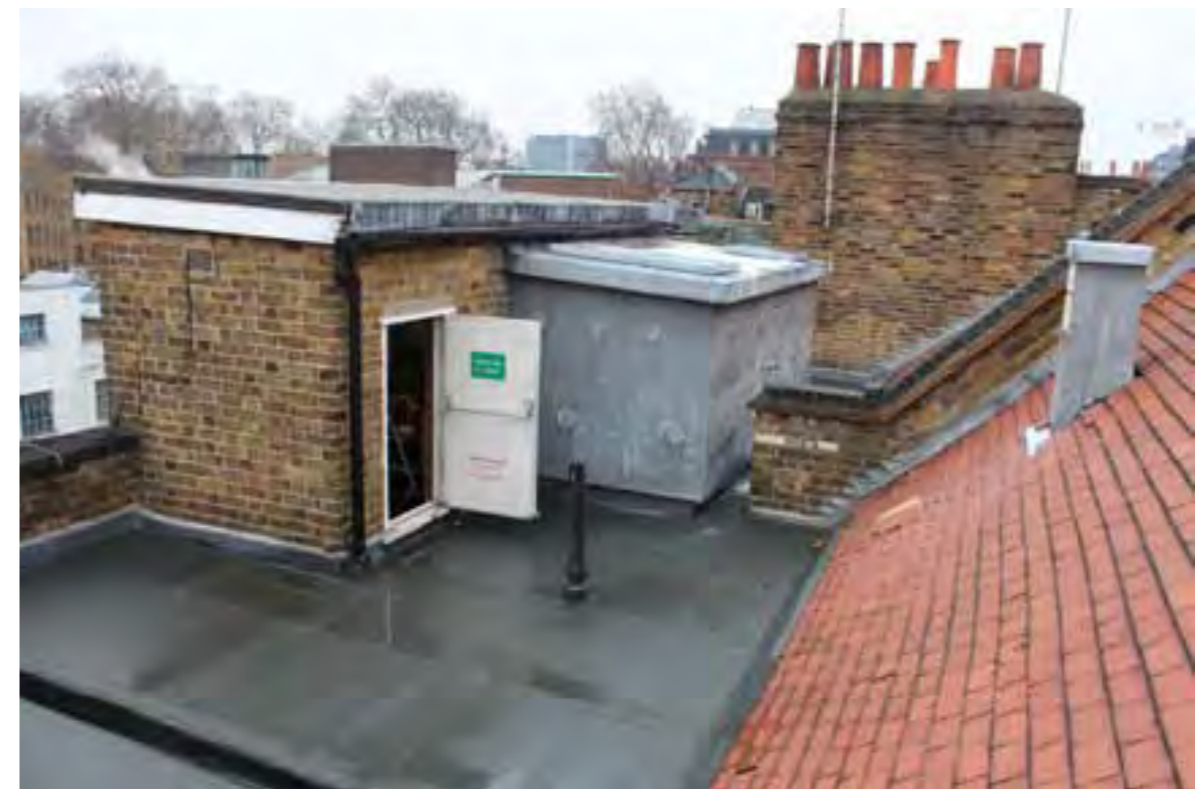
The original parapet and gutter at the rear were removed when the properties were extended in 1965. The rear part of the main roof is flat and has a felt roof covering. There is a lift motor room which has solid brick walls, a shallow pitch roof with felt roof covering and a water tank housing attached with zinc cladding (fig.32).

FIG 32. POST-1964 MAIN ROOF EXTENSION AND LIFT MOTOR ROOM TO NOS. 14 AND 15

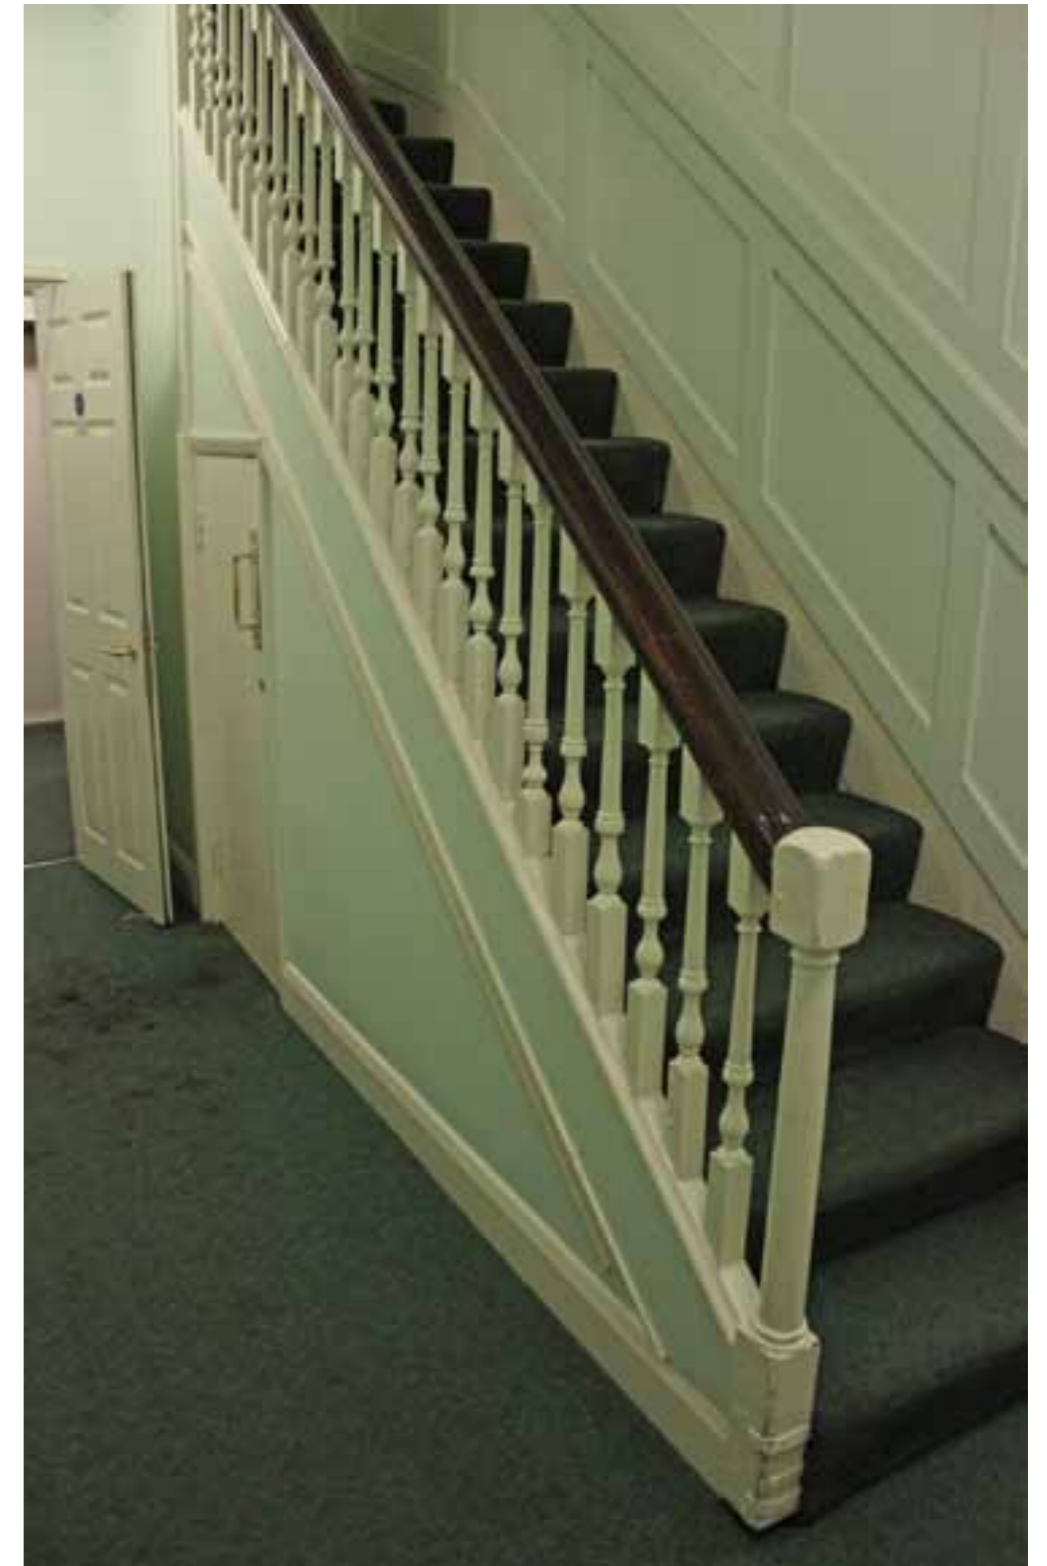
The stairs are the only original feature remaining (fig.39). The balustrades are the same design as stairs between second and third floors with panelling retained to the stair wall on one side, but elsewhere all finishes are modern plaster. The panelled doors and joinery are similarly all modern. The floor is a modern concrete ground bearing slab. There is a lift in the 1965 extension and incoming electrical service boards and meters are located in the front room. There are vaulted brick cellars that extend under the street.

FIG 39. BASEMENT STAIR AND PANELLING AT NO.14

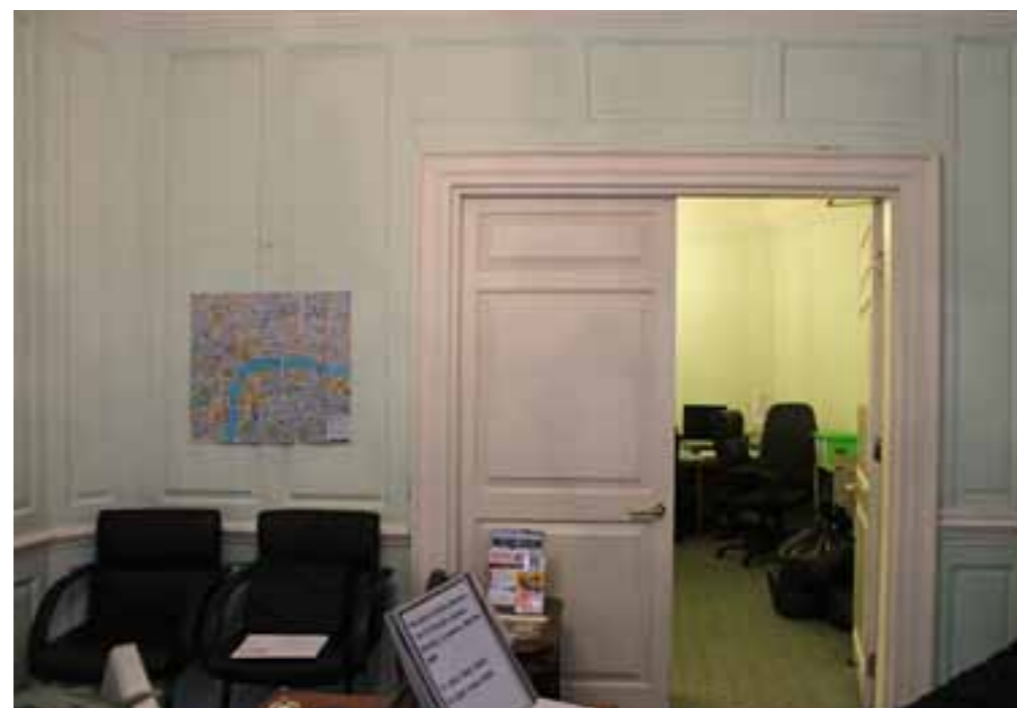
The ground floor panelled doors match the wall panelling, although some are modern reproduction period doors. The double doors between the front and rear rooms were added in 1989 to replace a single door (fig.40). The middle panels in the panelled door between the hall and front room have been replaced with glazing. The front room has a recessed cupboard to the left of the chimney breast with a panelled door and internal linings (screwed shut and used as a pipework riser duct).

FIG 40. GROUND FLOOR FRONT ROOM AND PANELLING AT NO.14

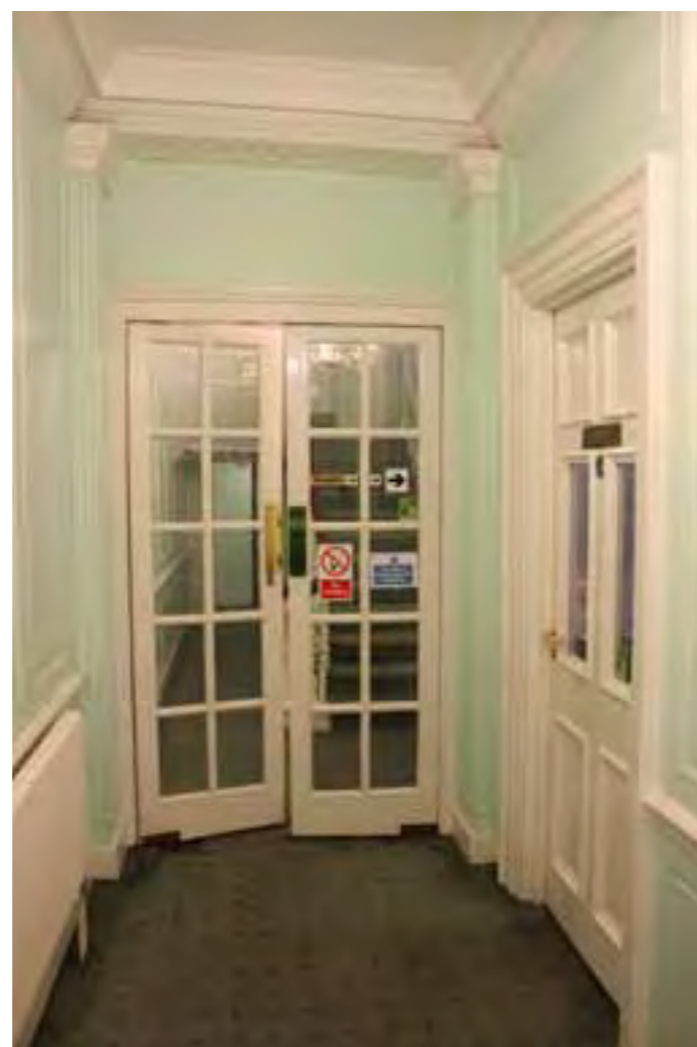
There is a lift in the 1965 extension. The layout of the principal rooms, entrance hall and stairs is original. The winders at the head of the basement stair also appear to be original. A door opening in the party wall connects the hall with No.15 and is a modern addition. The double doors dividing the front hall from the stairs are also a modern addition (fig.41).

FIG 41. GROUND FLOOR HALL AND PANELLING AT NO.14

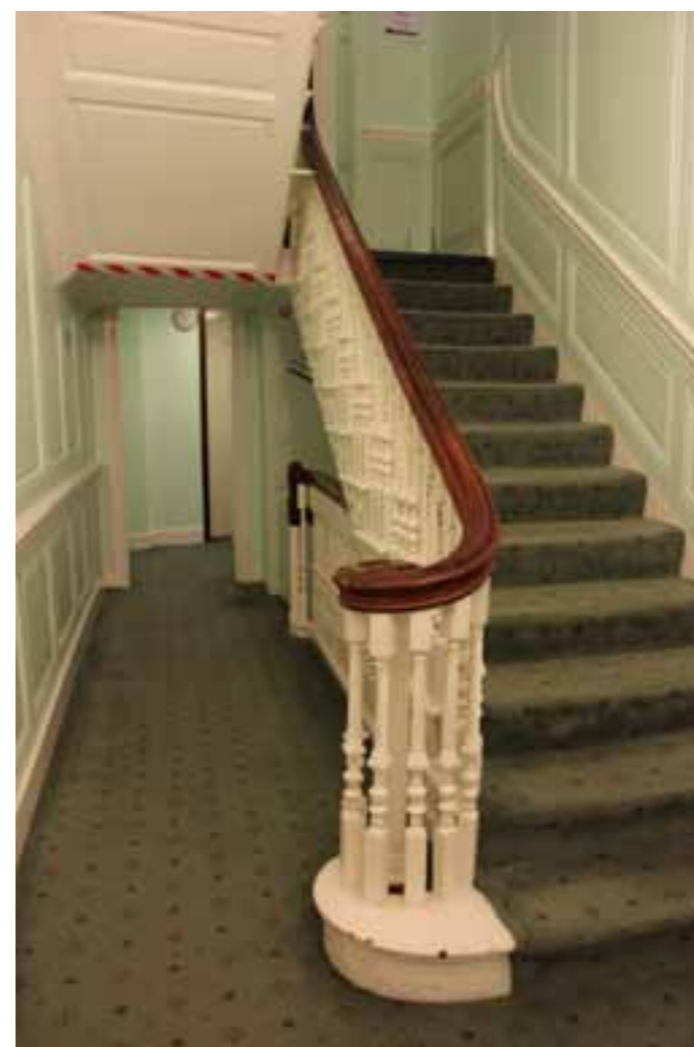
The staircase has ornate balustrades with carved open strings, moulded nosings, twisted barley-sugar balusters and hardwood frogs back handrails that spiral at the base of the stair (fig.42). The half landing newels comprise a pair of fluted columns. The stair panelling at the bottom of the stair and at half landings includes fluted pilasters up to dado height with decorative ionic capitals. The stair soffits comprise raised and fielded panels to match the wall panelling.

FIG 42. GROUND FLOOR STAIR AND PANELLING AT NO.14

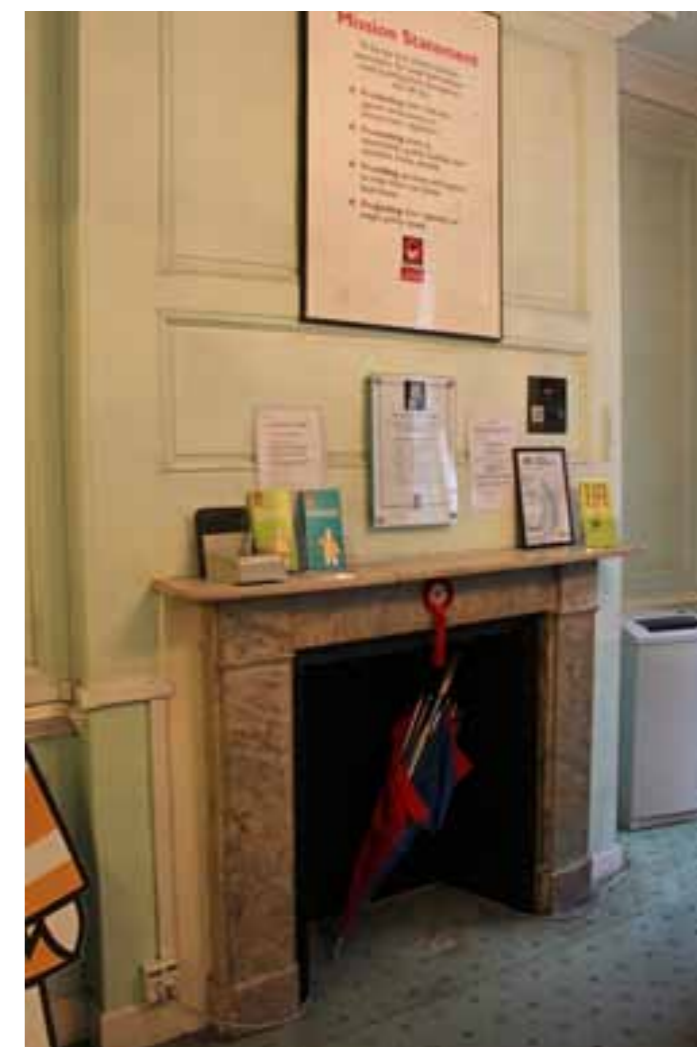
There is a plain marble fireplace surround in the front room. The mantelpiece is cracked and the marble discoloured. The surrounding panelling suggests that a larger timber fire surround may originally have been incorporated (fig.43). There is no grate. The fireplace in the rear room is sealed flush with the panelling and the fireplace surround is missing.

FIG 43. GROUND FRONT ROOM FIREPLACE AT NO.14

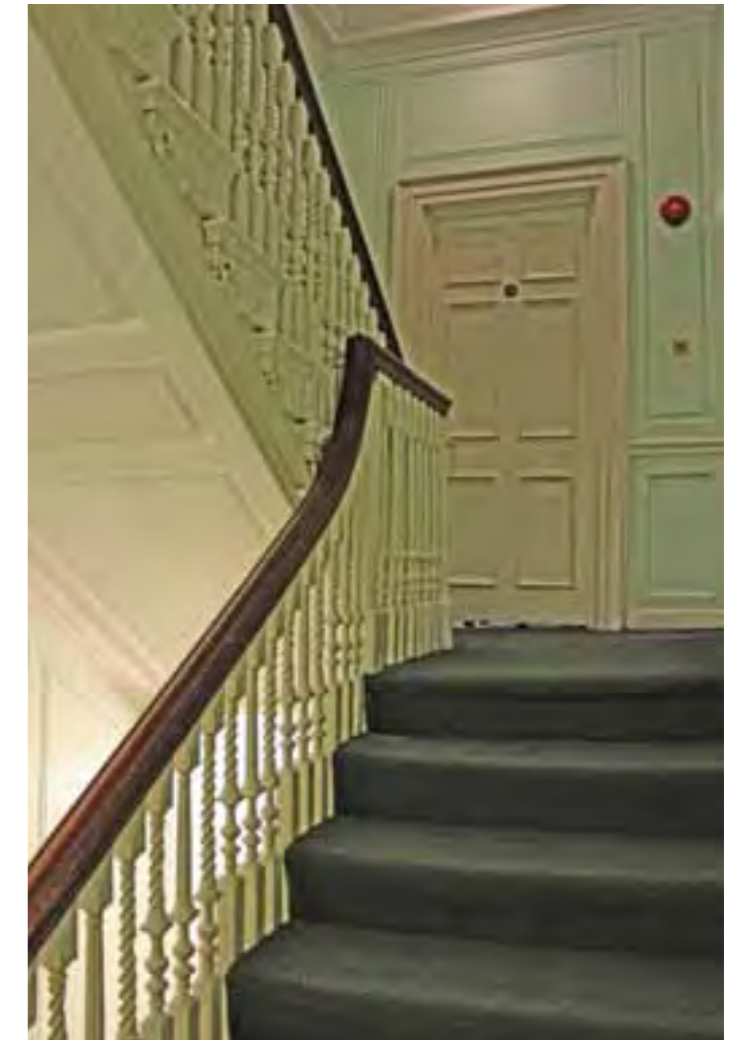
The staircases have ornate balustrades which are a continuation of the ground floor. The half landing newels and stair panelling also repeat the pattern of the ground floor. The stair soffits comprise raised and fielded panels to match the wall panelling (fig.48).

FIG 48. FIRST FLOOR STAIR AND LANDING AT NO.14

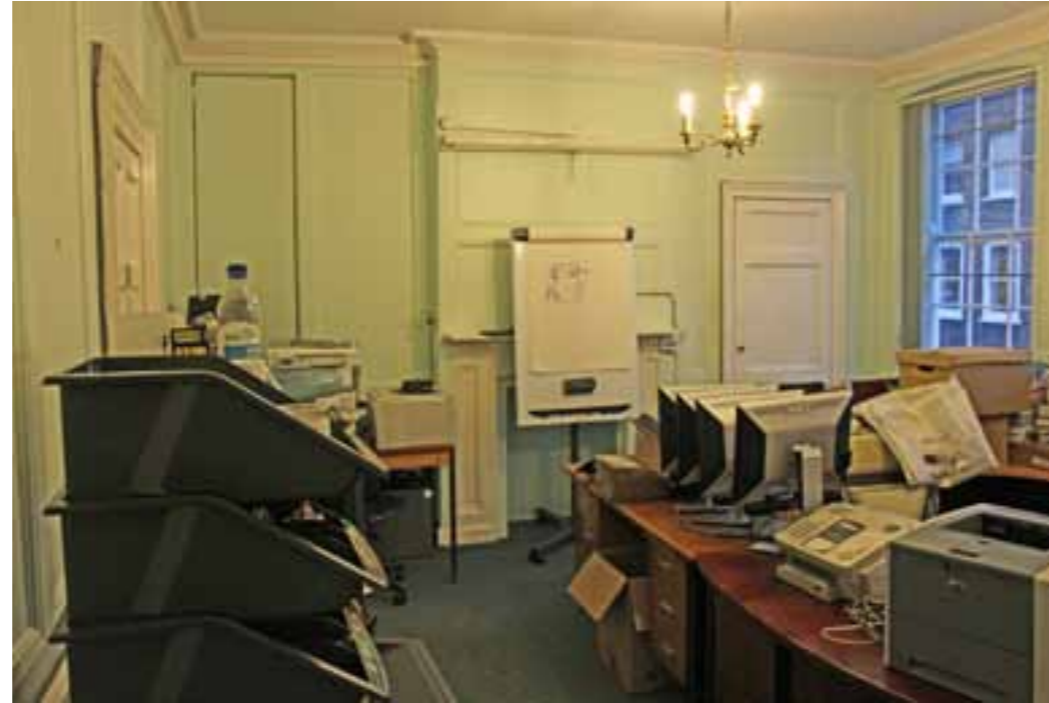
There are modern single connecting 'panelled' doors to rooms off the landing and between the main front and rear rooms, in the same position as the double doors on the lower floors. The front room has a recessed cupboard adjoining the chimney breast with a panelled door and architrave on the RH side and a flush panel on the LH side (fig.49).

FIG 49. SECOND FLOOR FRONT ROOM AND PANELLING AT NO.14

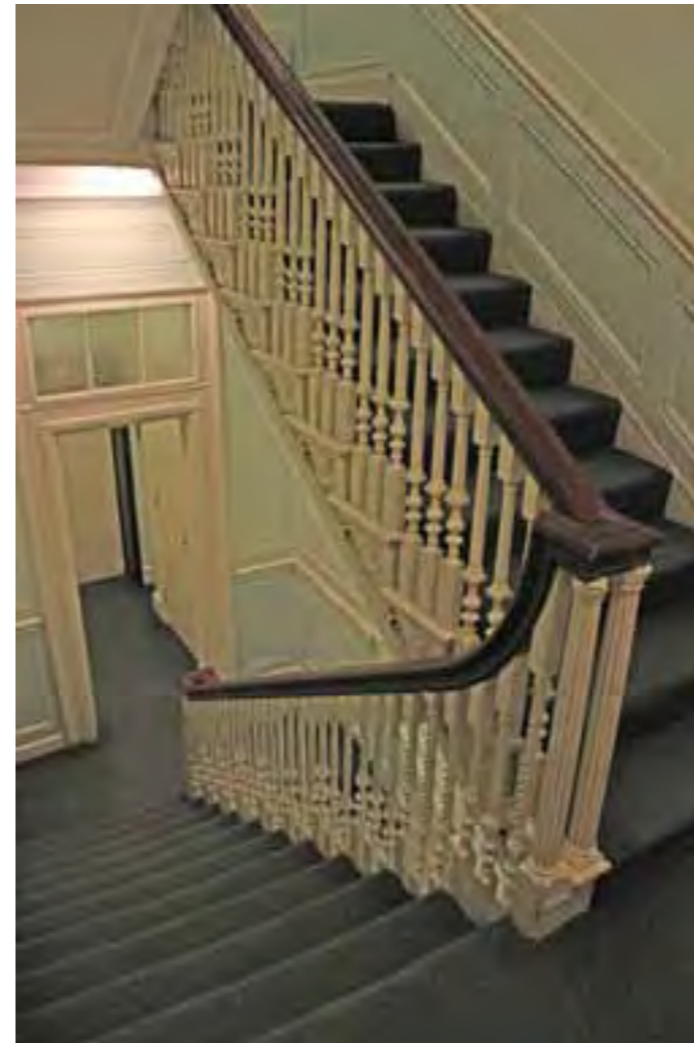
The staircase has ornate balustrades which are a continuation of the lower floors with carved open strings, twisted barley-sugar balusters and hardwood frogs back handrails. The half landing newels and stair panelling repeat the pattern of the ground floor. The stair soffits are panelled. The ornate stair panelling at the bottom of the stair and at half landings also repeats the pattern of the lower floors (fig.52).

FIG 52. SECOND FLOOR STAIR AND PANELLING AT NO.14

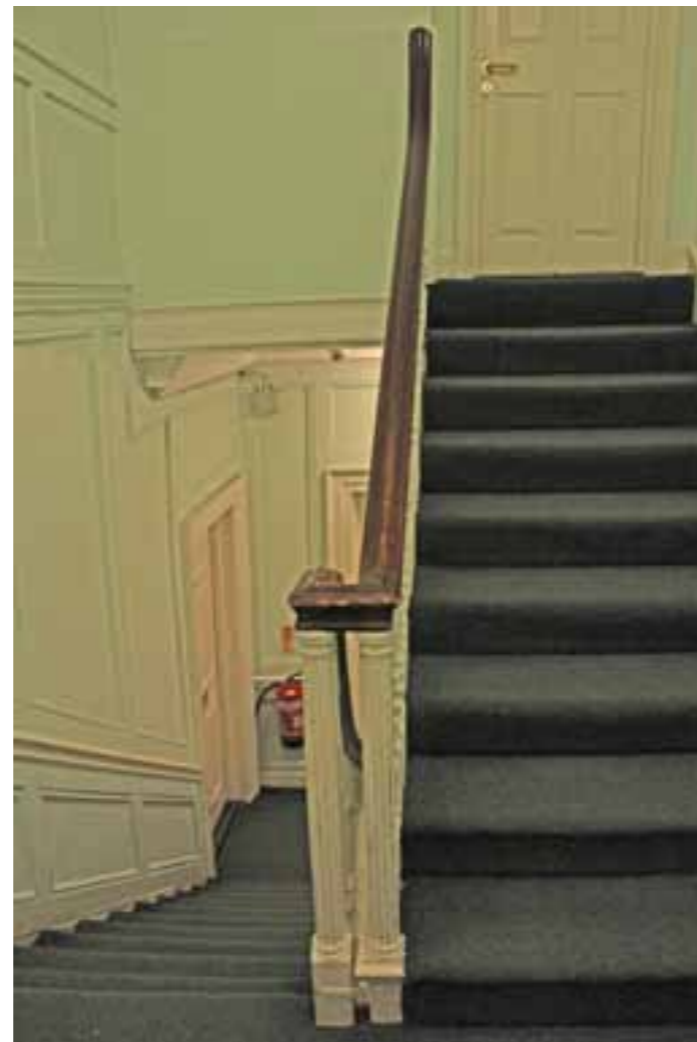
There is plain panelling to one side of the stair well (fig.56). There are panelled window seats in the front room window recesses. No other panelling remains. No window shutters or panelled reveals remain and rooms may originally have been plastered and not panelled. There are moulded dado rails and skirtings in all rooms which are modern additions. The cornices are all modern. There is a false ceiling in the front room. There is a ceiling hatch in the front room and above the stair landing providing access to each of the pitched roof voids. The panelled doors and moulded architraves are modern additions. There are no fire surrounds and all fireplaces have been blocked and plastered over.

FIG 56. THIRD FLOOR STAIR AND HALF LANDING AT NO.14
