41-42 CHESTER TERRACE
LONDON, NW1 4ND

REPAIR OF THE STUCCO FACADE: Schedules of Work and Specification

PREPARED FOR
SHALIMAR INVESTORS LTD
September 2014

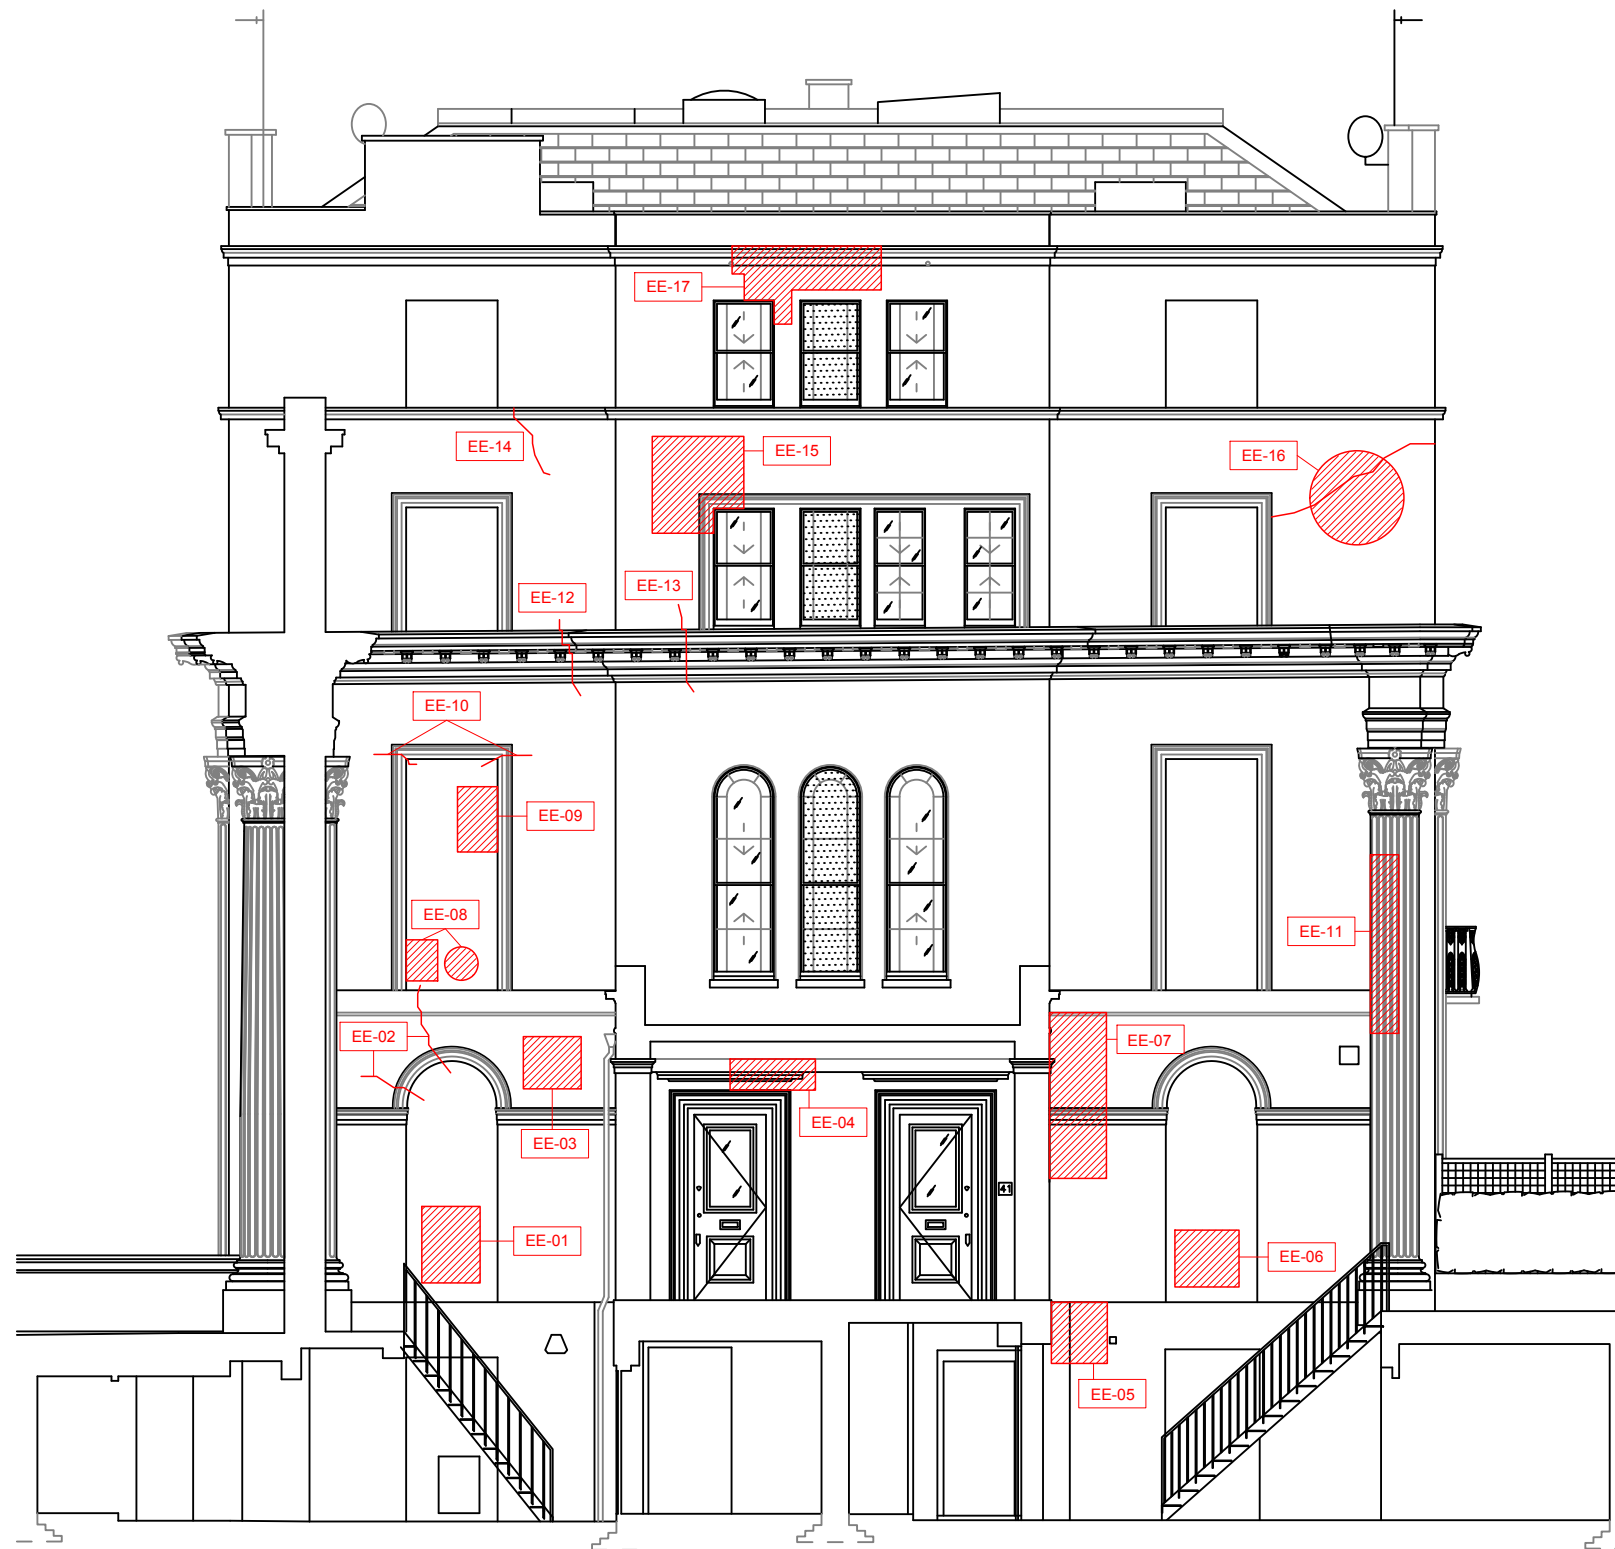
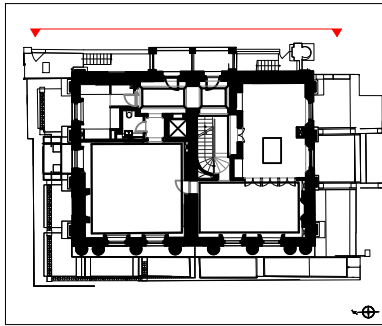
EAST ELEVATION

Areas that need repairing

Fractures through the stucco

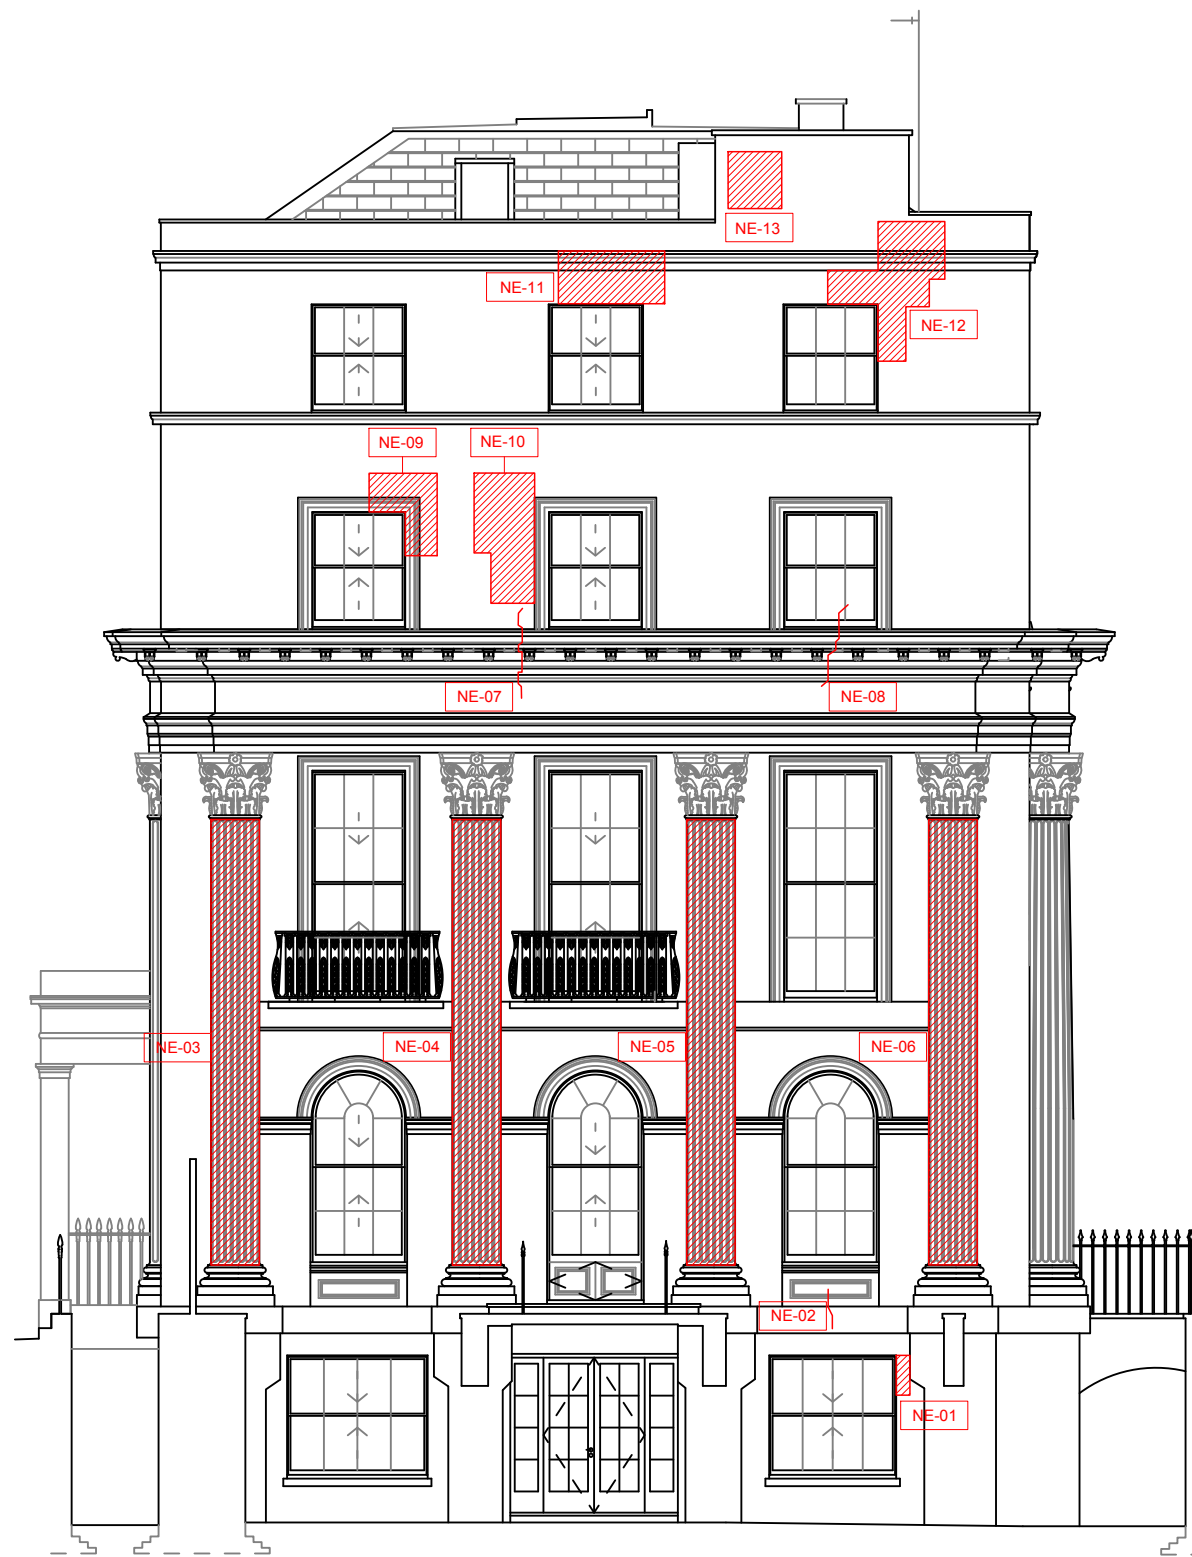
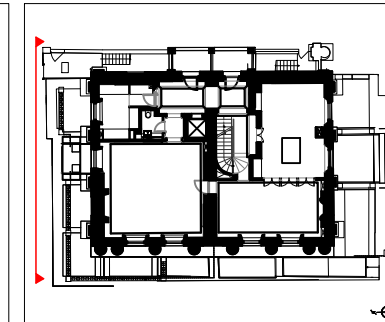
NORTH ELEVATION

Areas that need repairing

Fractures through the stucco

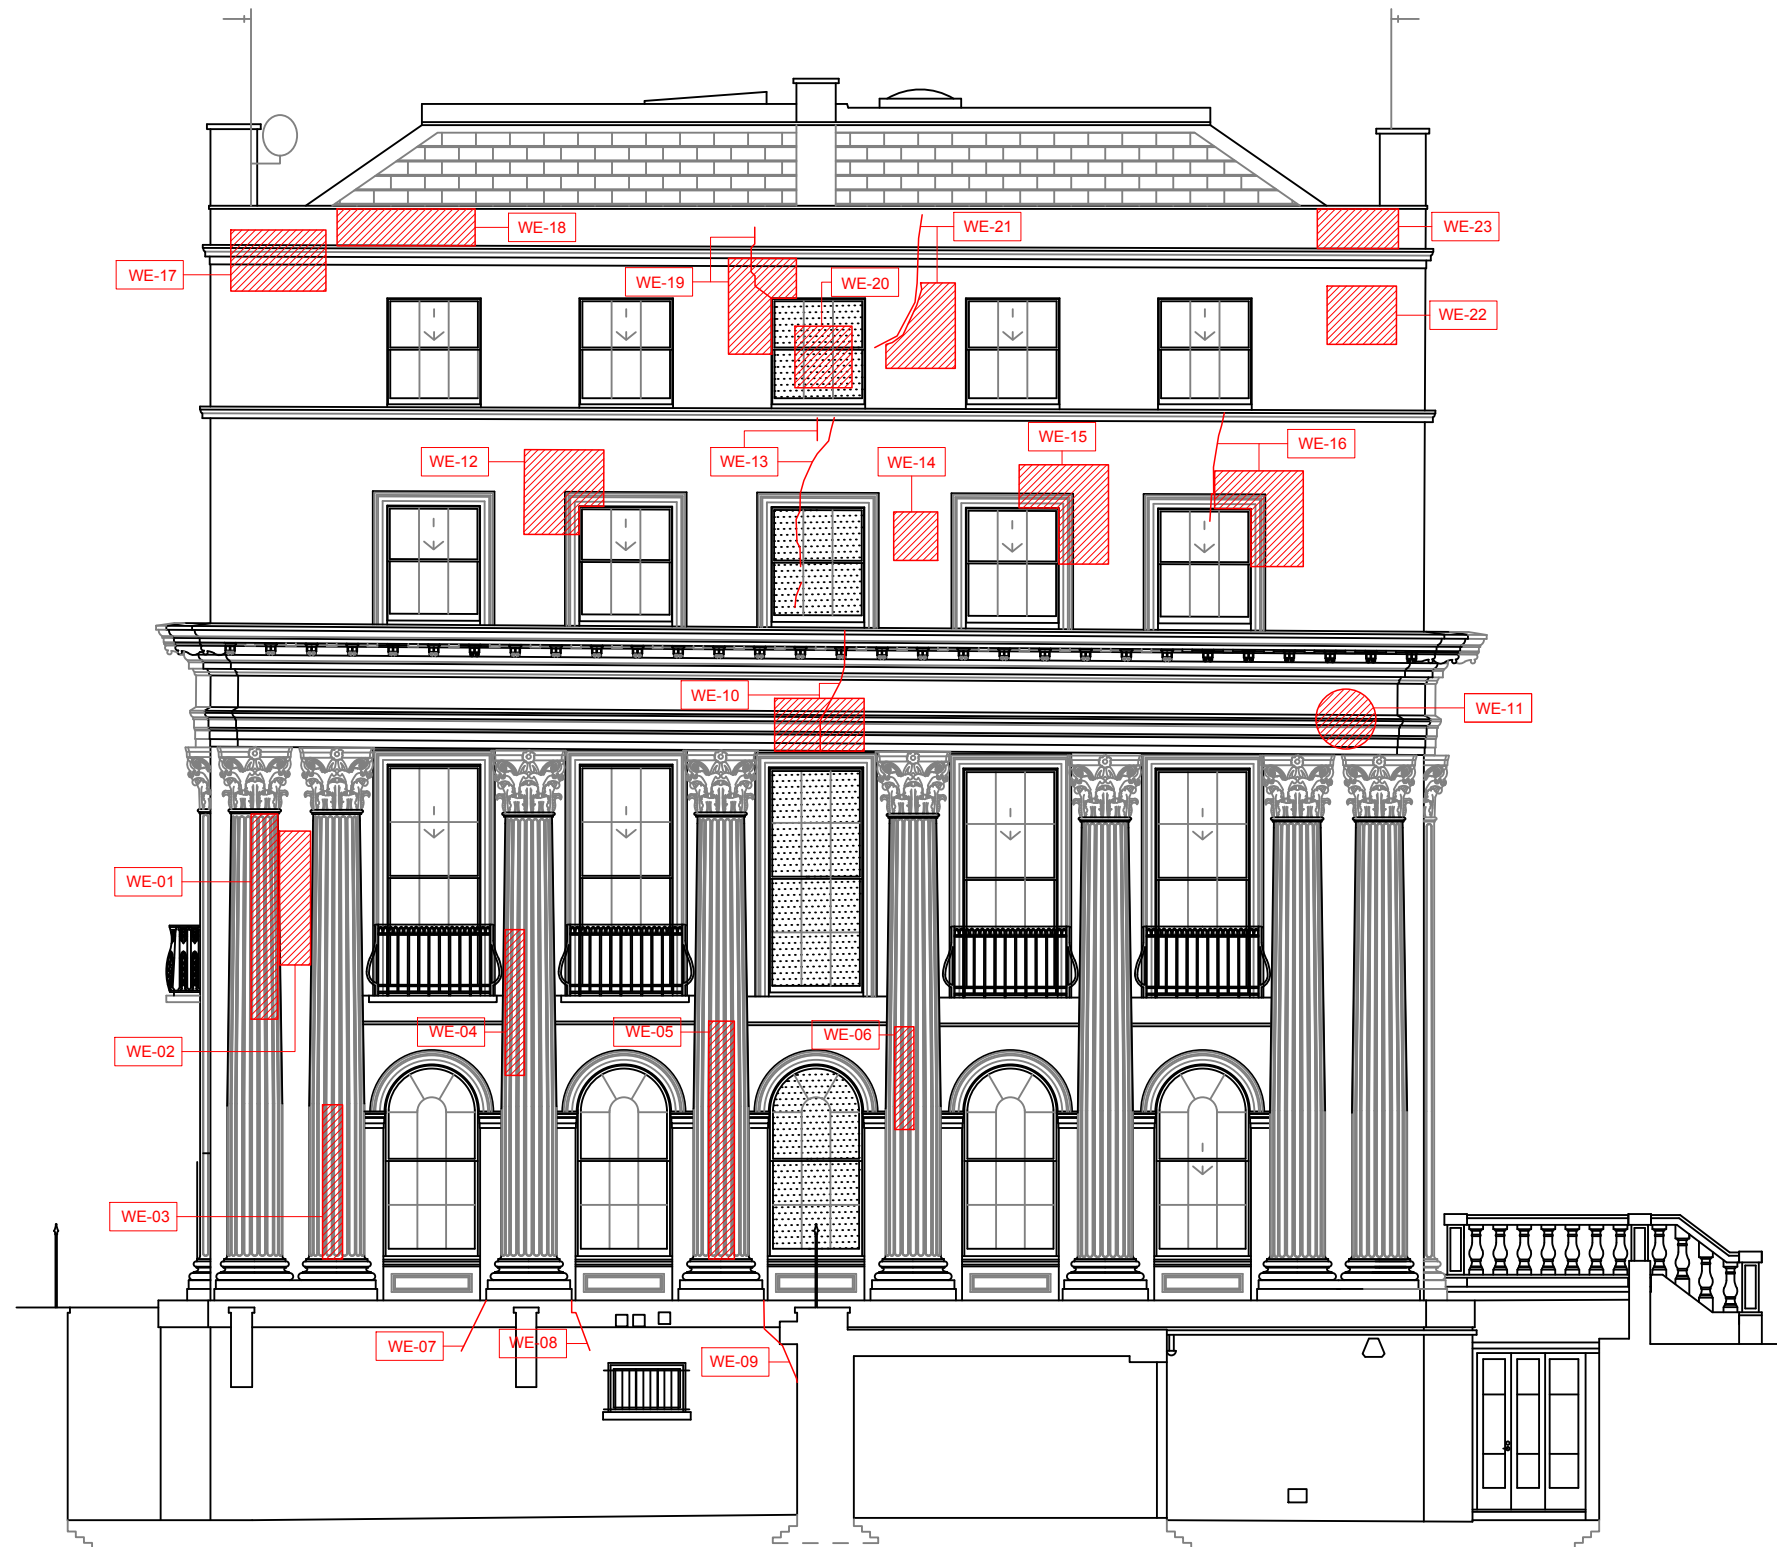
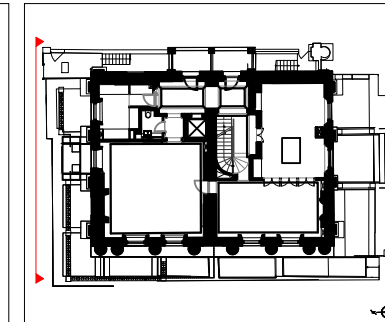
WEST ELEVATION

- Areas that need repairing
- Fractures through the stucco

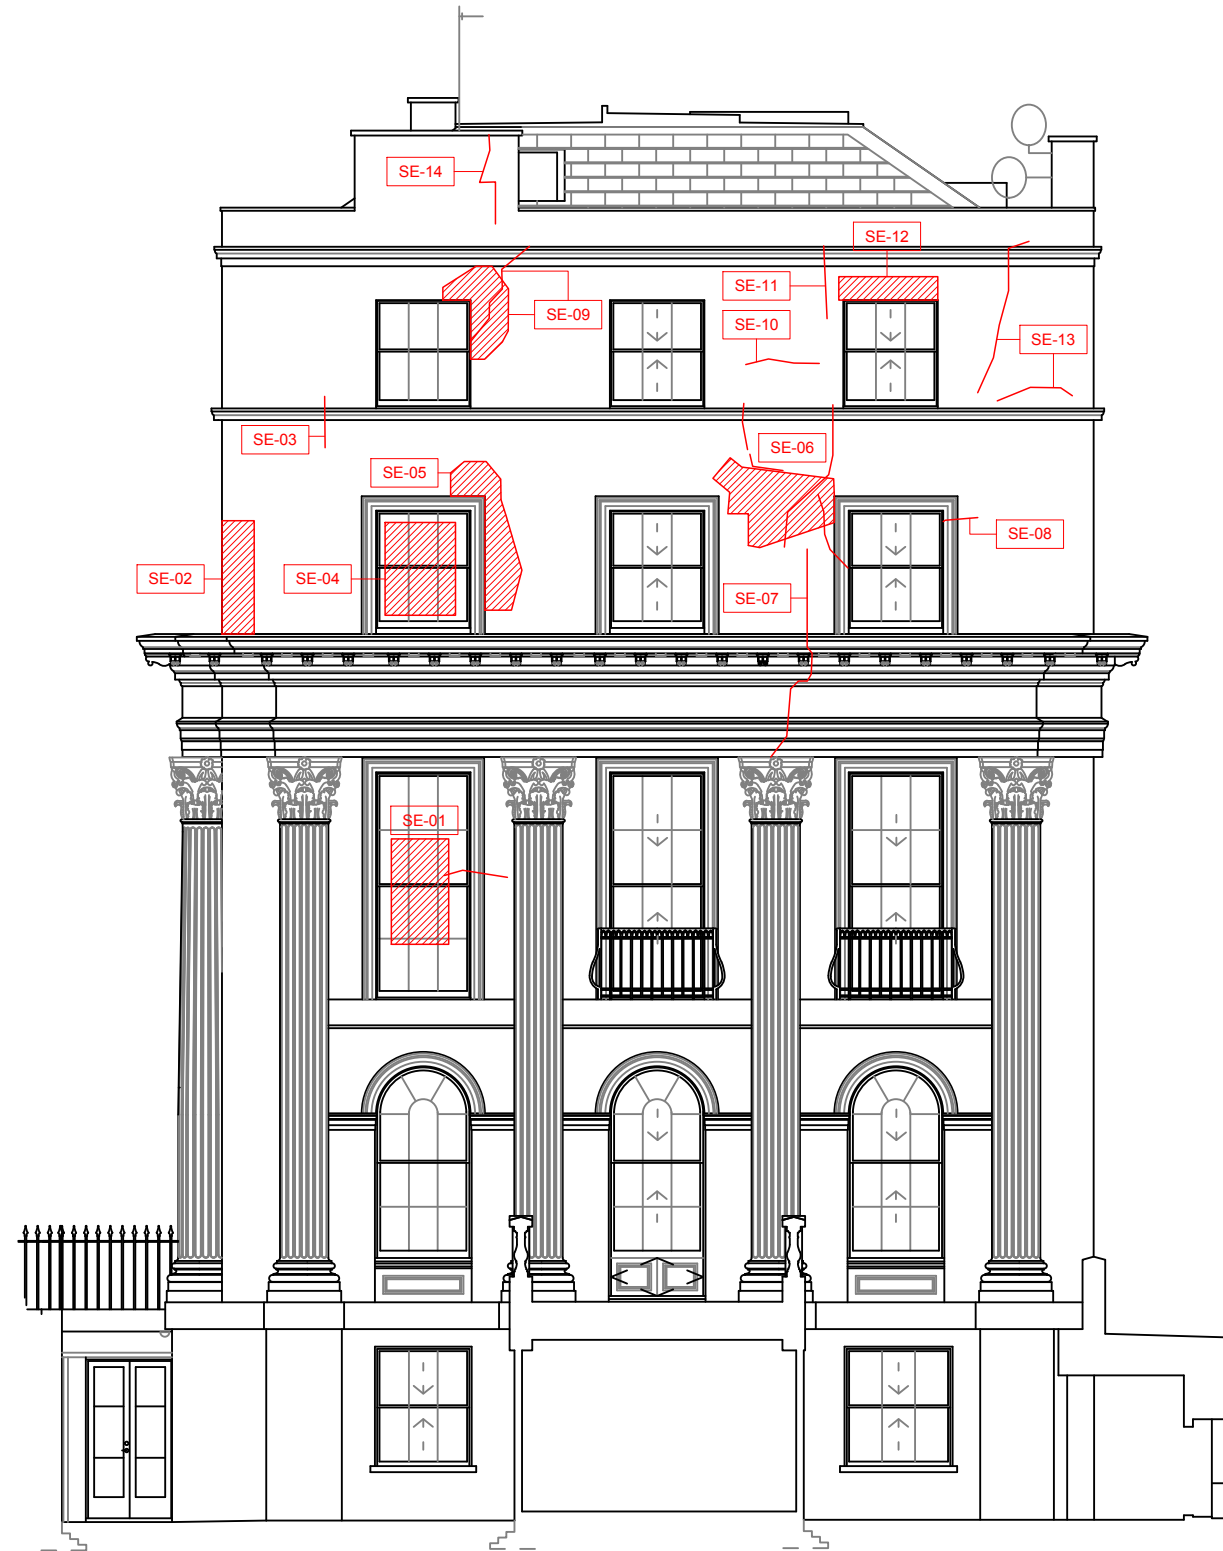
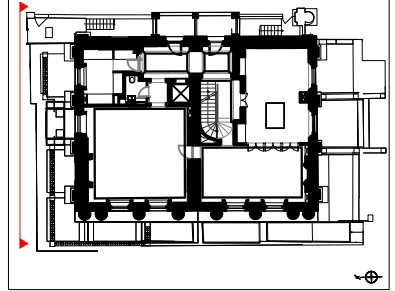
SOUTH ELEVATION

Areas that need repairing

Fractures through the stucco

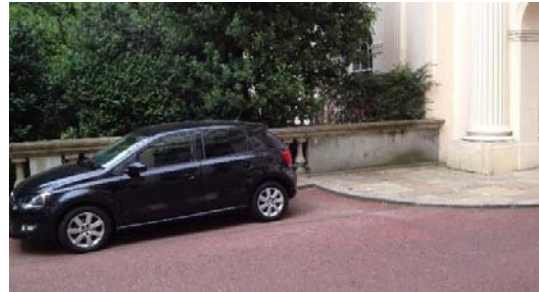
- 2 The pointing to the plinth wall and balustrade connecting to the house is open and should be repointed.

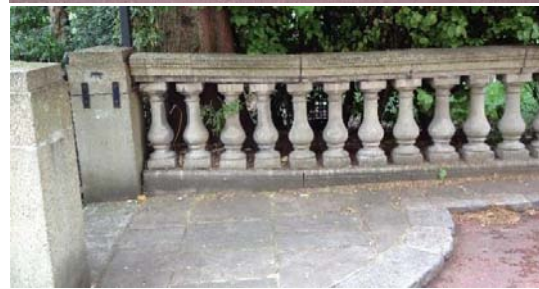
- 3 The pointing to the southern end of the balustrade is also defective. The level of the balustrade and gate post has also lifted and displaced which was probably caused by the roots of the adjacent tree

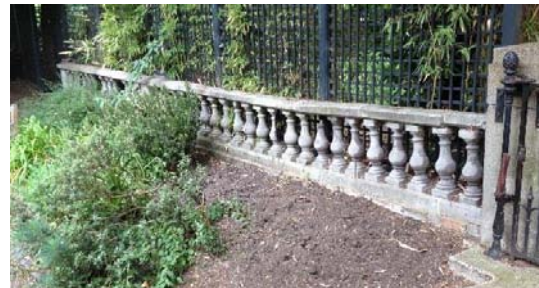
- 4 The balustrade along the garden line dividing the private garden from the communal garden is in a poor condition with excessive displacement and settlement.

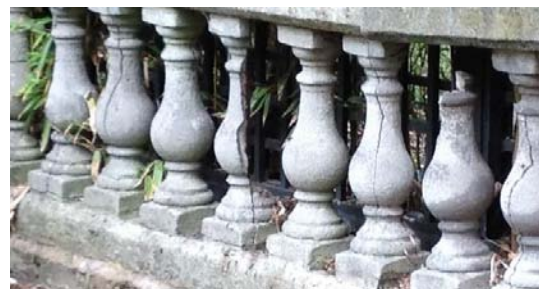
- 5 A majority of the bottles have split and fractured and require replacing. It is anticipated that the remaining bottles are in a similar condition and the whole wall should be reconstructed.

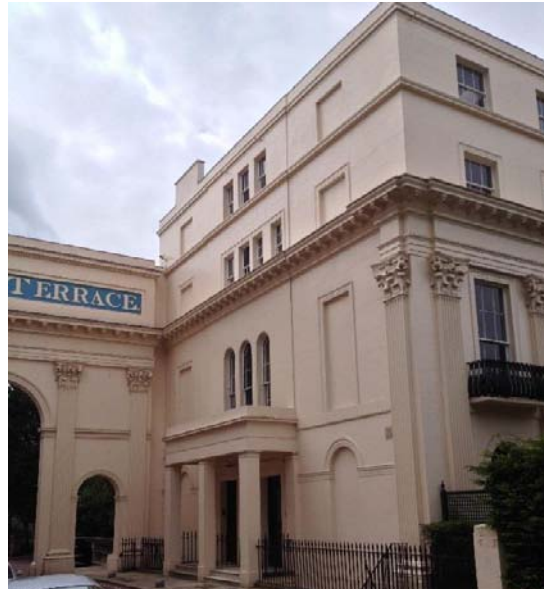
7 As with all elevations the Chester Terrace elevation is in reasonable condition with limited defective stucco render.

8 To maintain the quality of the facades we would recommend that the asphalt and lead guttering details and coverings to cornices are replaced.

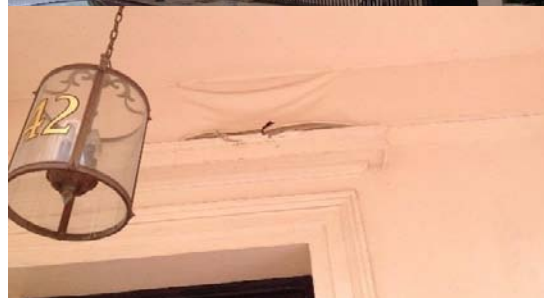
9 Within the entrance porch the paint is debonding in sheets which is indicative of the impermeable quality of the paint system and the extent of water ingress from the flat roof above.

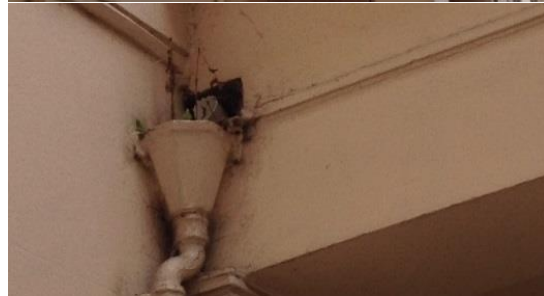
10 The current rainwater discharge from the porch is via a small cast iron hopper and 50mm diameter downpipe with no lead shoe to the outlet.

11 The hopper contains tree growth and also plastic cups impeding the flow from the porch roof.

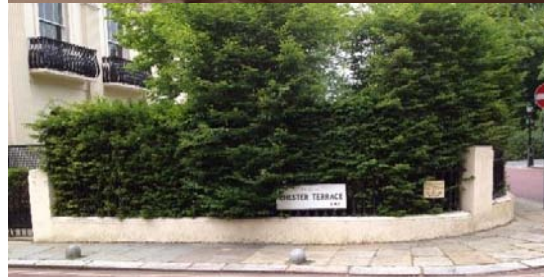
12 The Chester Terrace perimeter wall is in reasonable condition with no evident hollow render.

As with all balustrades we were unable to inspect the internal face due to vegetation and tree growth.

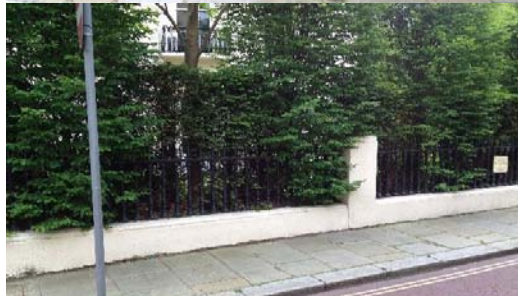
14 The conifer tree screening has been planted close to the boundary wall but at present root disturbance is not evident.

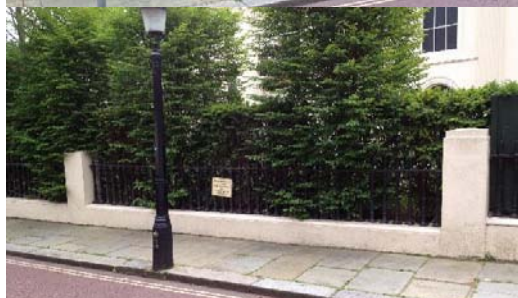
15 The wall is in reasonable condition with only minor shrinkage cracks evident that would be covered with the decoration scope of works.

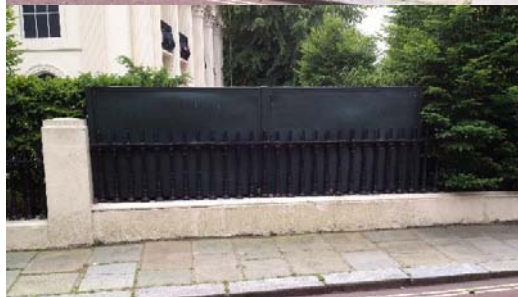
16 The screening to some of the bays have been replaced with plywood screening which is sat on the plinth coping. Over time this will increase the moisture content within the stucco which could cause freeze thaw damage.

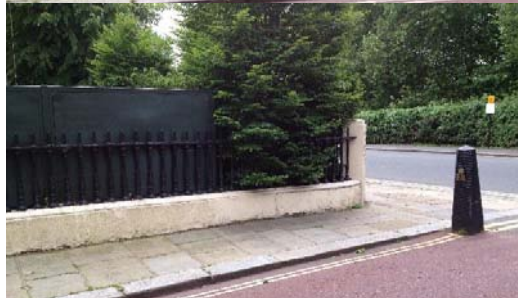
17 The pier on the corner of Outer Circle and Cumberland Place has been repaired previously.

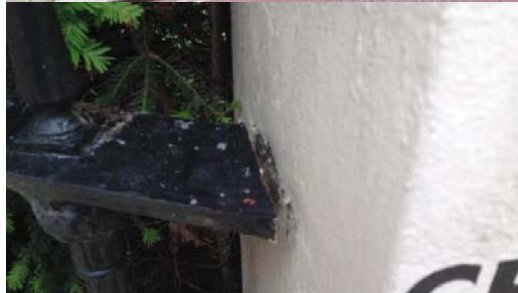
18 The top rail of the Cumberland Place balustrade has been disconnected from the boundary wall pier.

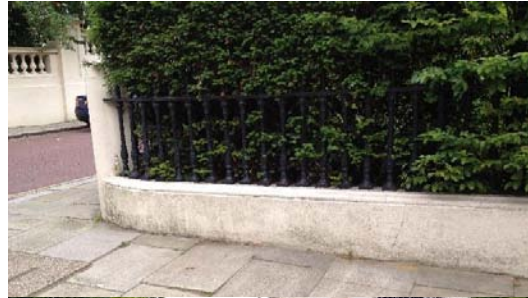
19 The outer circle boundary wall comprises of 5 bays of cast iron balustrading set between cementitious rendered brick piers. The decorations are in a poor condition due to traffic pollutants and the texture of the stucco.

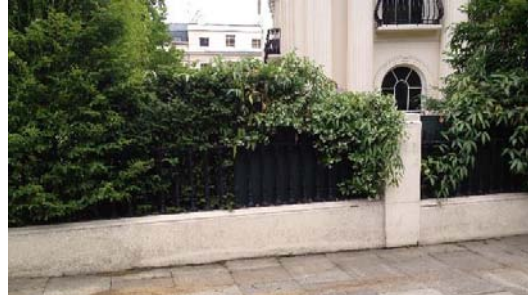
20 The vegetation covers a considerable amount of the railings and it is difficult to determine the condition of the iron railings.

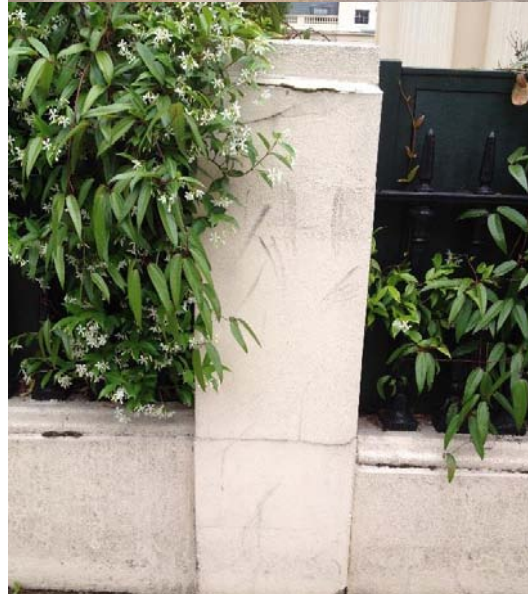
21 The pier between bays 1 & 2 is showing signs of fracture in two levels.

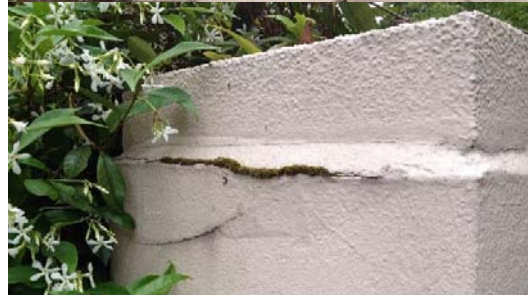
22 The connection between the pier and the boundary wall has fractured which is most probably due to the dissimilar thermal movement patterns of the masonry and the cast iron.

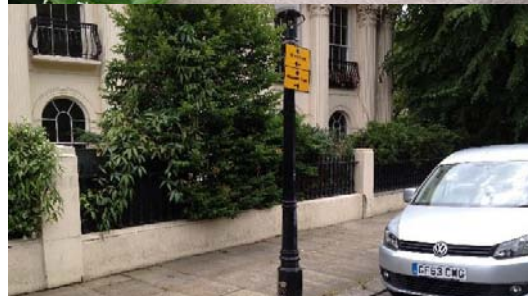
23 The stucco render just below the capping stone has blown which is most probably attributable to the saturation of the pier cap and water ingress through incorrectly applied stucco renders.

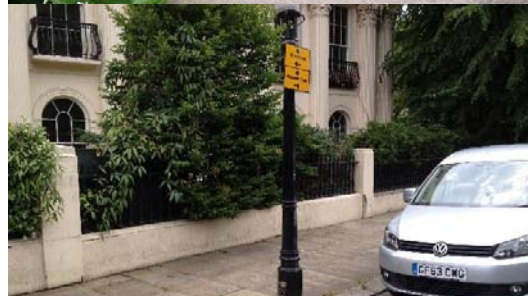
24 The stucco to bay 2 walling is in a reasonable condition and requires cleaning and redecorating.

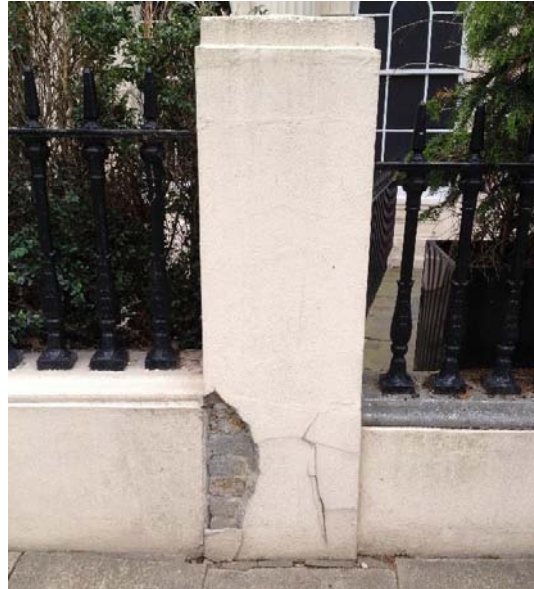
25 The stucco render to pier 2/3 has failed in three locations. The junction between the cap and column has failed in a similar manner to pier 1/2.

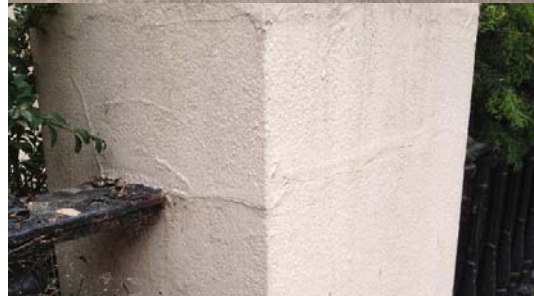
26 The stucco to the bottom of the pier has blown and failed

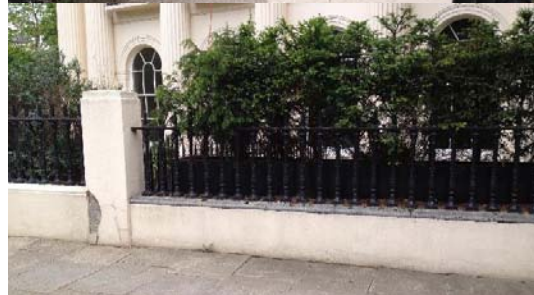
27 The pier has fractured at the level of the balustrade top rail. On closer inspection it is apparent that the corrosion of the top rail is the cause of the fracturing.

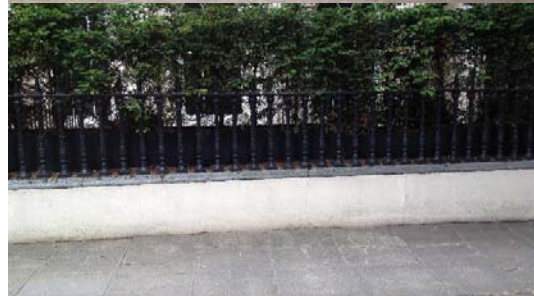
28 The reconstituted stone coping stone to bay 3 is heavily eroded and not decorated.

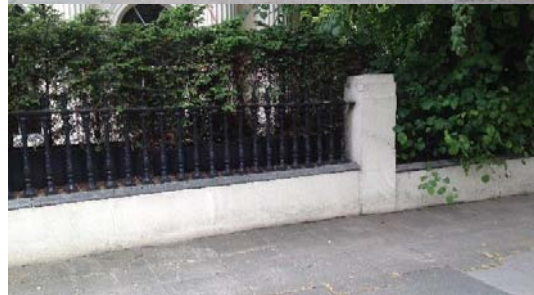
29 A small patch of hollow render is evident to bay 3 located either side of a fracture through the balustrade wall.

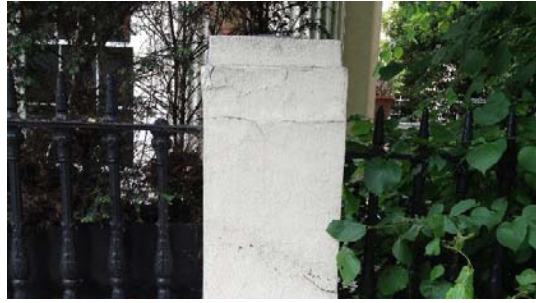
30 A small planter box has been constructed directly behind the wall which is providing a water trap to the coping detail and allowing the stucco to become saturated.

31 The pier cap to pier 3/4 is fractured and hollow due to a combination of water ingress and displacement caused by the corroding railing top rail connection.

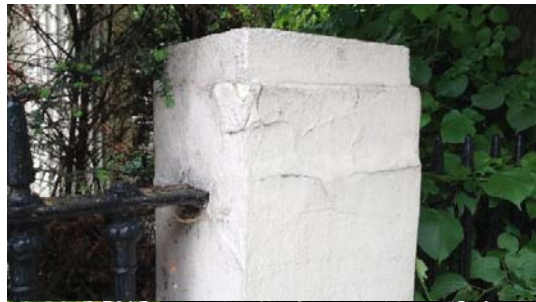
32 The pier column is fractured at the junction with the balustrade wall.

33 The render to the pier cap is sounding hollow on all sides.

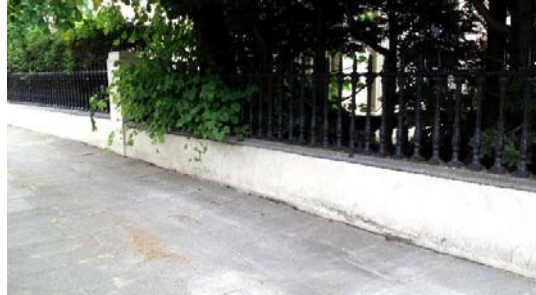
34 The wall to bay 4 is fractured in 4 locations with render sounding hollow around one of the fractures.

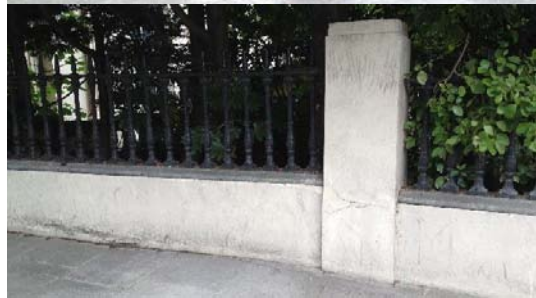
35 The column shaft to pier 4/5 is fractured at the connection with the balustrade wall.

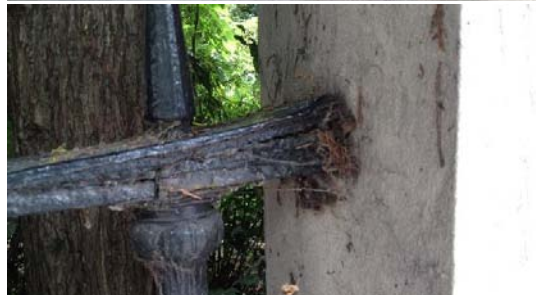
36 The railing connection within the southern pier to bay 5 is fractured at the level of the top rail and at the junction between the column and the balustrade.

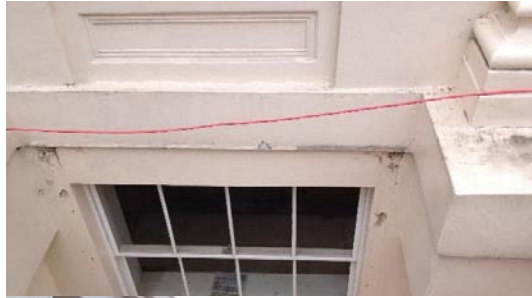
37 Where window grills have been removed within the basement area damage has occurred around the redundant fixing holes that require making good.

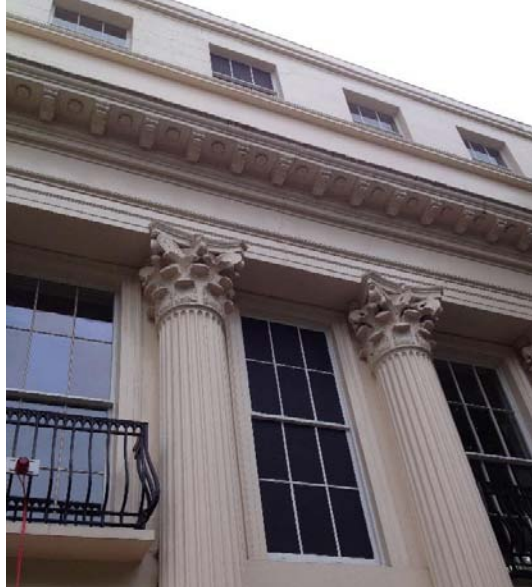
38 On the west (Outer Circle) elevation there is a fine vertical fracture approximately on the line of the party wall.

39 The fracture is shown on the marked up drawing of the west elevation running through the basement wall, second floor cornice, through the blind window on the second floor and then either side of the third floor windows.

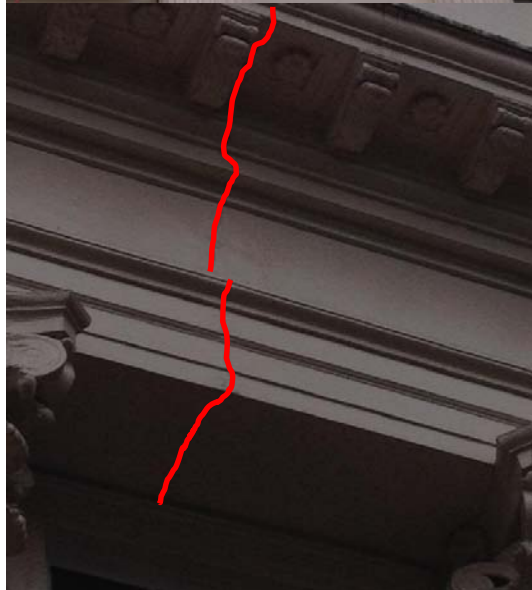
40 The fracture is most noticeable through the lintel and frieze of the second floor cornice.

41 It would be prudent to ascertain the method of cornice construction and window lintel construction once access is available to allow any repair strategy to be finalised.

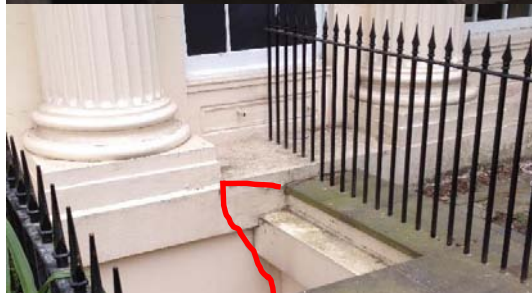
42 Fracture through the basement wall / column plinth.
