51 Werrington Street, NW1 1QN

Report on Vault Structures

Ref: 150234/TA

Date: 12 May 2015

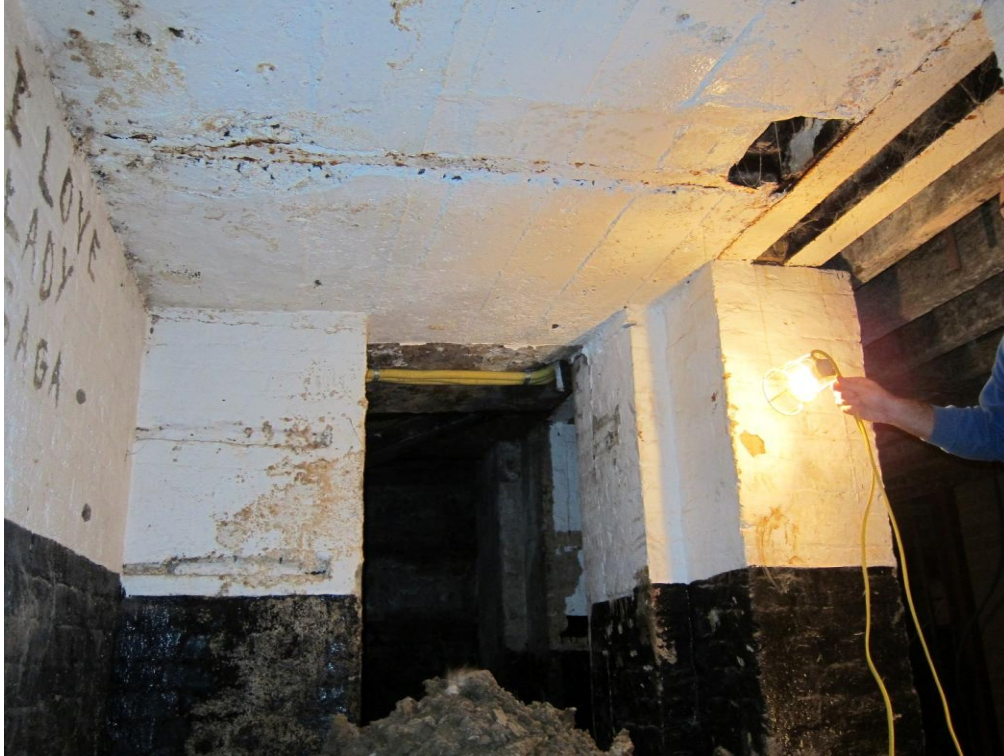
- 2.3 The condition of the roof structure is poor with a large number of leaks, voids in the concrete and severe corrosion to the steel joists. The areas of corrosion are noted on S100 and typical examples shown below. The vaults were originally inspected in October 2012. A follow up survey in March 2015 found that corrosion and spalling of the concrete from the embedded steel had increased over that time period.

Typical view of vaults showing leaks, honeycombing to concrete and corrosion of steels

- 2.4 The life expectancy of the roof is very limited. It has limited ability to support heavy loads, is potentially unsafe and is not adequate as a pavement structure. We recommend that it should be replaced.

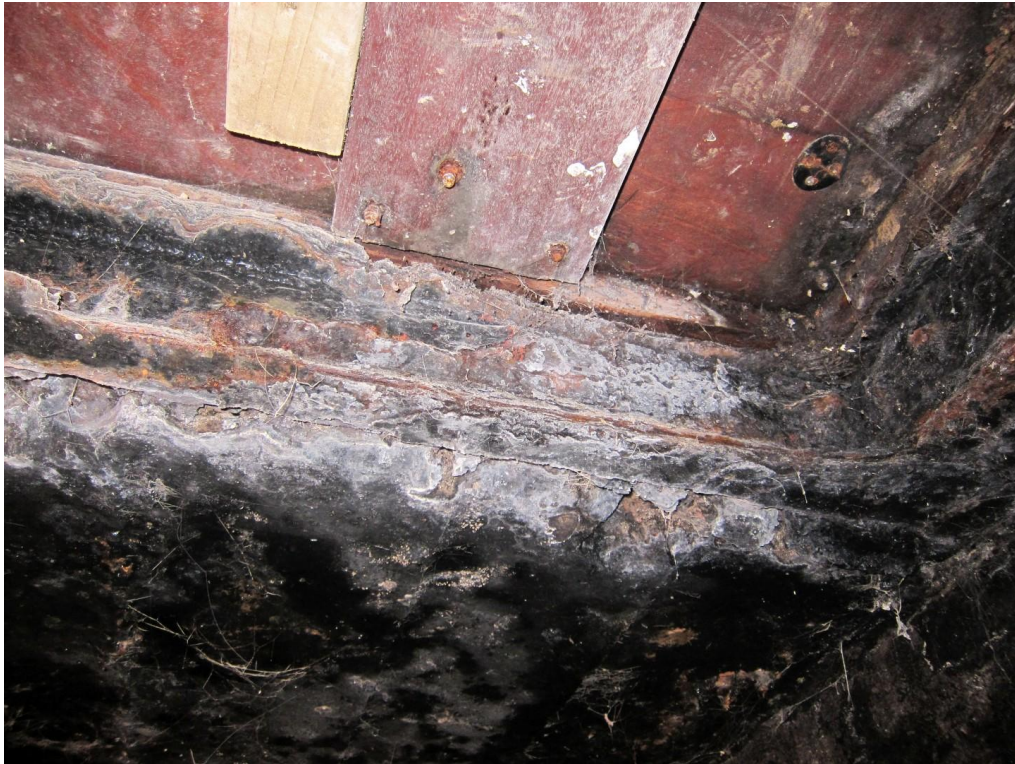
Heavy corrosion to steels around openings

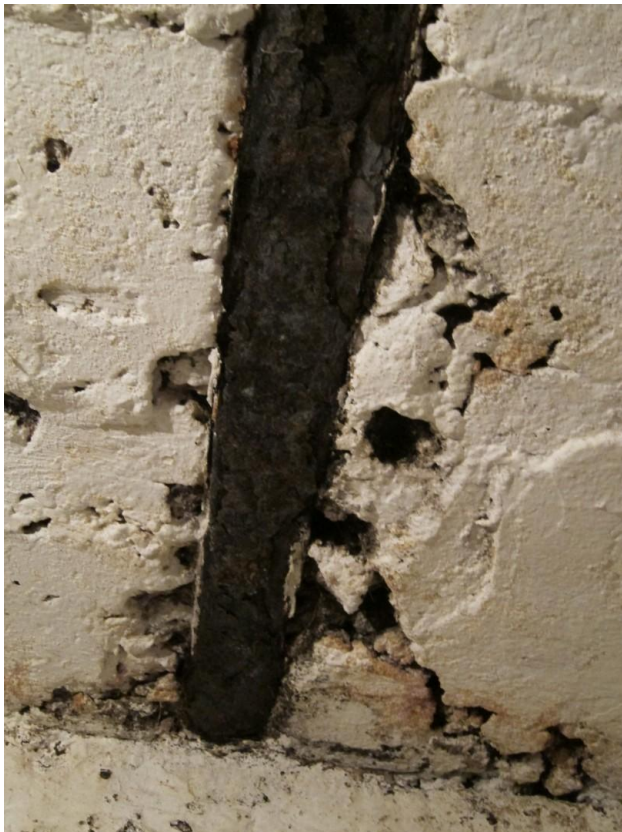
Heavy corrosion to steel

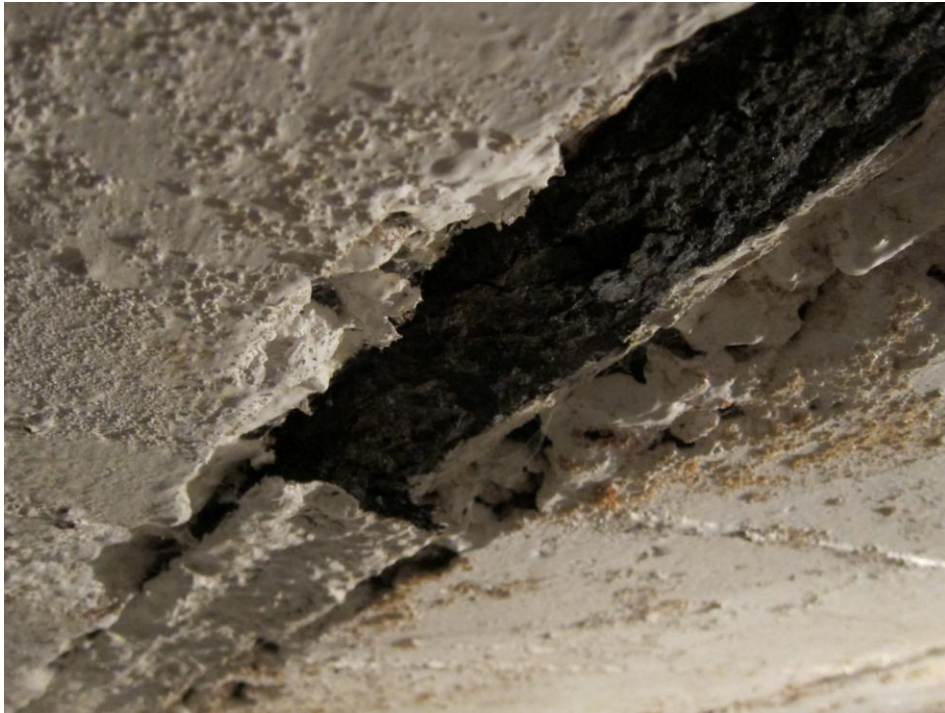
Delaminating flange of steel joist

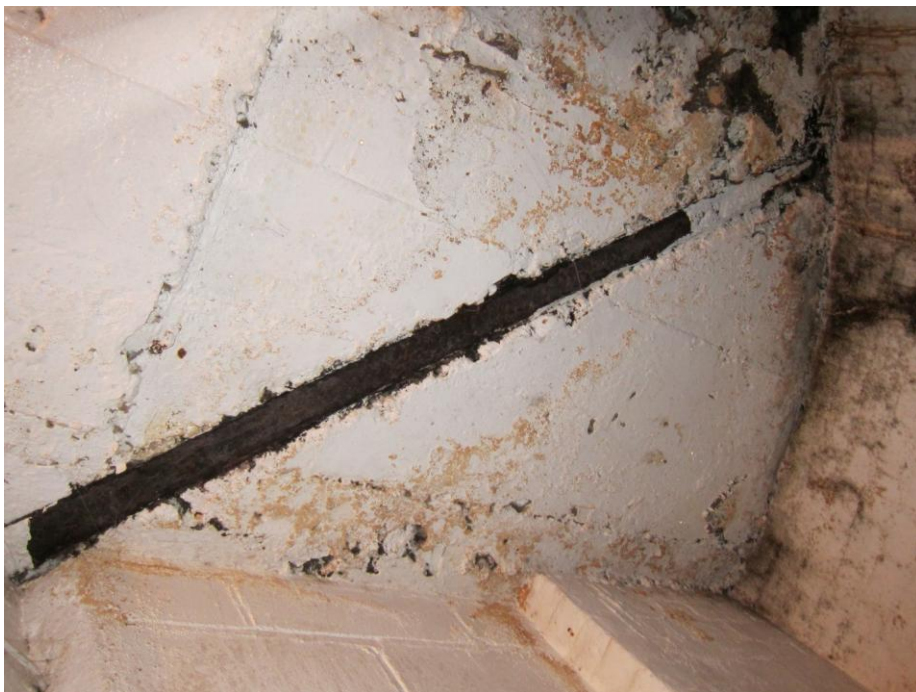
Corner showing leaks, honeycombing to concrete and heavy corrosion to steel

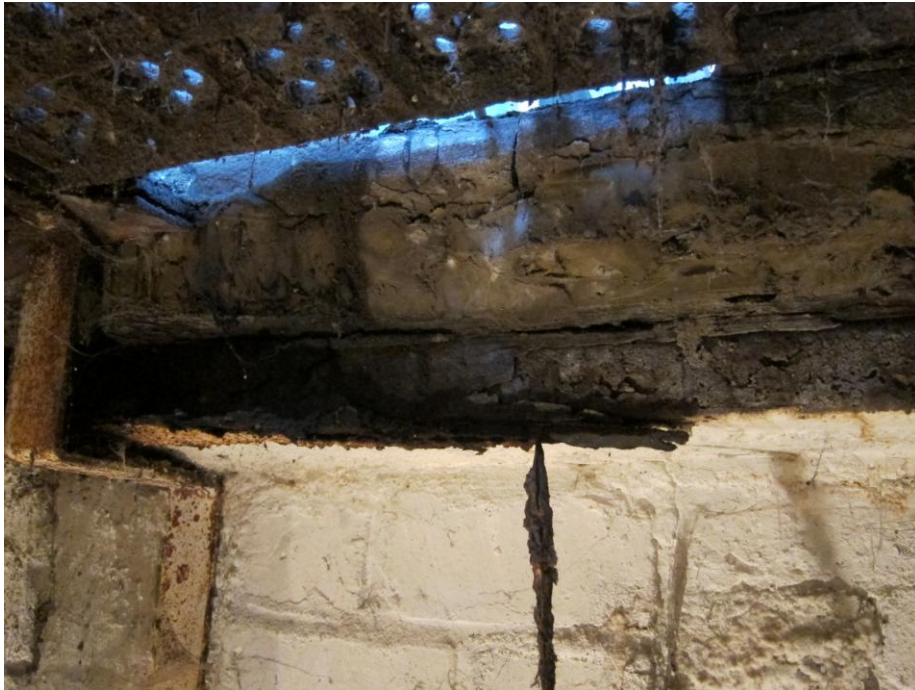
Steel trimmer virtually disintegrated
