REPORT OF SITE VISIT

PROJECT: 34 Downshire Hill, London, NW3

JOB NUMBER: 14117

DATE OF SITE VISITS: 08th May

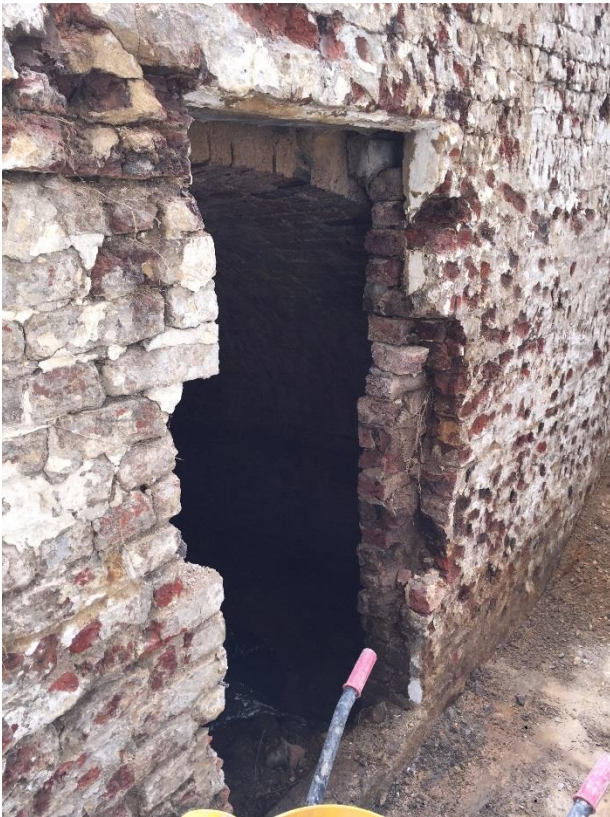
Action
1.0	<p><u>8th May</u></p> <p>This site visit was made to inspect the existing front wall to the vaults at lower ground floor, at the front of the property.</p> <p>The existing front wall to the vaults at lower ground floor is built in 225mmth Stack brickwork. The current condition of wall is poor and appears unstable. Inspection of the junction of the wall and the vault brick construction indicated that this wall is independent of the vault. It can therefore be rebuilt without any implications for the structural integrity of the vault construction.</p> <p><u>DEMOLITION</u></p> <p>Demolition is to be carried out to and in accordance with BS 6187: 1982, Health and Safety Executive Guidance Note GS 29/1 paragraph 32, and any other relevant statutory undertakings or regulations.</p> <p>Cares to be taken in the methodology of demolition to avoid any interference with existing vault construction.</p> <p>Demolition is to be undertaken in a manner which avoids excessive noise and nuisance. All work is to be well-watered to minimize dust. All material is to be carted away from site as soon as practicable.</p> <p><u>MASONRY</u></p> <p>Workmanship is to comply generally with BS 5628 Parts 1 & 3. Brickwork to be BS 3921. Blockwork to be to BS 6073.</p>	<p>Photo 1</p> <p>Photo 2</p>

Photo No. 1: Front wall to the vaults

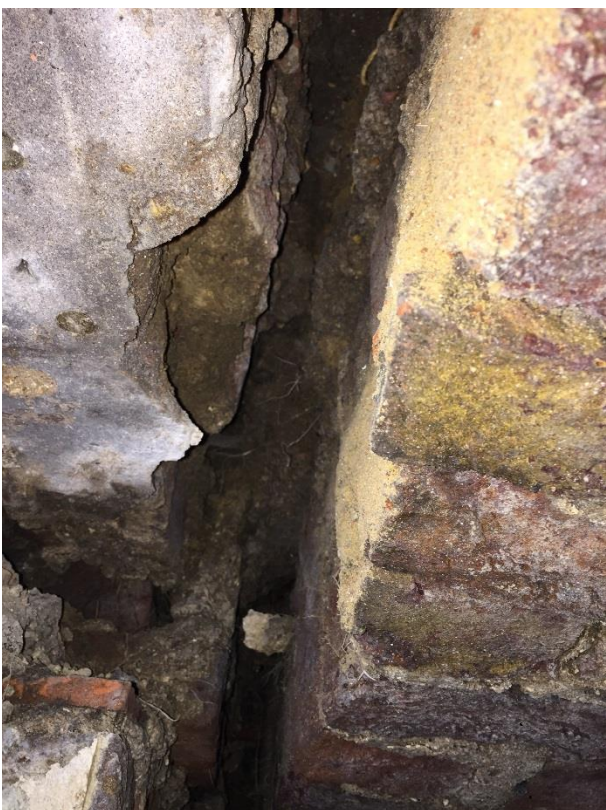
Photo No. 2: Gap between Existing vault and front wall.
