Our Ref: IW/15-129
Your Ref:
Date: 03 July 2015

Subject: 20 FITZJOHNS AVENUE, LONDON, NW3
Our Ref: Structural Report On Impact On Rear Bay And Wall From Existing Tree

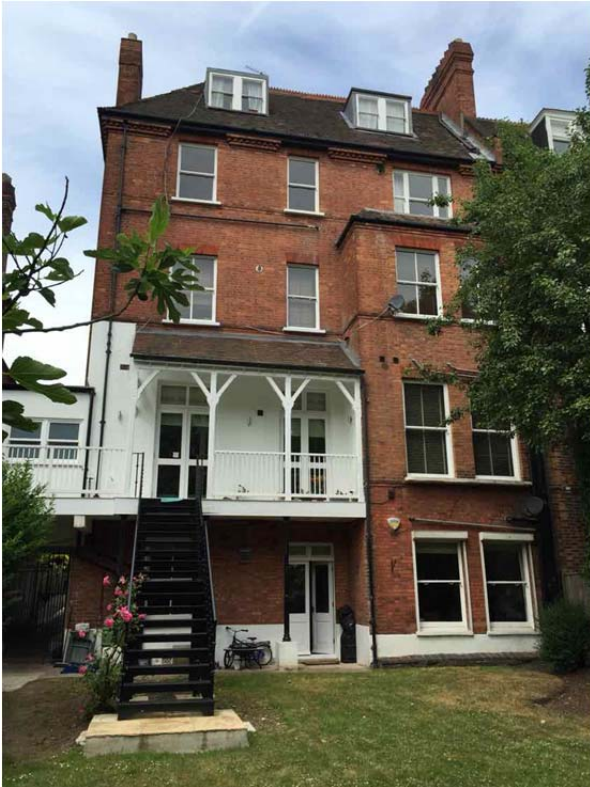
Rear Elevation Of Property

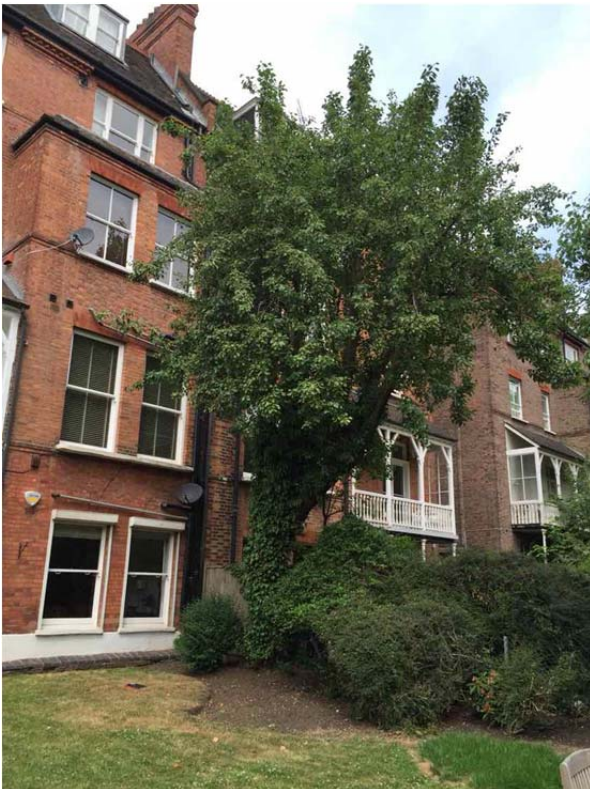
There is an existing pear tree within 3 meters of the rear bay to the property which appears to be a mature tree. We understand that a cctv survey was carried out of the underground drainage that runs parallel to and very close to the rear wall of the property. This survey identified fractured and damaged underground drainage pipes which had tree roots in and around the pipe. These fractures result in leakage of the surface and foul water from the underground pipes into the surrounding ground.

Proximity Of Pear Tree To Rear Elevation Of Property

We would recommend as a minimum the drainage run be lined as per the cctv survey and report. In addition to this and due to the extreme seasons we experience and the effects these seasons can have on the ground and ground movement, we recommend that the rear bay and wall be visually checked every 3-6 months for the sign of any new cracks.

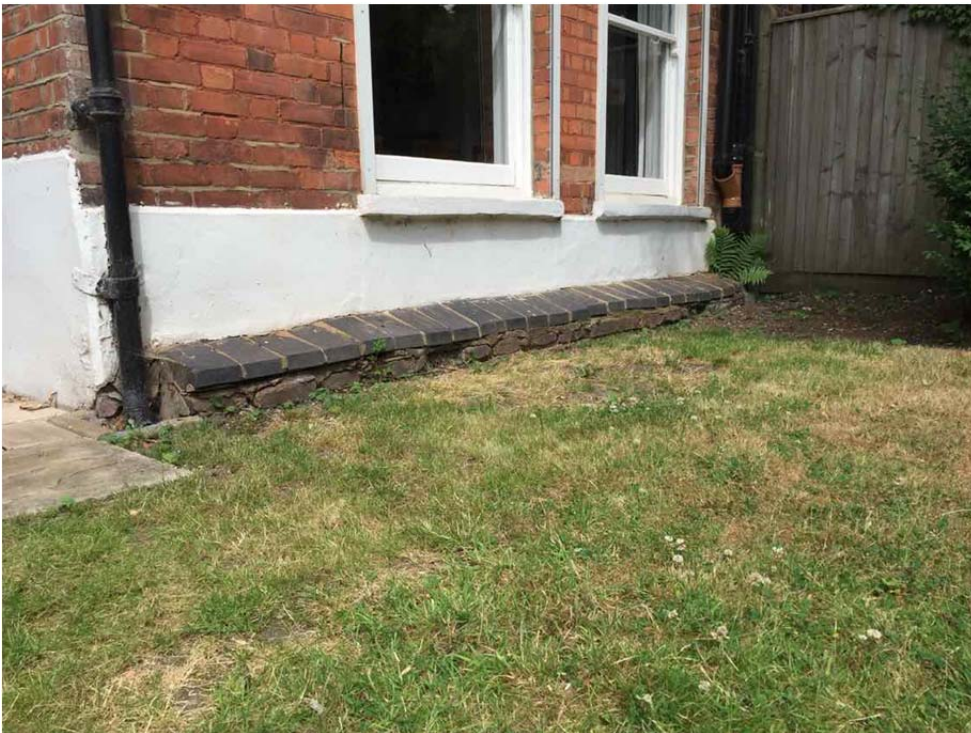
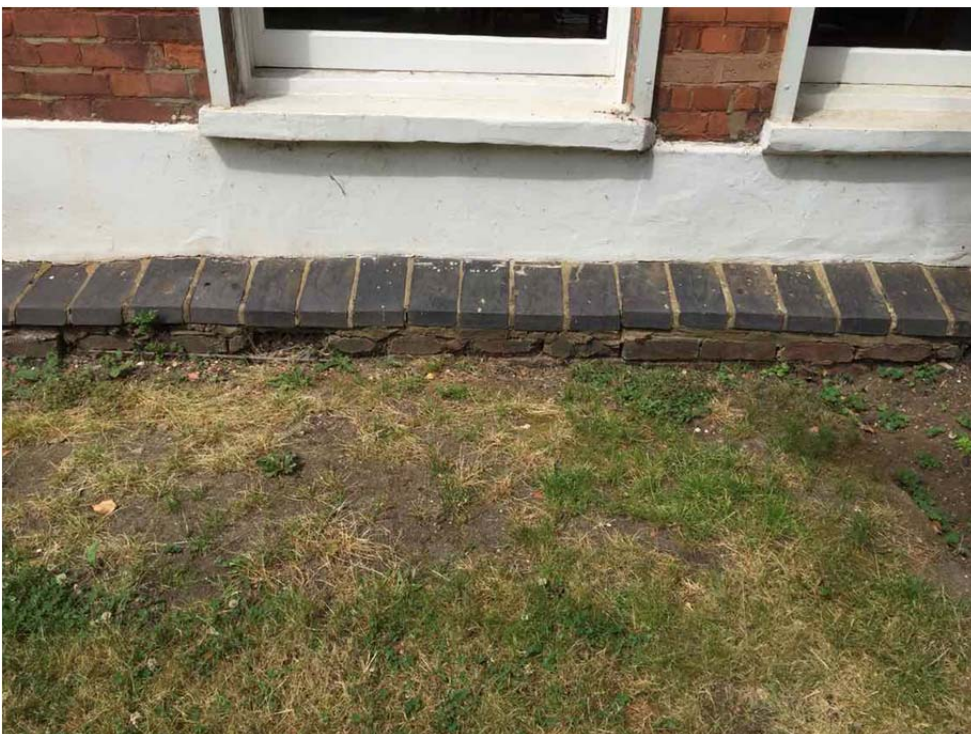
The low level plinth along the rear wall appears to be uneven. There are areas of brickwork above the two ground floor rear windows to the bay adjacent to the pear tree that have been re-pointed, there was a diagonal crack in one of the brickwork arches above one of the two windows within the bay at ground floor level and at the corner of the rear bay wall where it returns there was a vertical crack through one brick. There were also signs of cracking in the next door properties brickwork arches above the two rear windows that are close to the pear tree.

The white rendered section of wall just above the plinth at low level was showing no signs of cracking or distress.

Low Level Plinth And Render

The low level plinth appeared to be uneven, which could be caused by localised ground movement as a result of the leaking drainage pipes, however, the white rendered section above the plinth was not showing any signs of cracking or movement. It is therefore assumed that any ground movement that may have affected the plinth has not affected the main foundations to the bay window.

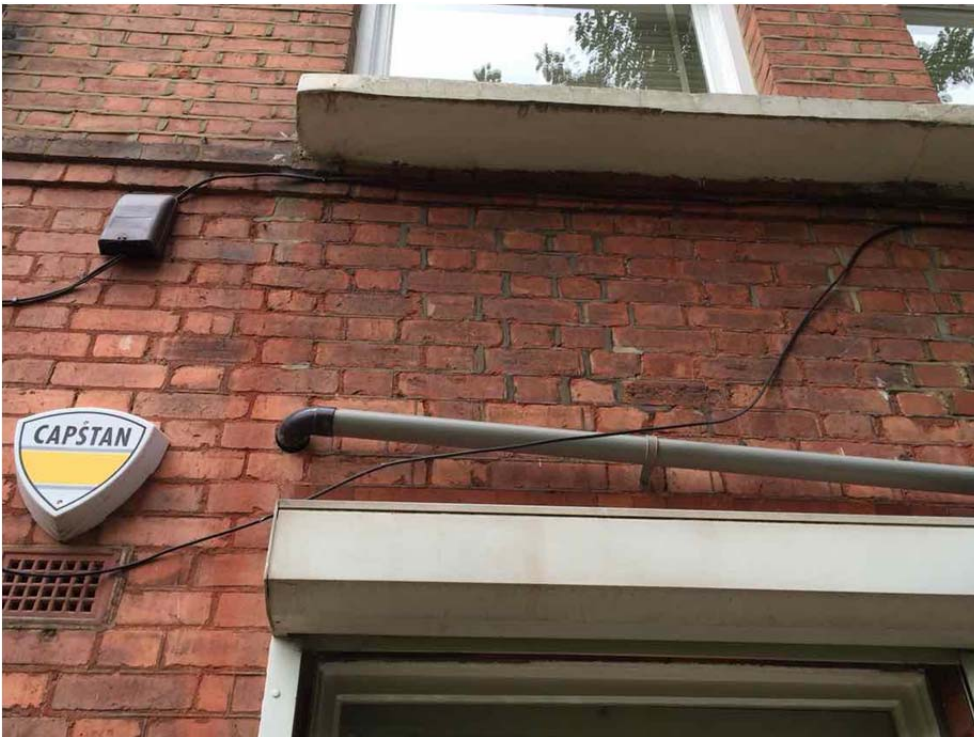
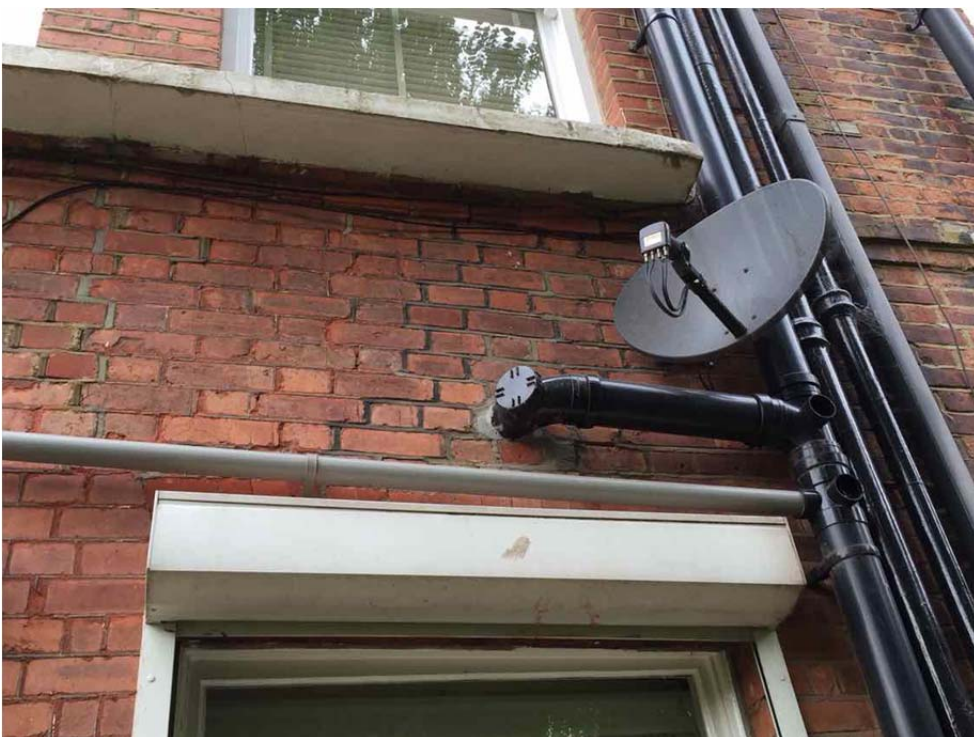
Repointing Above Bay Window

Based on our visual site inspection there was no sign of any significant ground movement or structural movement in the rear bay or wall to the property as a direct result of the proximity of the pear tree to the building. However there were areas of cracking in the brickwork arches and areas of re-pointing above the bay windows at ground floor level.

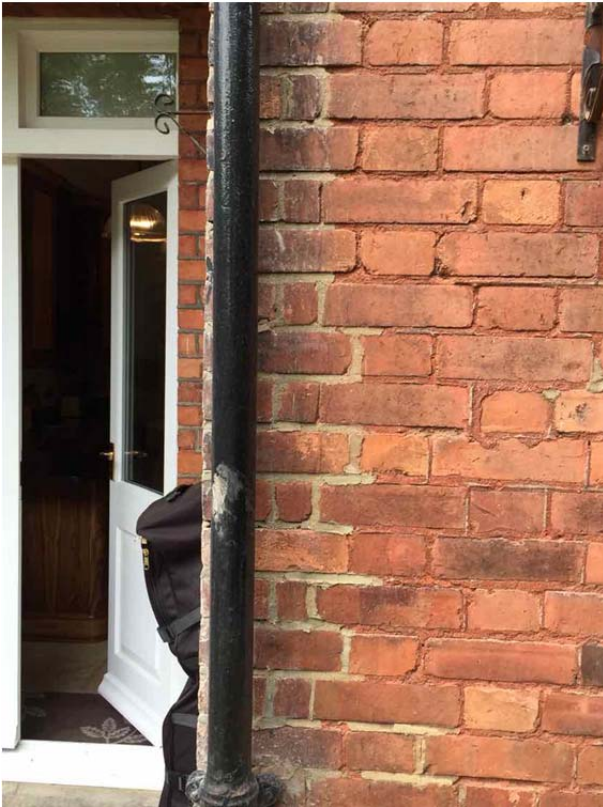
Repointing At Corner Of Bay Return

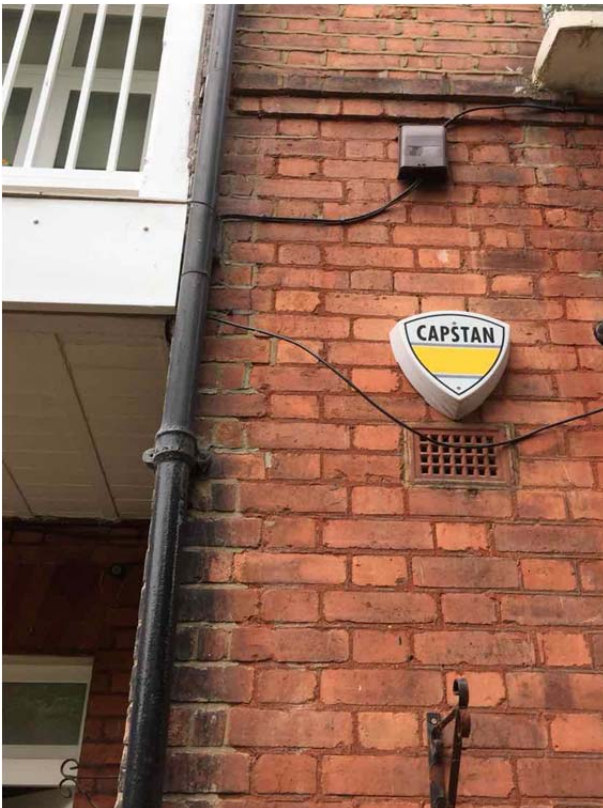
One Cracked Brick At Corner Of Bay Return

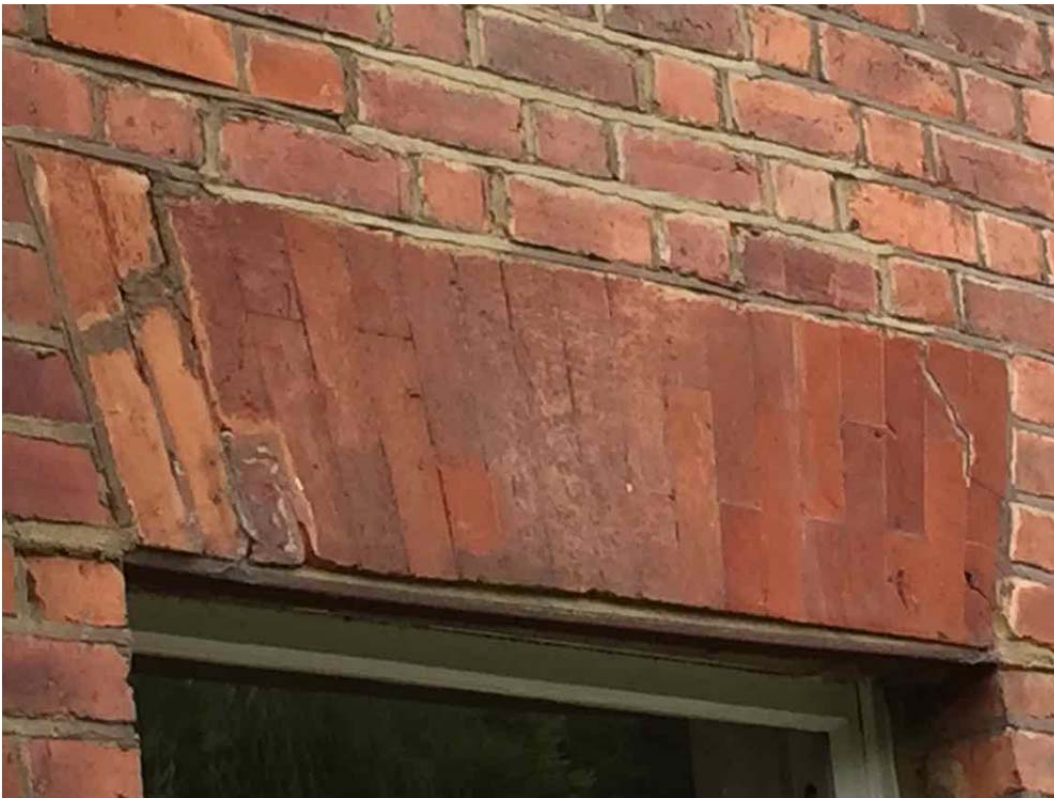
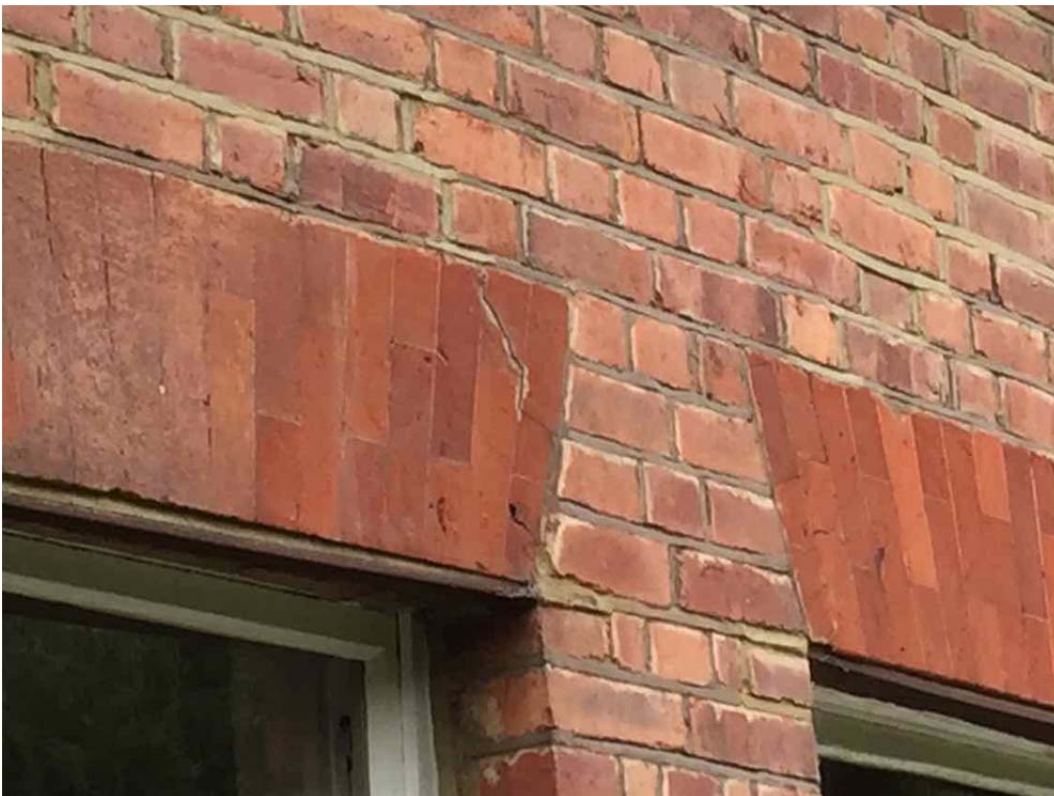
Cracking In Brickwork Arch Next Door
