Factual Report

Client:	Zurich Insurance C/o Pyle Consulting
Site:	56 Parkway London NW1 7AH
CSI Ref:	FACT/4137/Visit 1
Dated:	7 th January 2014

DRAINAGE REPORT

**56 Parkway
London
NW1 7AH**

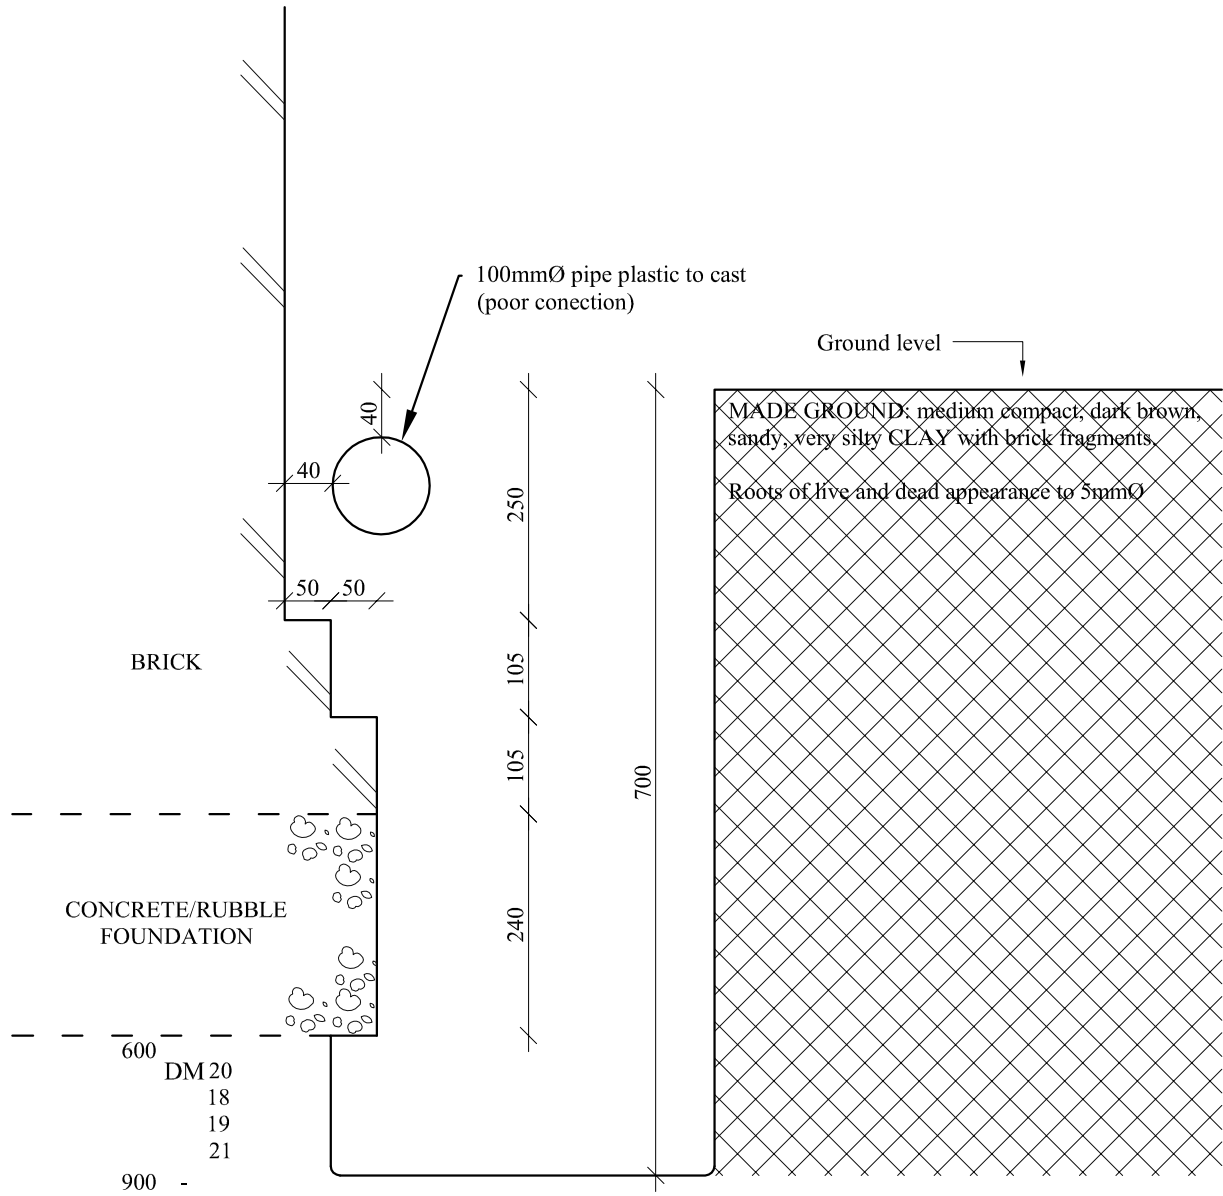
Client: Pyle Consulting	Scale: N.T.S.	Sheet No: 1 of 1	Date: 07.12.13
Location: 56 Parkway, London NW1 7AR	Job No: 4137	Trial Pit No: 1	Weather: Overcast
Excavation Method: Hand tools		Drawn by: BU	Checked by: ME

FOR STRATA BELOW 700mm SEE BH1 Log

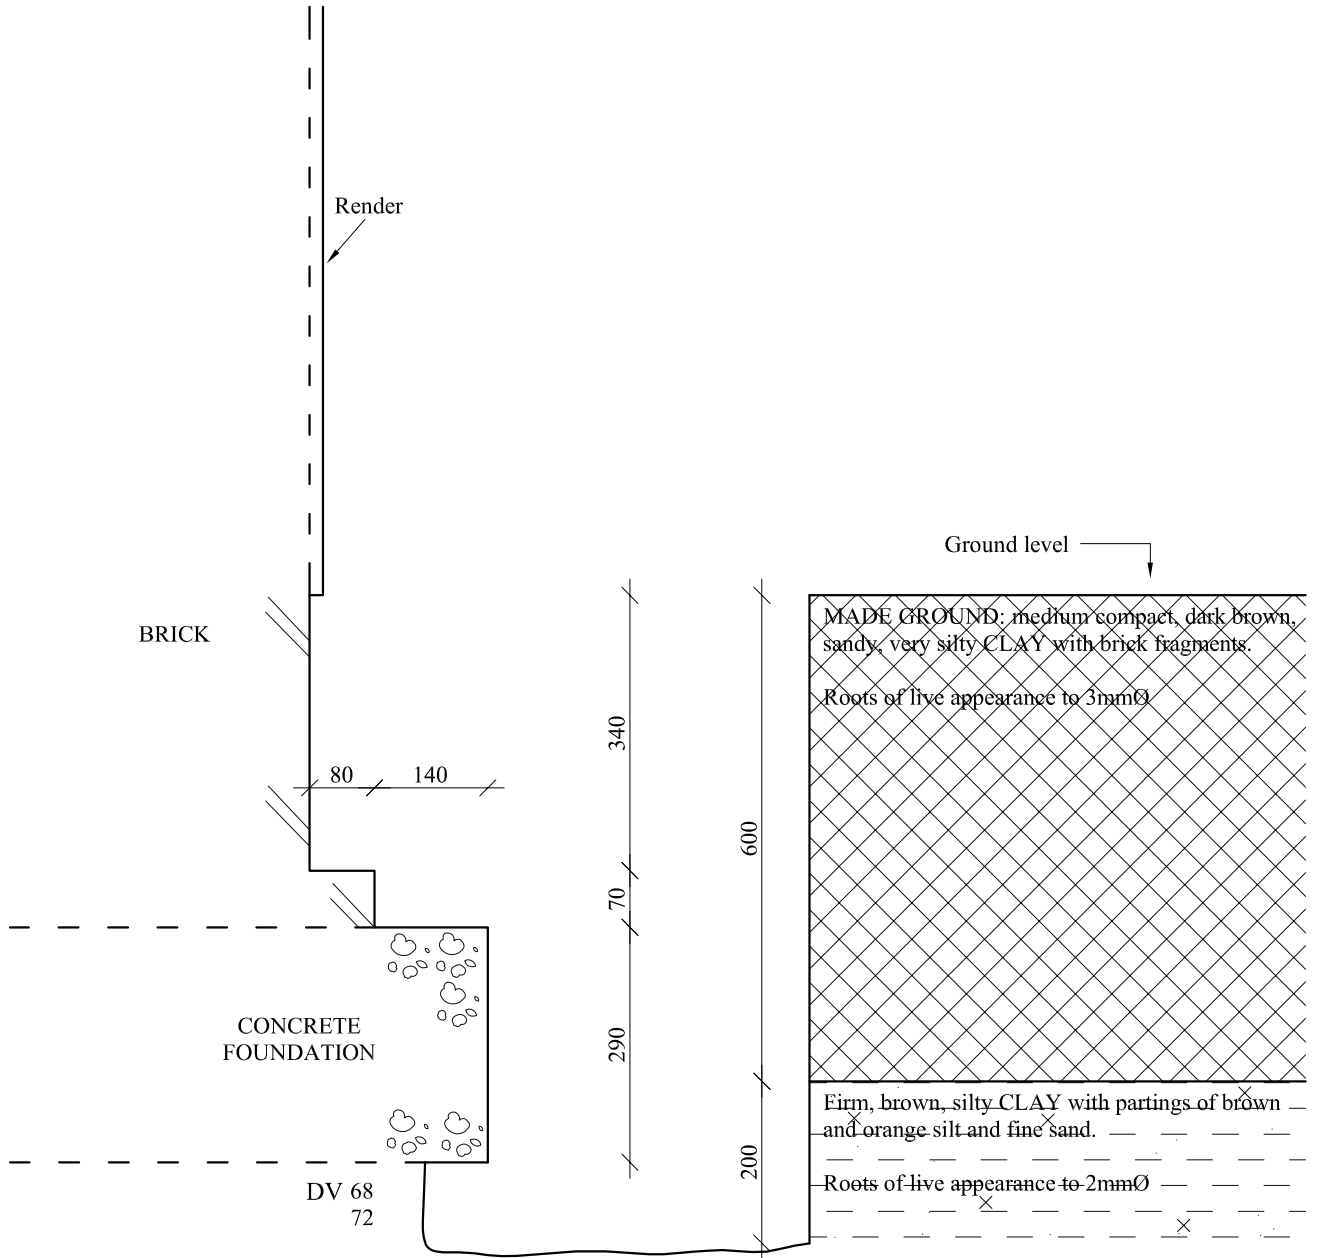
Client: Pyle Consulting	Scale: N.T.S.	Sheet No: 1 of 1	Date: 07.12.13
Location: 56 Parkway, London NW1 7AR	Job No: 4137	Trial Pit No: 2	Weather: Overcast
Excavation Method: Hand tools		Drawn by: BU	Checked by: ME

FOR STRATA BELOW 800mm SEE BH2 Log

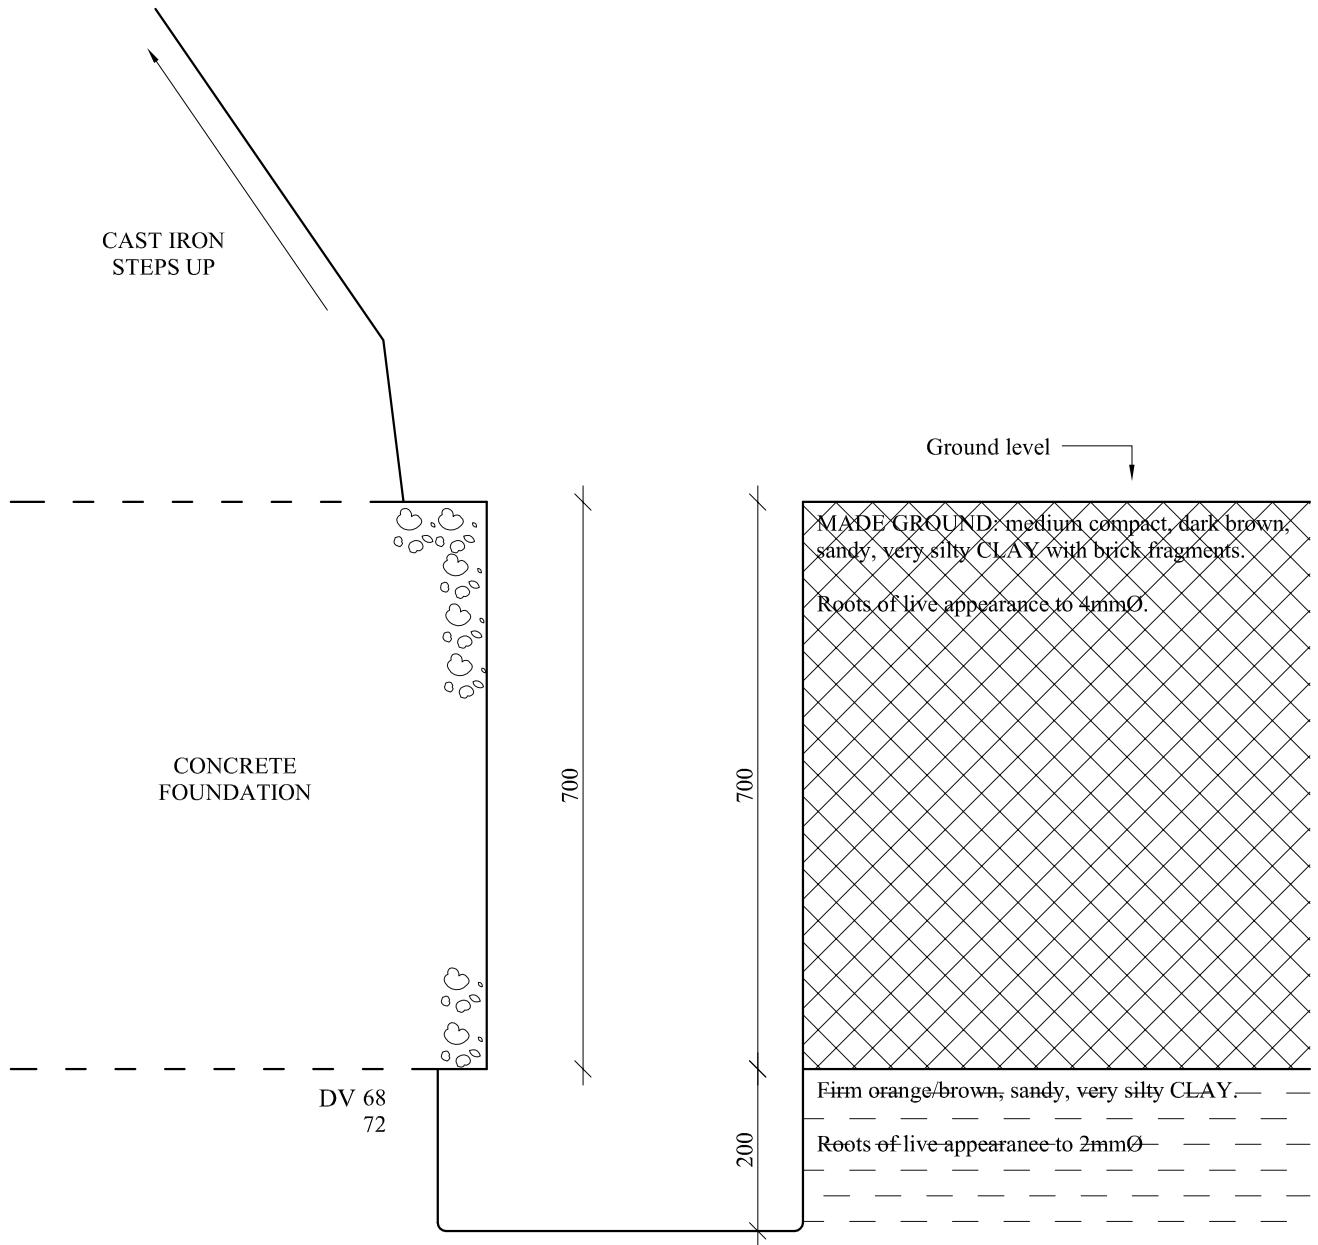
Client: Pyle Consulting	Scale: N.T.S.	Sheet No: 1 of 1	Date: 07.01.14
Location: 56 Parkway, London NW1 7AR	Job No: 4137	Trial Pit No: 3	Weather: Overcast
Excavation Method: Hand tools		Drawn by: BU	Checked by: ME

FOR STRATA BELOW 900mm SEE BH3 Log

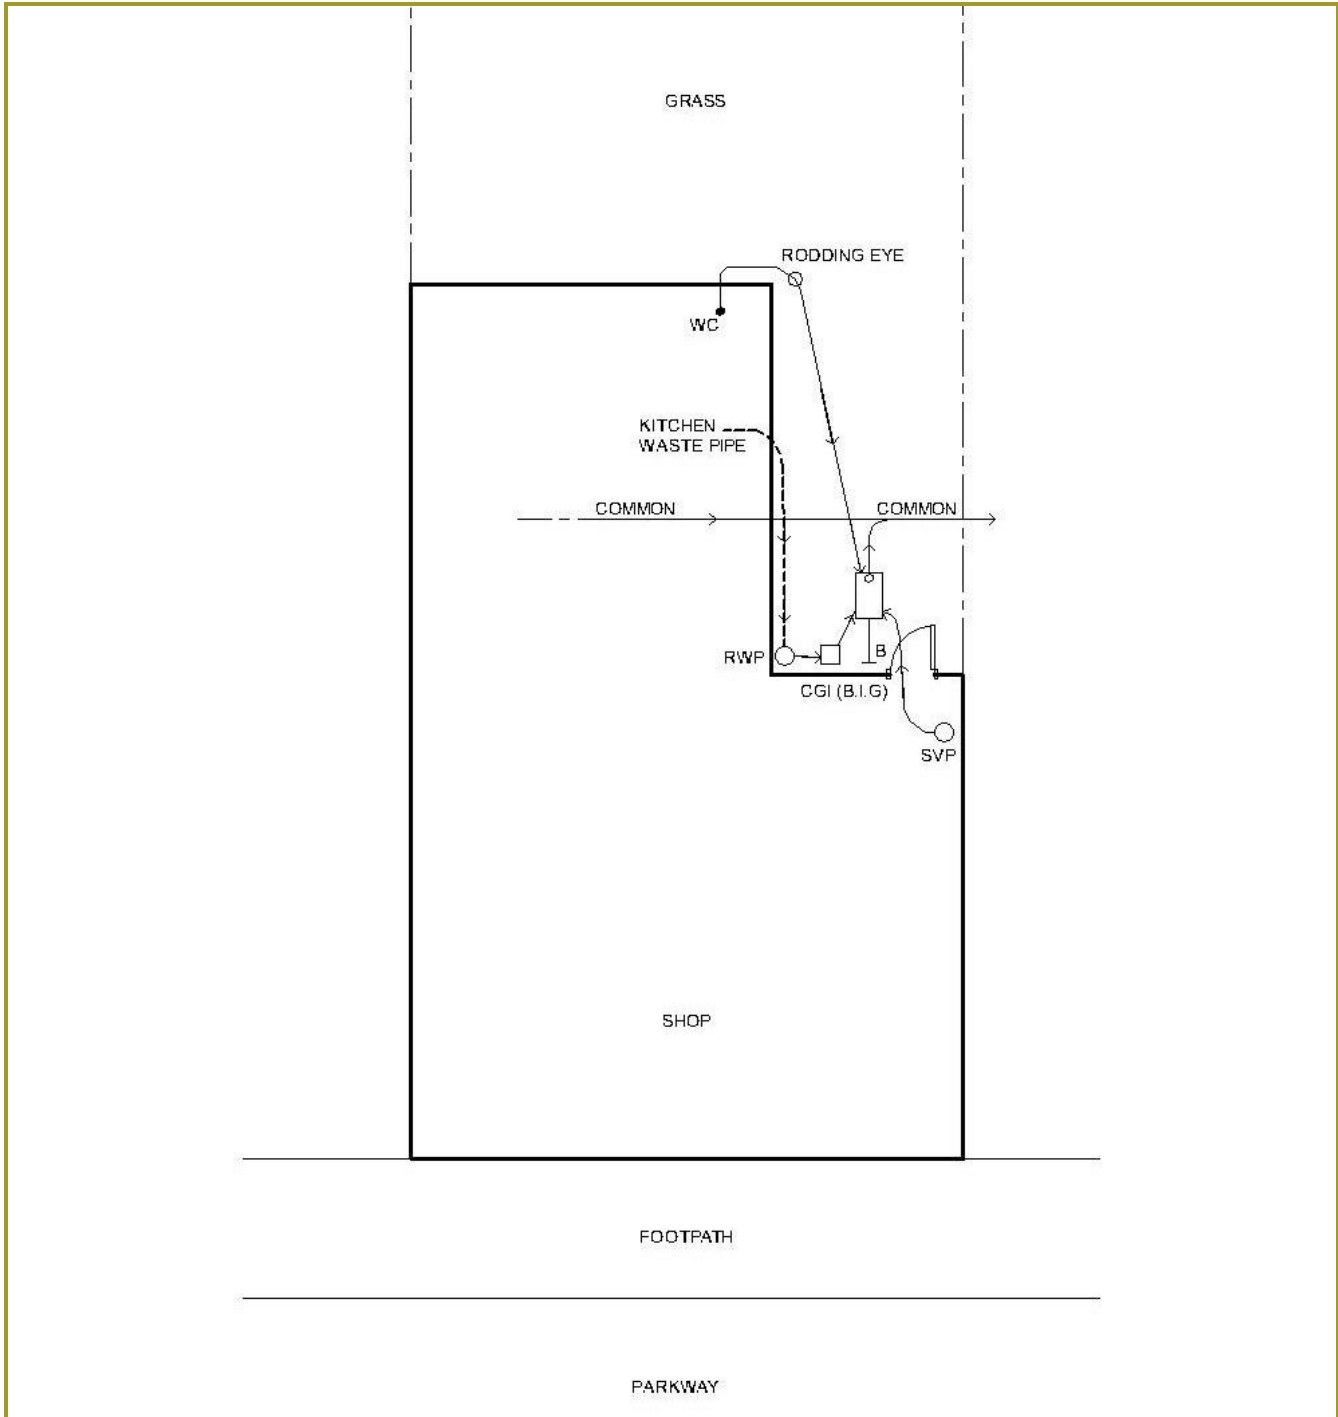
2.0 DRAINAGE LAYOUT PLAN (NTS)

This property has a combined drainage system with services collected from the rear of the property into an interceptor manhole, MH1, before flowing out and connecting to a common sewer. This common sewer appears to flow across the rear of the properties, passing under the back addition.

There were no operational issues noted at the time of the survey, however some defects were noted and are outlined in this report.

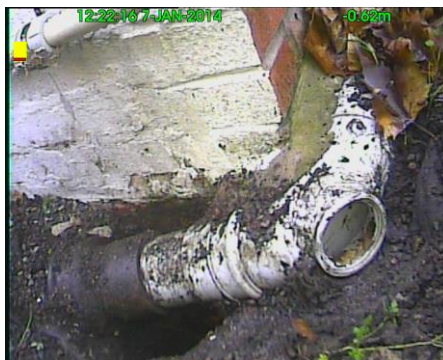
SURVEY 4:	RODDING EYE UPSTREAM TO WC: 100mm PLASTIC: FOUL DUTY	
Meterage	Observations and comments	
00.0	Start survey	
00.7 – 01.0	Bend up to WC	
Invert level:	GL	Operational condition: No operational issues noted at time of survey
Recommendations:		
<p>This section of pipework is unusually installed in that the pipework is at ground level. There were no visual defects or operational issues in the section surveyed therefore further works are not considered essential, however the arrangement is not ideal.</p>

Pipework to WC is visible at ground level

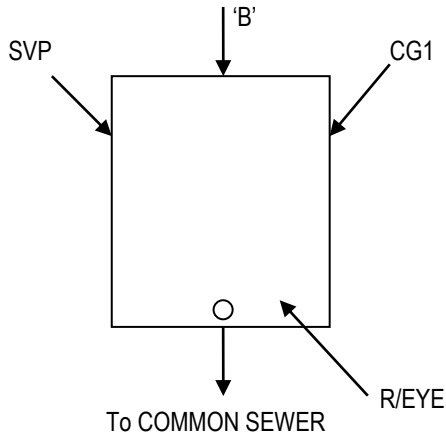
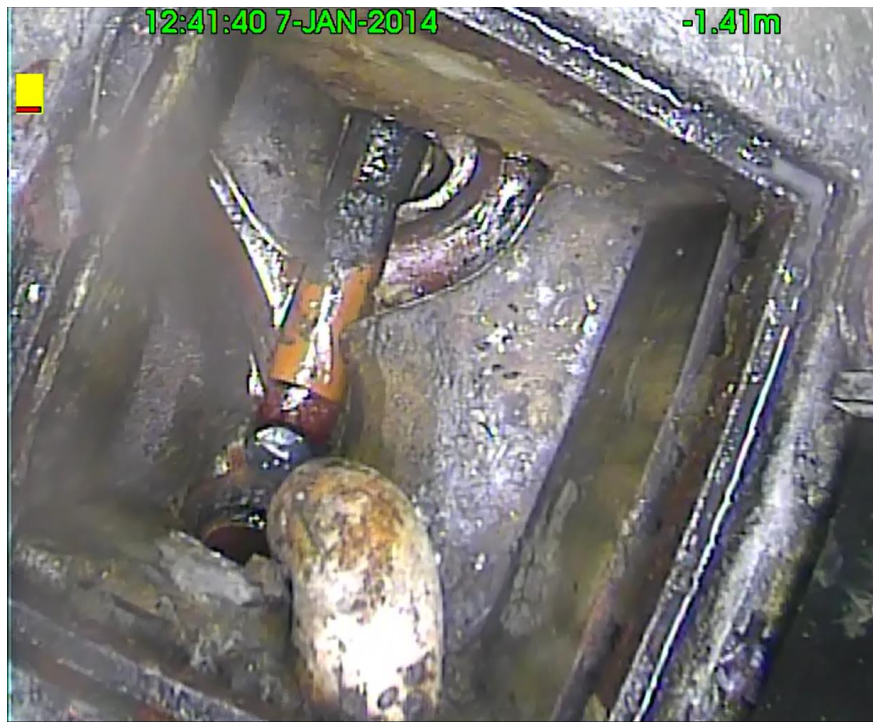
MH1

Invert level (relative to cover level): 650mm

Cover dimension: 500 x 500mm

Chamber dimension: 500 x 500mm

Construction: Brick and render

Condition: No defects noted

Recommendation: None
