Arboricultural Consultancy for Zurich Insurance Company

1. Case Details

Insured	Mr M Citron	Address	56 Parkway, London, NW1 7AH		
Client	Pyle Consulting	Contact	Bret Champion	Claim No.	BRC/sp/7663
MT Ref	NL/1709141520/TP	Consultant	Thomas Peppiatt	Contact No.	0330 380 1036
Report Date	02/01/2015

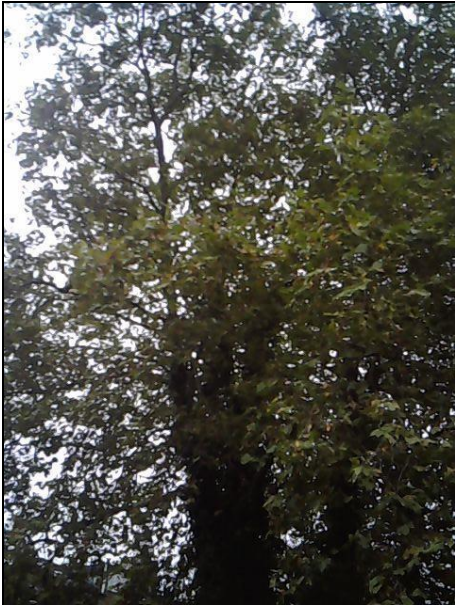
T1 - Plane (London)

In assessing the potential drying influence of the vegetation on site, T1 (Plane (London)) is considered the dominant feature and accordingly we have identified it as the principal cause of the subsidence damage.

Tree No.	Species	Age Cat	Approx. Height (m)	Distance to Building (m)	Ownership	Action	Requirement
T1	Plane (London)	3	27	17	A - Third Party 52 Parkway. London. NW1 7AR.	Remove	Remove subject to heave assessment.
T2	Plane (London)	3	27	20	D - Unknown	Remove	Remove subject to heave assessment.

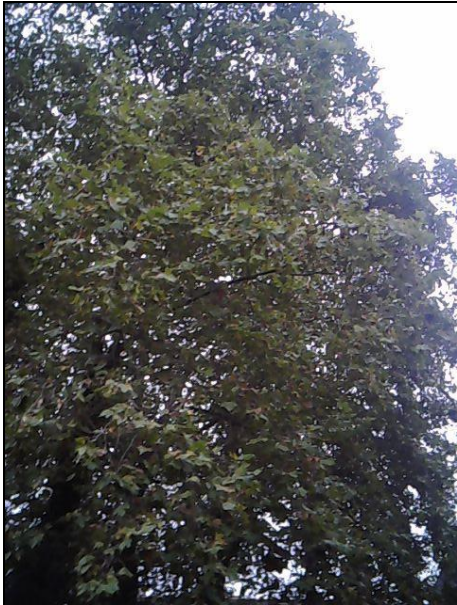
T2 - Plane (London)

T2 (Plane (London)) cannot be discounted as contributing to the overall level of soil drying proximate to the area of damage and is therefore also considered to retain a contributory influence, albeit in a limited / secondary capacity when compared to T1.
