SECOND ADDENDUM TECHNICAL REPORT

**38-40 Belsize Park Gardens
London
NW3 4NA**

Date of Report 8 July 2015

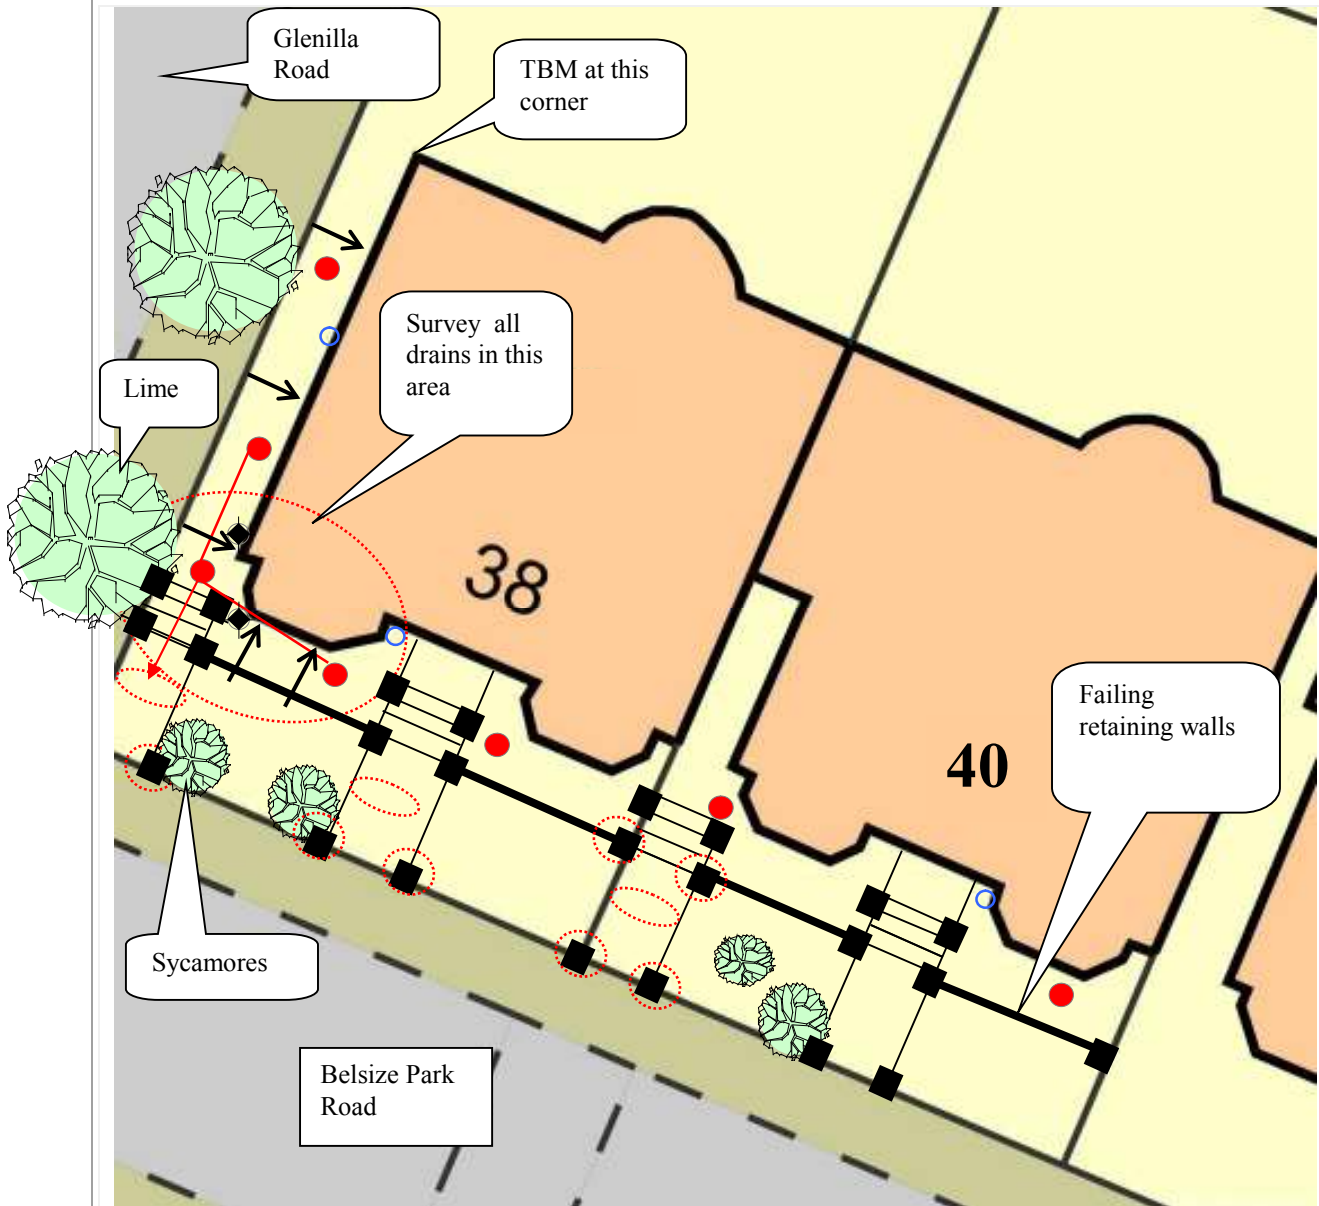
Site Plan

Since our Addendum Technical Report, an arboricultural report was obtained to form recommendations as how to remove the influence of the nearby vegetation, which is seen to be the cause of the claim. The MWA report has recommended the reduction of a nearby Council owned Lime tree, viewed as a secondary cause, and the removal of two TPO protected Sycamore trees, seen as the dominant cause of the claim.

The Lime tree was reduced at the end of 2014 by the Council. Level monitoring readings gathered from 2014 to and including July 2015 show ongoing property movement as to reaffirm the view the Sycamore trees are the dominant cause of the claim and need to be felled. The movement is cyclical with the property moving upward during wet weather and downward during dry weather; this sort of movement can only be attributed to clay shrinkage movement. The movement is pronounced to the front of the property nearest the Sycamore trees, which further shows the influence of the trees.

An application shall be submitted to fell the Sycamore trees. The trees can be removed without causing risk of heave related damages. The tree work should stabilise the property to allow repairs to proceed.

Repairs are estimated to cost £8k if the tree work is permitted. If the tree work is refused then underpinning localised to the area of the movement will be needed at a cost exceeding £120k.
