Arboricultural Appraisal Report

Subsidence Damage Investigation at:

38-40 Belsize Park Gardens
London
NW3 4NA

CLIENT:	Crawford & Company
CLIENT REF:	SU1401214
MWA REF:	NW210714.01GM
MWA CONSULTANT:	Giles Mercer (B.Sc (Hons))
REPORT DATE:	04 August 2014

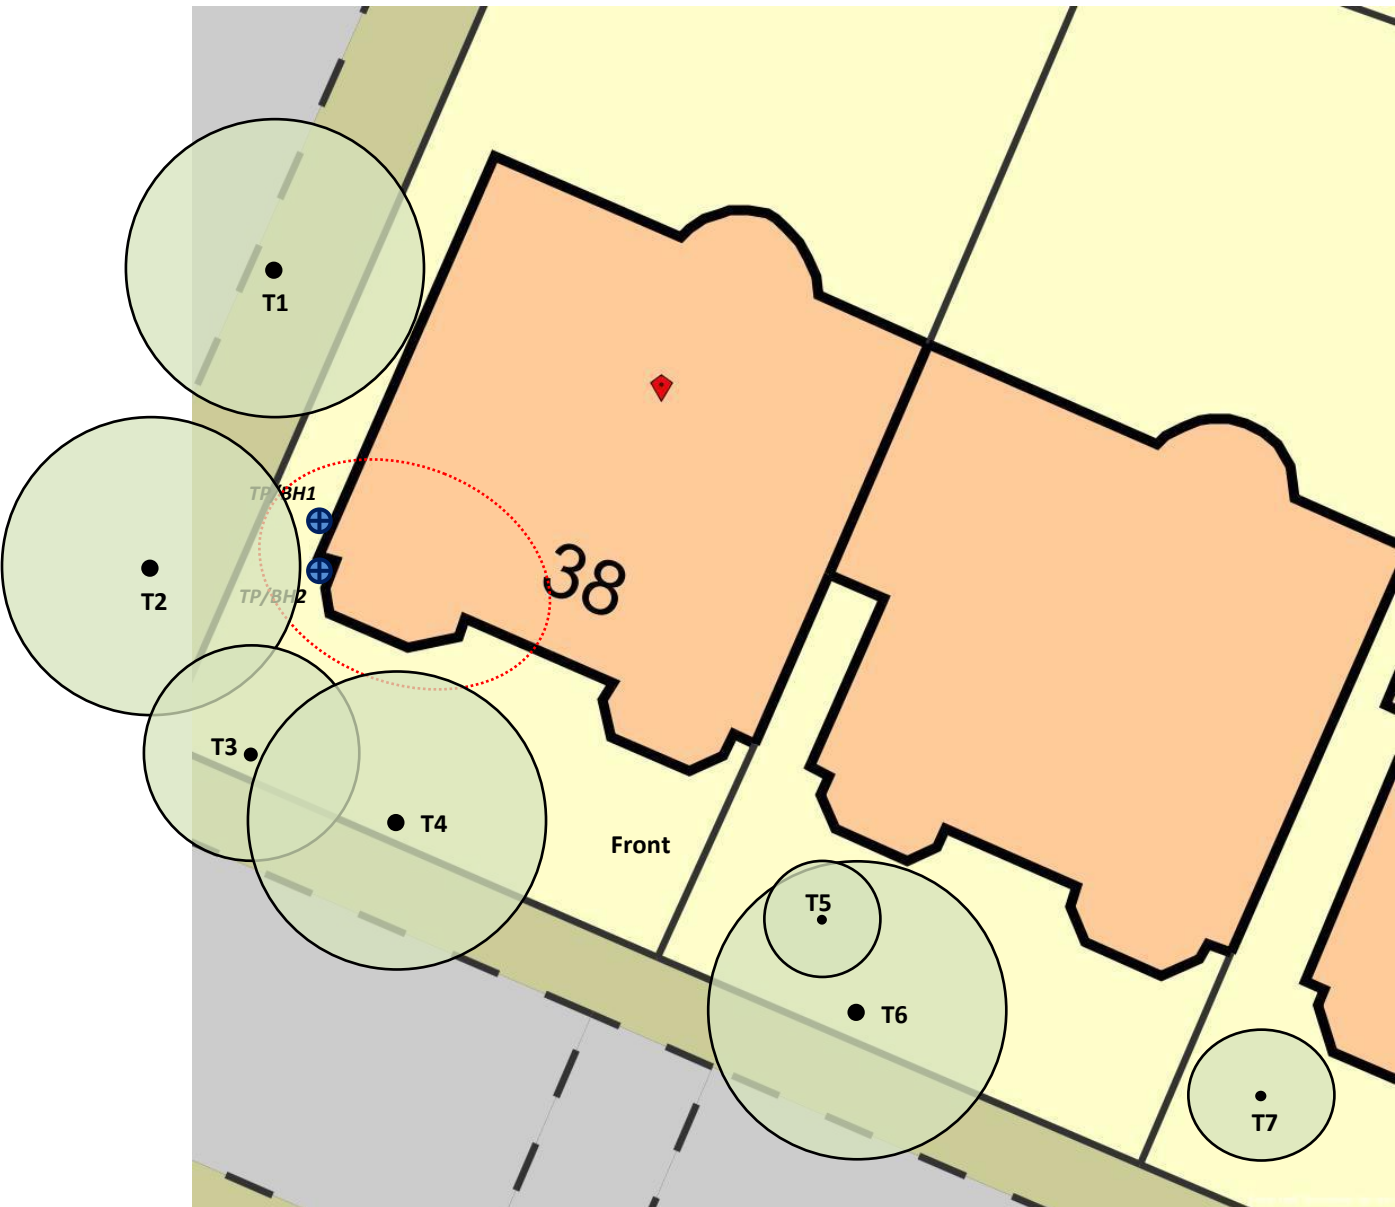
SITE PLAN

Approximate areas of damage

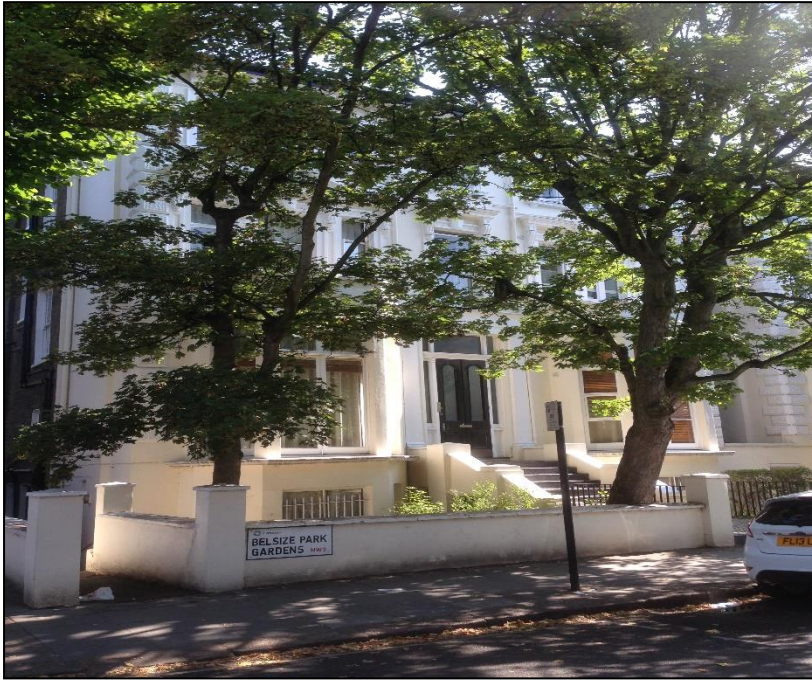
View of T3 & T4

Our survey of the site identified the Sycamores T3 and T4 and we believe that these are the source of the recovered roots. A lack of roots from T2 should not be relied upon to discount the causal role of this tree.

Having considered the available information, it is our opinion that the Sycamores T3 and T4 are the material cause of the current subsidence damage. However, T2 is also thought to be exerting a secondary influence.

If an arboricultural solution is to be implemented to mitigate the current damage and allow the soils beneath the property to recover to a position such that an effective engineering repair solution can be implemented we recommend that the Sycamores T3 and T4 be removed and T2, Lime, be pruned.

We have given consideration to pruning as a means of mitigating the vegetative influence, however in this instance we believe that the trees are too large and close for pruning to represent a viable mitigation option.
