### Arboricultural Survey (BS5837:2012) & Impact Assessment Report

44 Dartmouth Park Road  
London  
NW5

8th July 2015

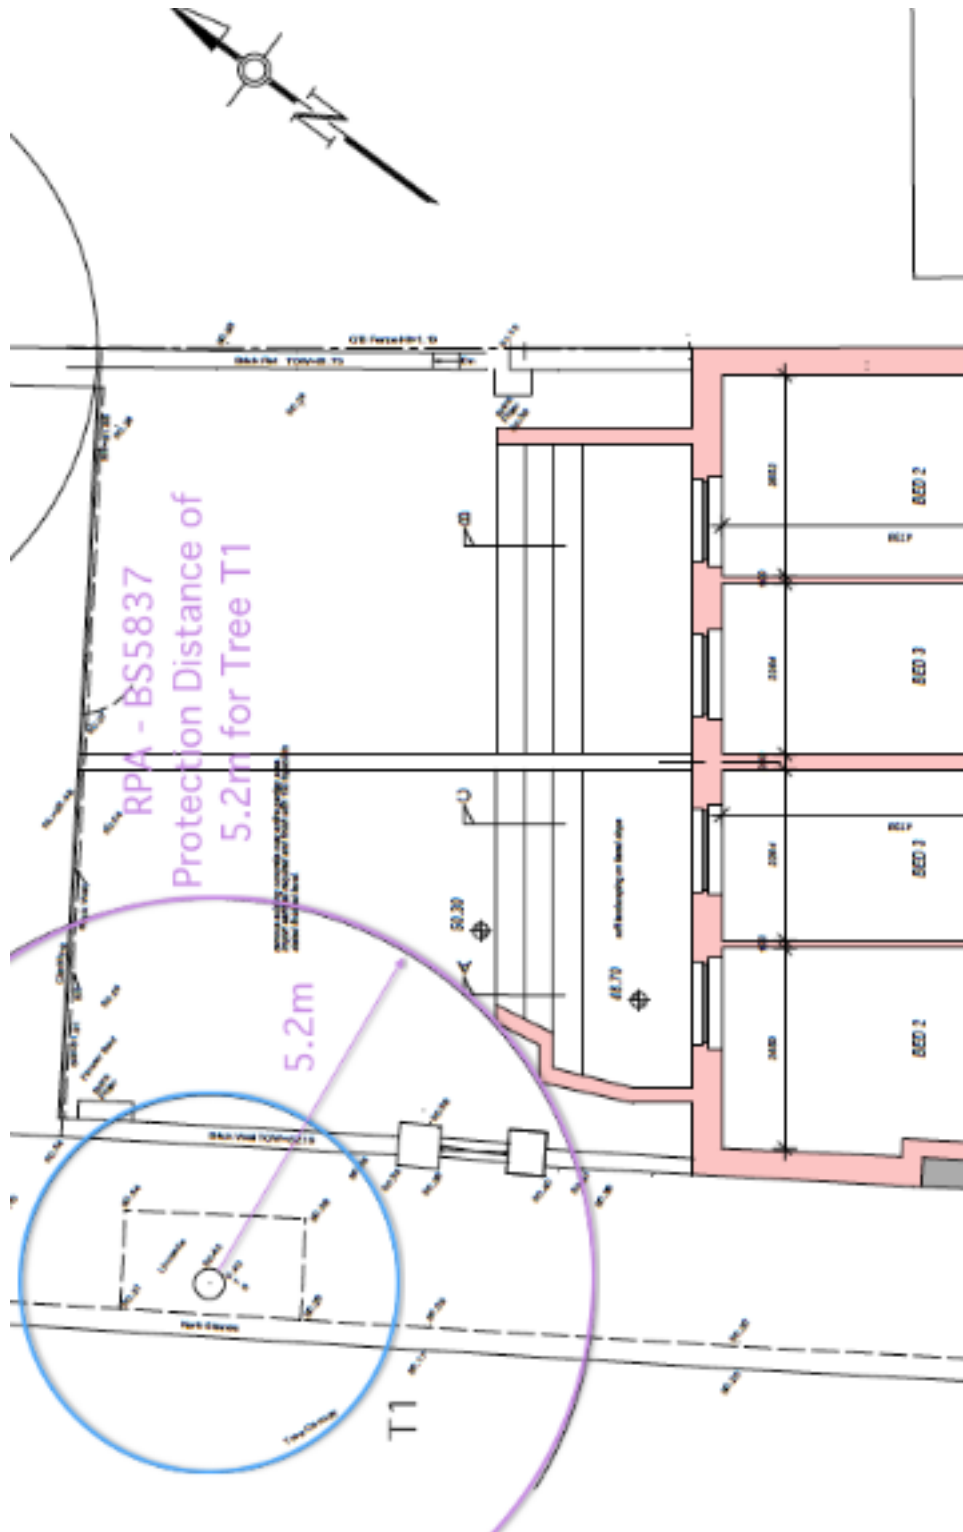
**Appendix B.1**  
**Proposed Site Plan with Root Protection Area**  
**(BS5837:2012)**

4.13 The development works ensure that no excavations are required within the recommended root protection area for this tree which extends 5.2 metres from the main stem of the tree. The RPA does extend within the property, but significant protection for the majority of the root plate can be provided; where not possible the hard standing surface will remain until final landscaping

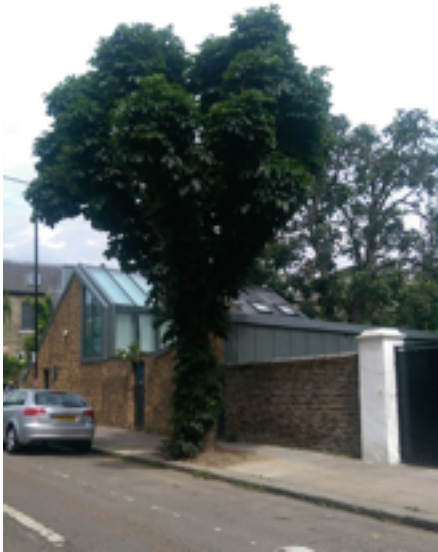
4.9 Tree T1 is a mature Horse Chestnut (*Aesculus hippocastanum*) located within the public highway adjacent to the proposed development site. The tree is a generally structurally sound specimen which had good buttress roots at the base and a straight main stem. The tree is sited within a thin soft landscape planting pit within the pavement and is surrounded by relatively recent hard landscaping (within the past 10 years). The planting pit is dressed with hoggin / brendon gravel or similar to ensure water penetration in this initial root plate area.

4.10 The main stem has some significant decay on the south side from approximately 2.0m - 3.5m which has reasonable compensatory growth but the heavily reduced state of the tree compensates for this. The decay does extend within the main union at approximately 3.0 metres and this structural defect requires for the management of the tree to be continued for the long term. Overall there is a good branch framework which has been cyclically crown reduced, lifted and thinned to manage its proximity to the road and adjacent buildings; works were likely last carried out within the past dormant season as there is significant fresh epicormic growth which is showing excellent vigour. Taking account of the prominent location within the streetscape and overall form, this tree is rated as a 'B.1' category specimen (BS5837: 2012) as when in leaf the tree offers a balanced and compact canopy with high amenity value in this urban area.

C.1 Photograph of tree T1, 44 Dartmouth Park Road, London, NW5 as viewed in a northerly direction from the public highway

*No action required at present\**

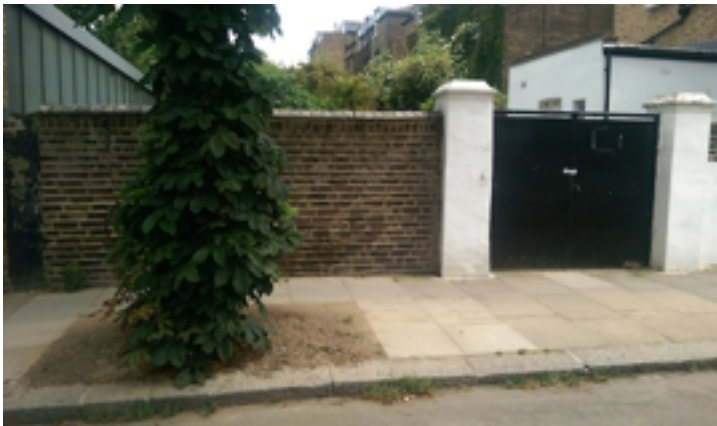
C.2 Photograph of tree T1, 44 Dartmouth Park Road, London, NW5 as viewed in a easterly direction from the public highway

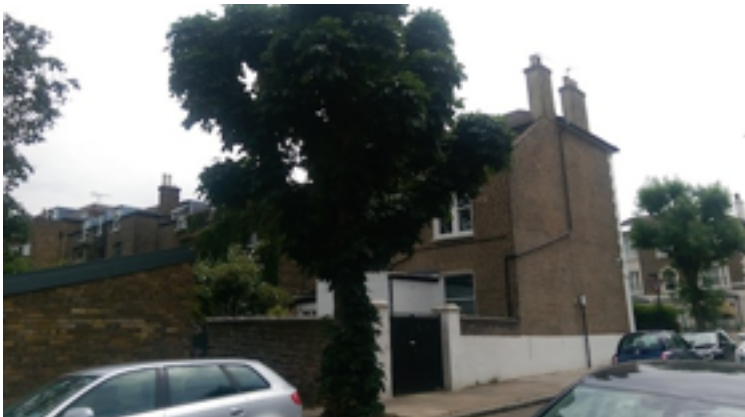
C.3 Photograph of tree T1, 44 Dartmouth Park Road, London, NW5 as viewed in a south easterly direction from the public highway
