**Arboricultural Report and Tree Condition Survey  
for the Proposed Works within the grounds of Lincoln's Inn,  
London, WC2A 3TL**

**The Honourable Society of Lincoln's Inn**

Our Ref 0115-1785  
July 2015

## **Pre-Development Tree Condition Survey at Lincoln's Inn, London, WC2A 3TL**

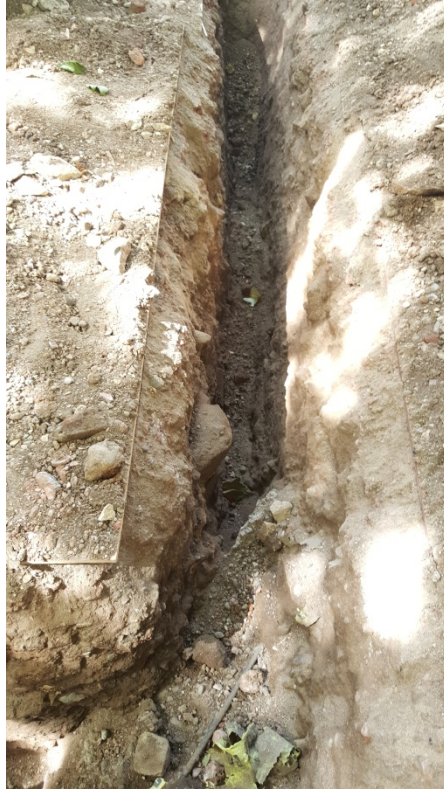
5.28 The area of the trenches is a gravel hardstanding, they were excavated to a depth of 1000mm, the top 150mm was gravel and MOT type 1, this overlaid a compacted fill consisting of stone and brick with densely compacted dusty fill/soil. To the very north-eastern corner of the excavation a service run and concrete haunching was encountered at approximately 400mm below ground level. Within the trenches only very occasional roots were encountered with no roots over 5mm in diameter observed. The trenches were inspected by Nick Bell the London Borough of Camden Tree Officer.

Photograph 1 (29-06-2015)  
View from the corner of the trench looking westwards along the east-west trench

5.29 With regard to the ground conditions encountered, the absence of roots in the area of excavation it is our opinion that subject to appropriate tree protection measures, (which are outlined in Section 6 of this report) the proposed basement can be constructed without detriment to the health of the retained trees.

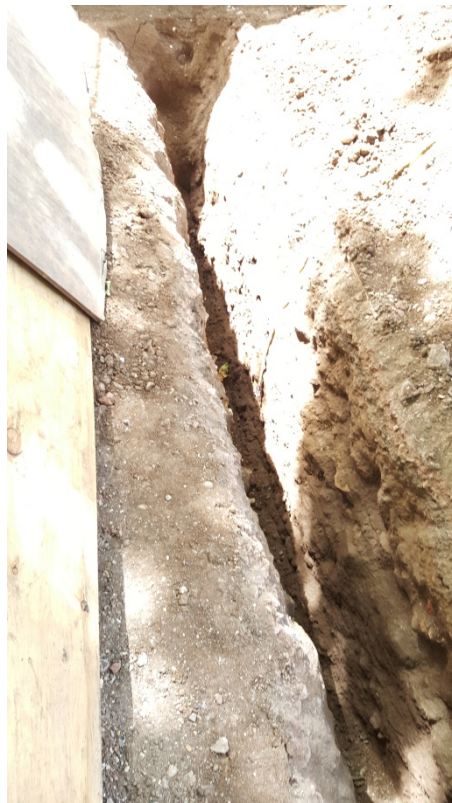
Photograph 2 (29-06-2015)  
View from the corner of the trench looking southwards along the north-south trench

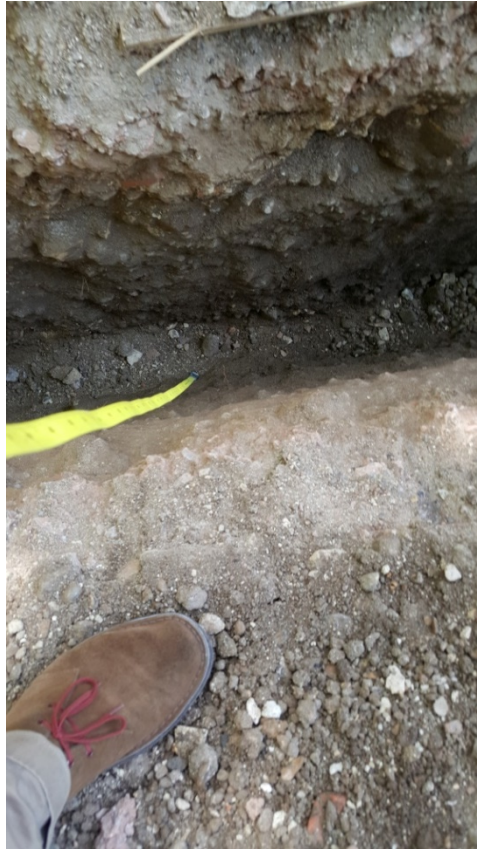
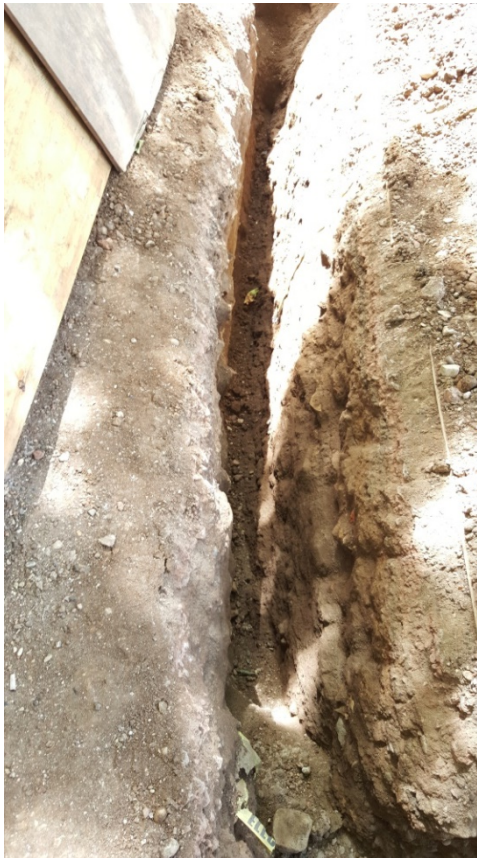
Photograph 3 and 4 (29-06-2015)  
2 Views into the trench showing the densely compacted inert fill material and absence of roots.
