STRUCTURAL CONDITION REPORT

27 Mercer Street, London, WC2H 9QR

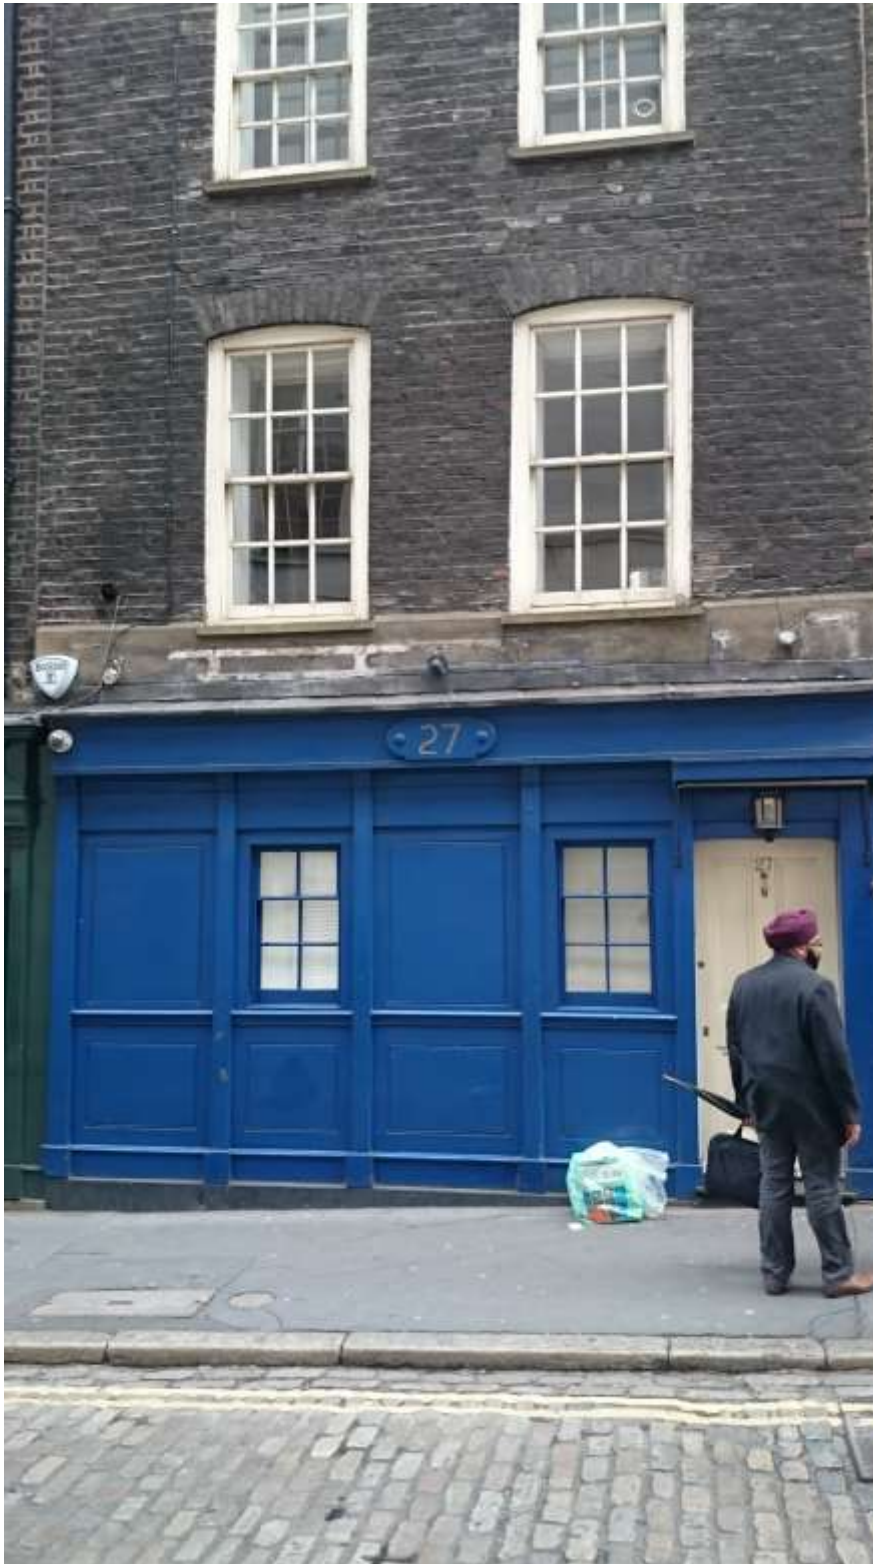
Photo 1:

Photograph 1 of front elevation

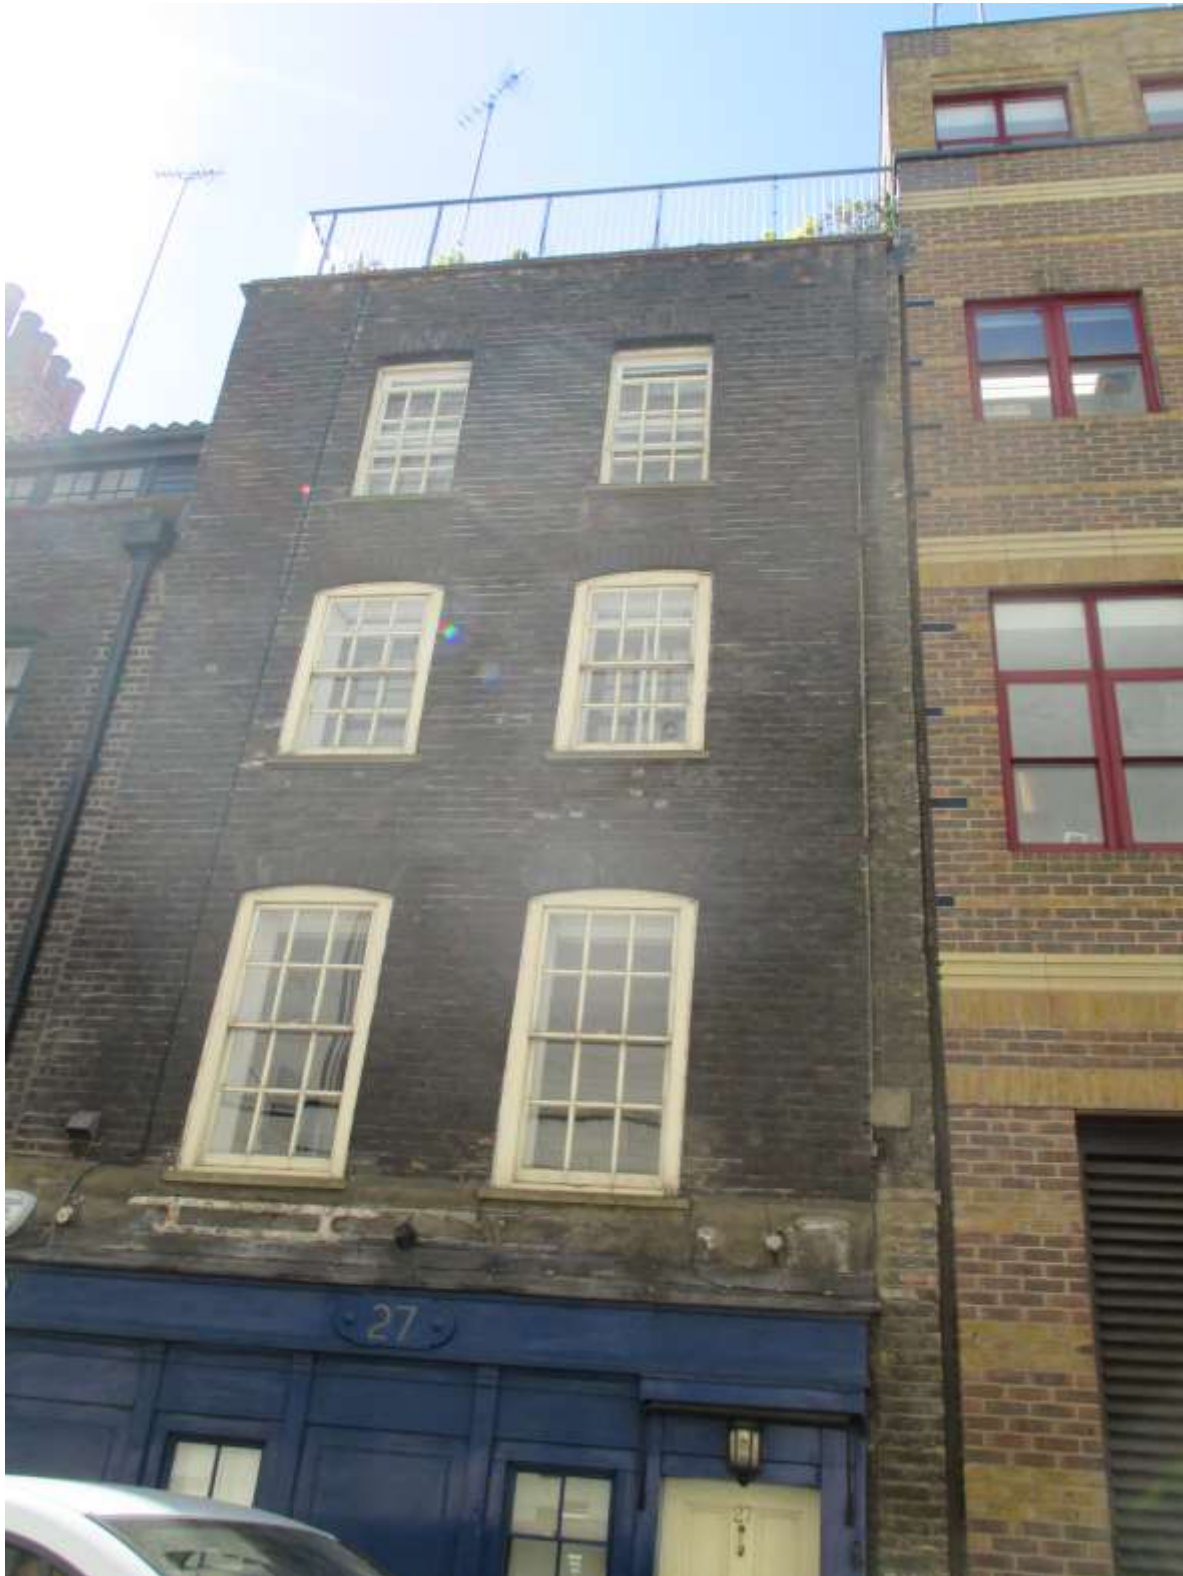
Photo 2:

Photograph 2 of front elevation

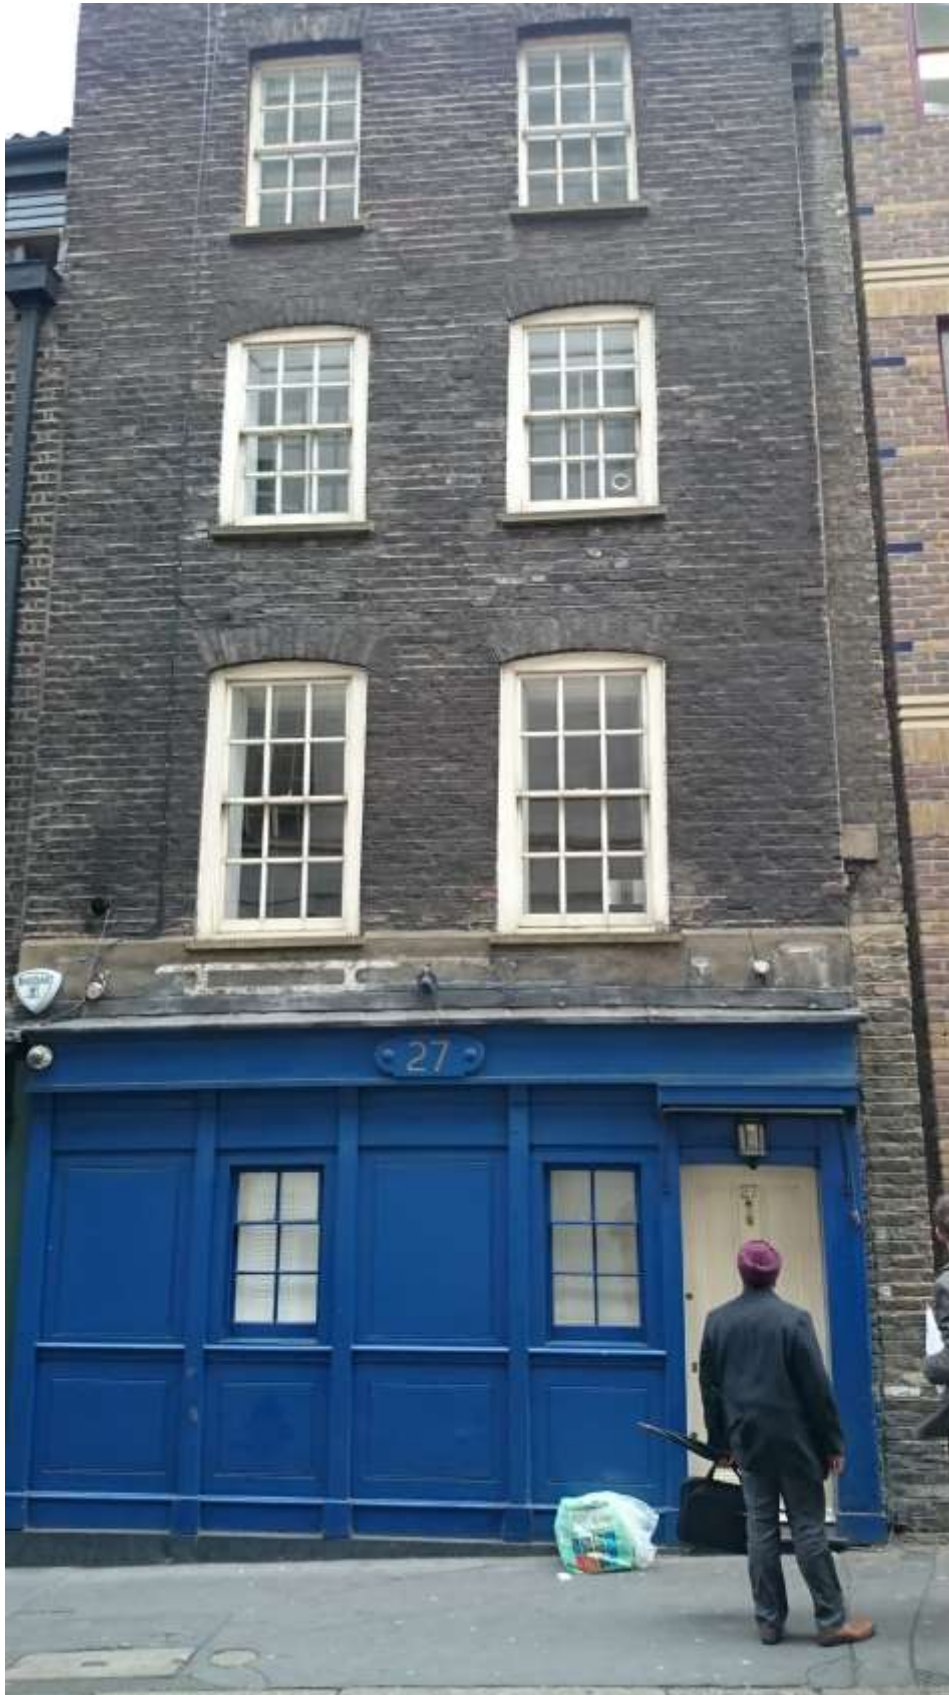
Photo 3:

Photograph 3 of front elevation

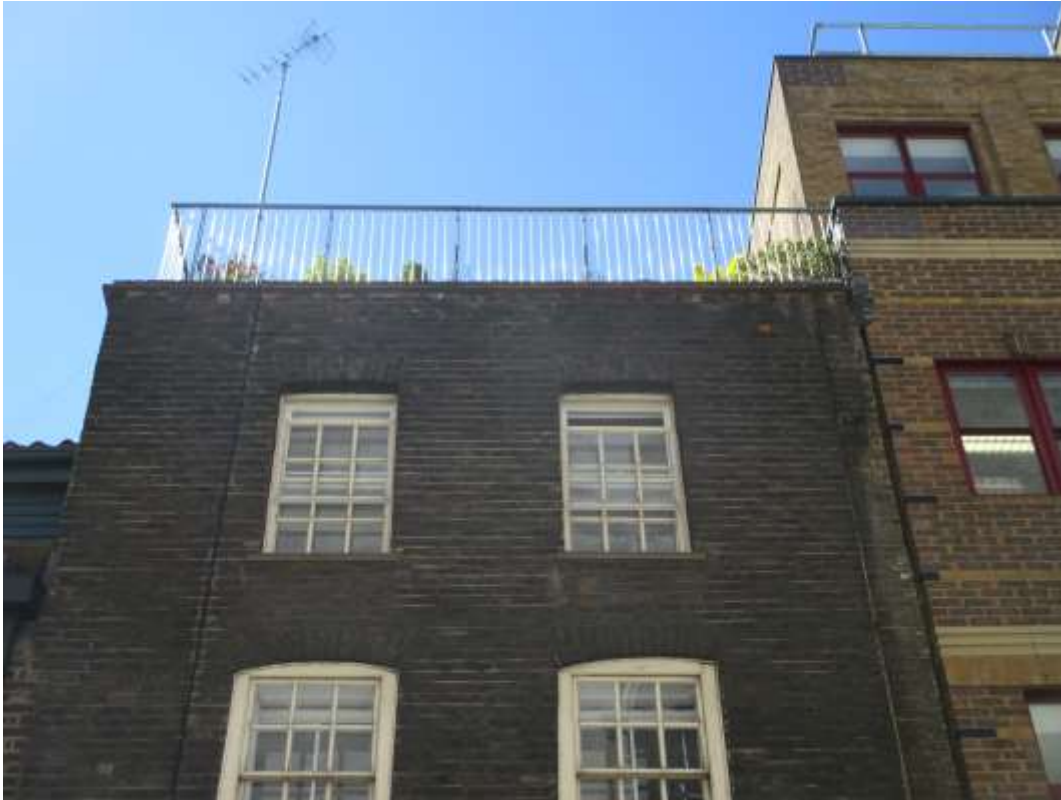
Photo 4:

The mortar infill along the front under the parapet slip tiles has some loose mortar but is not detrimental to the structure.

Photograph 4 of Front elevation showing roof parapet to roof terrace

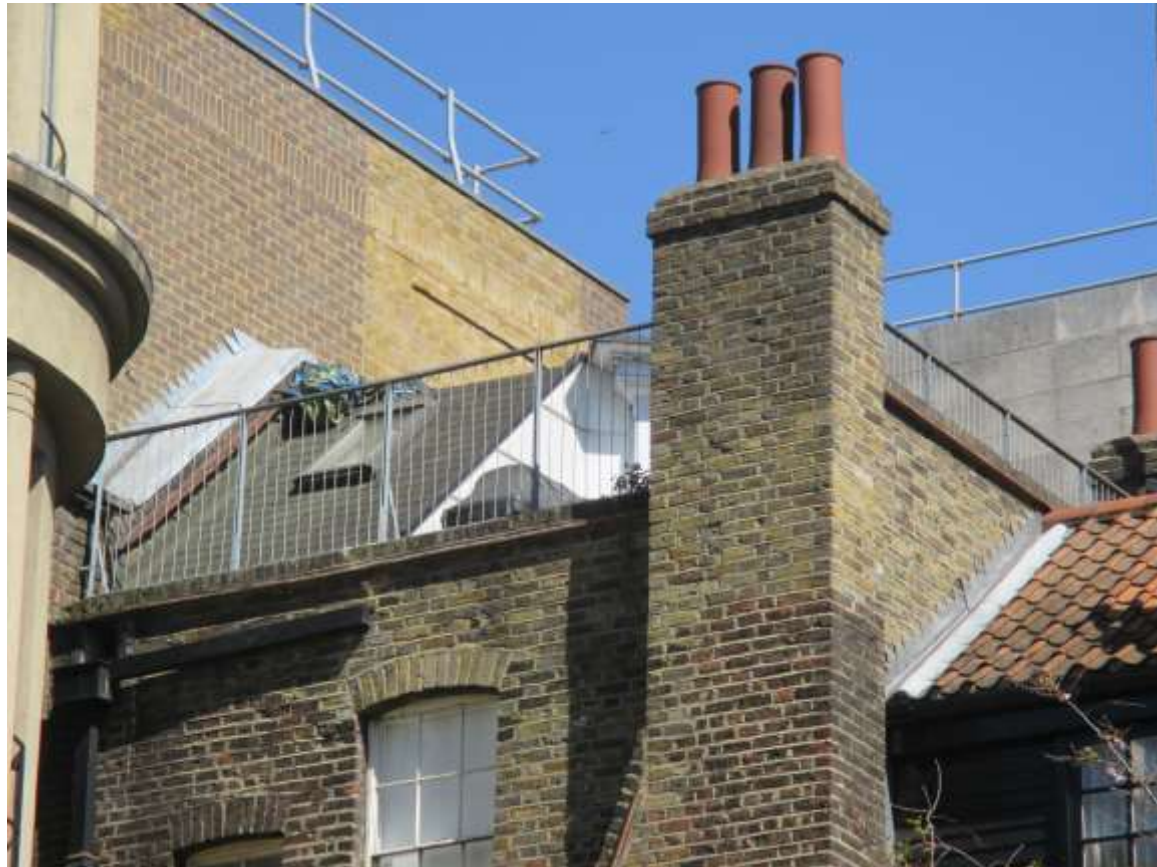
Photo 5:

The roof terrace is in very good condition; there is no spring in the timbers and all roof coverings flashings have been installed to a very good standard.

Photograph 5 of rear elevation showing roof terrace

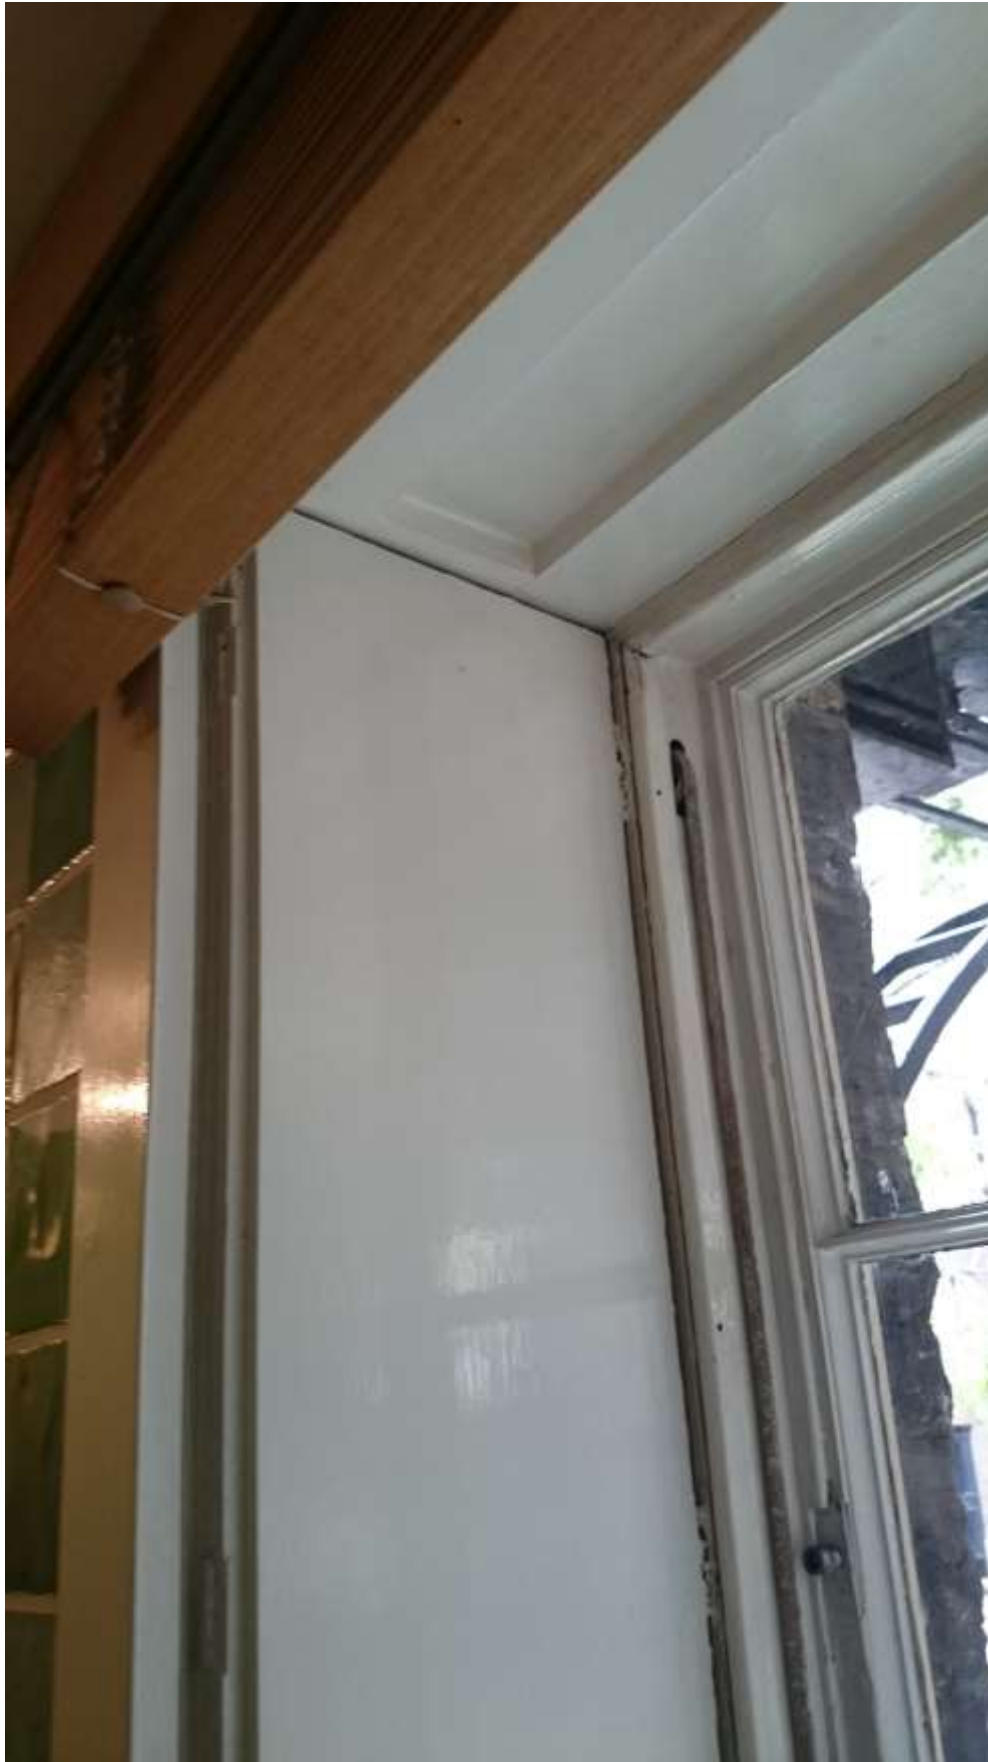
Photo 6:

There are no signs of cracking around any external door or window frames.

Photograph 6 of Ground floor window jamb

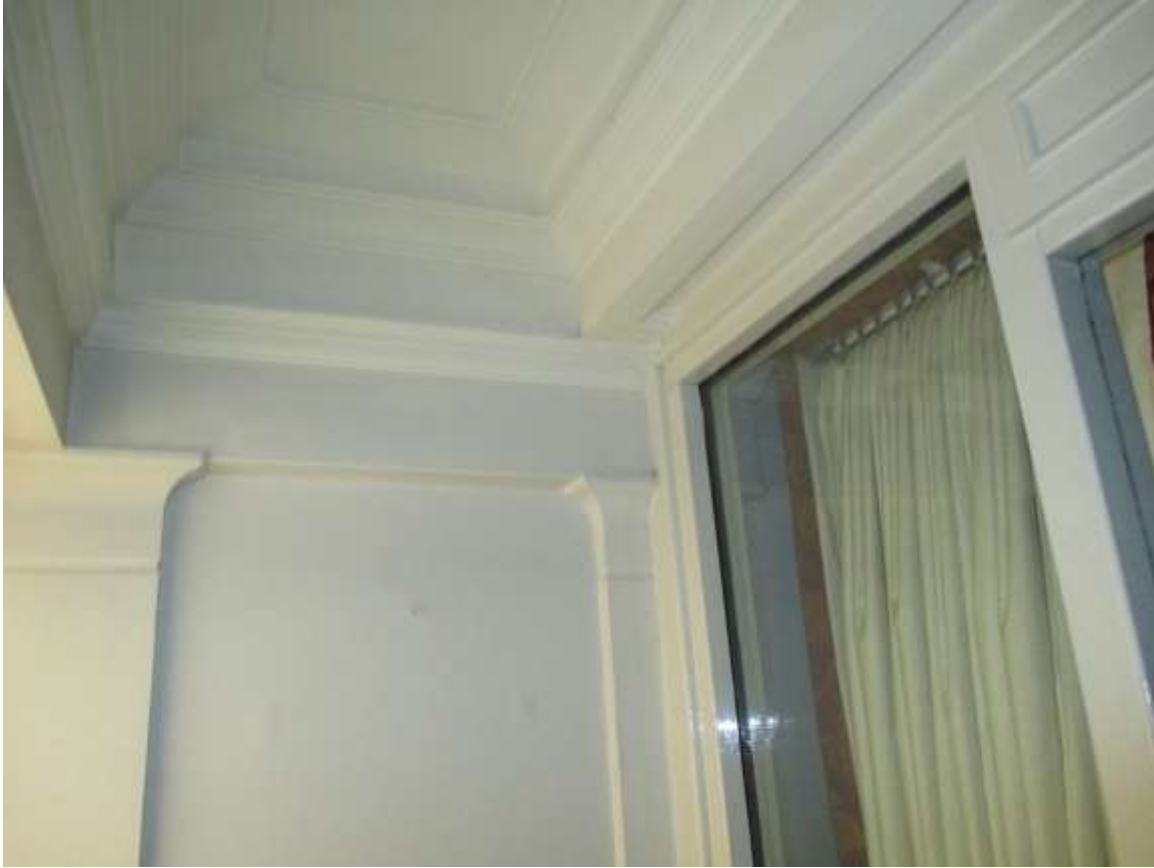
Photo 7

When the properties were renovated in the early 1980's there were many art deco plaster mouldings added to walls and ceilings, these clearly are not part of the original fabric of the building but again as no cracks are visible shows the structural integrity of the building is very good.

Photograph 7 of internal ornate plaster work

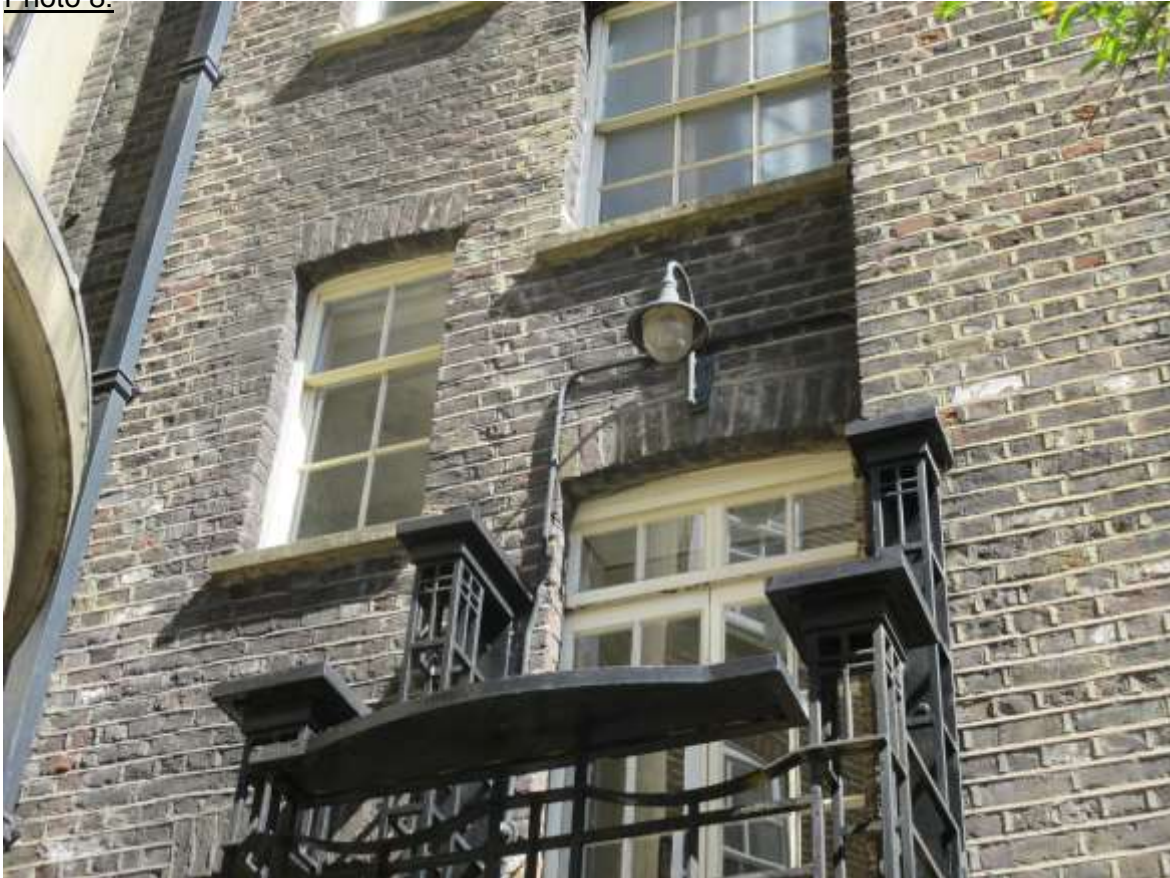
Photo 8:

Photograph 8 of rear balcony showing masonry details

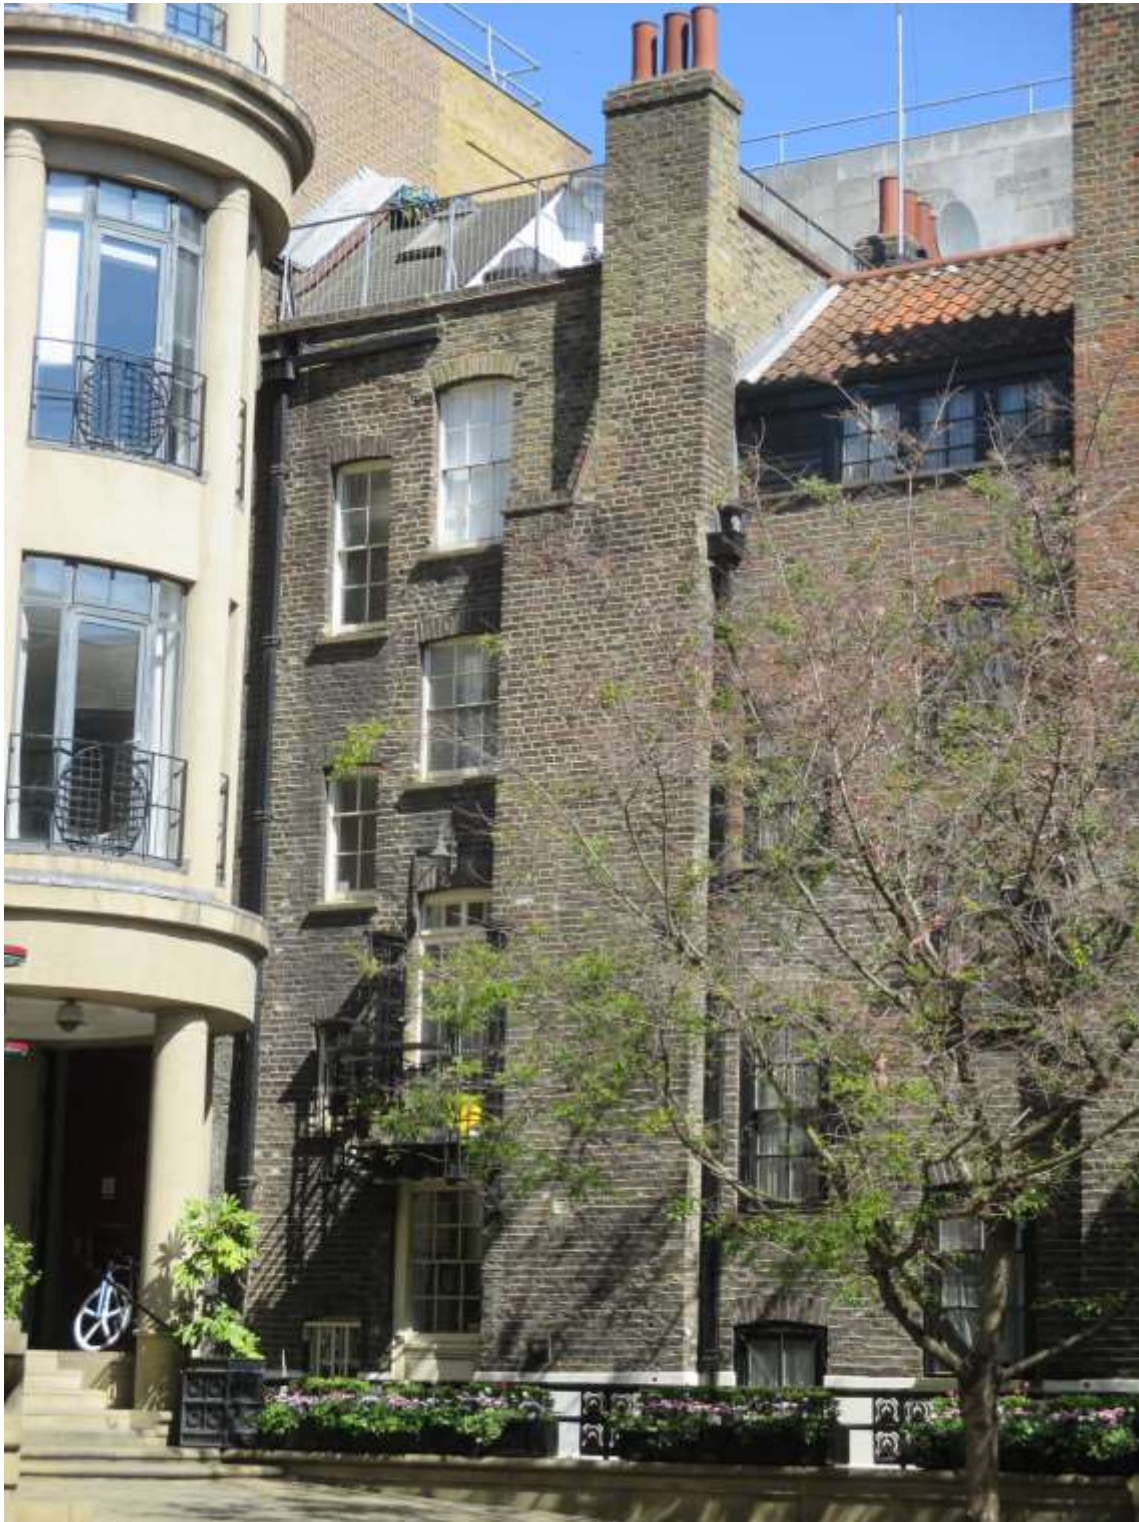
Photo 9:

At the rear of the property the basement to ground floor is sand / cement rendered.

Photograph 9 of Rear elevation from courtyard
