## **Appendix A**

# 94 HAVERSTOCK HILL, LONDON

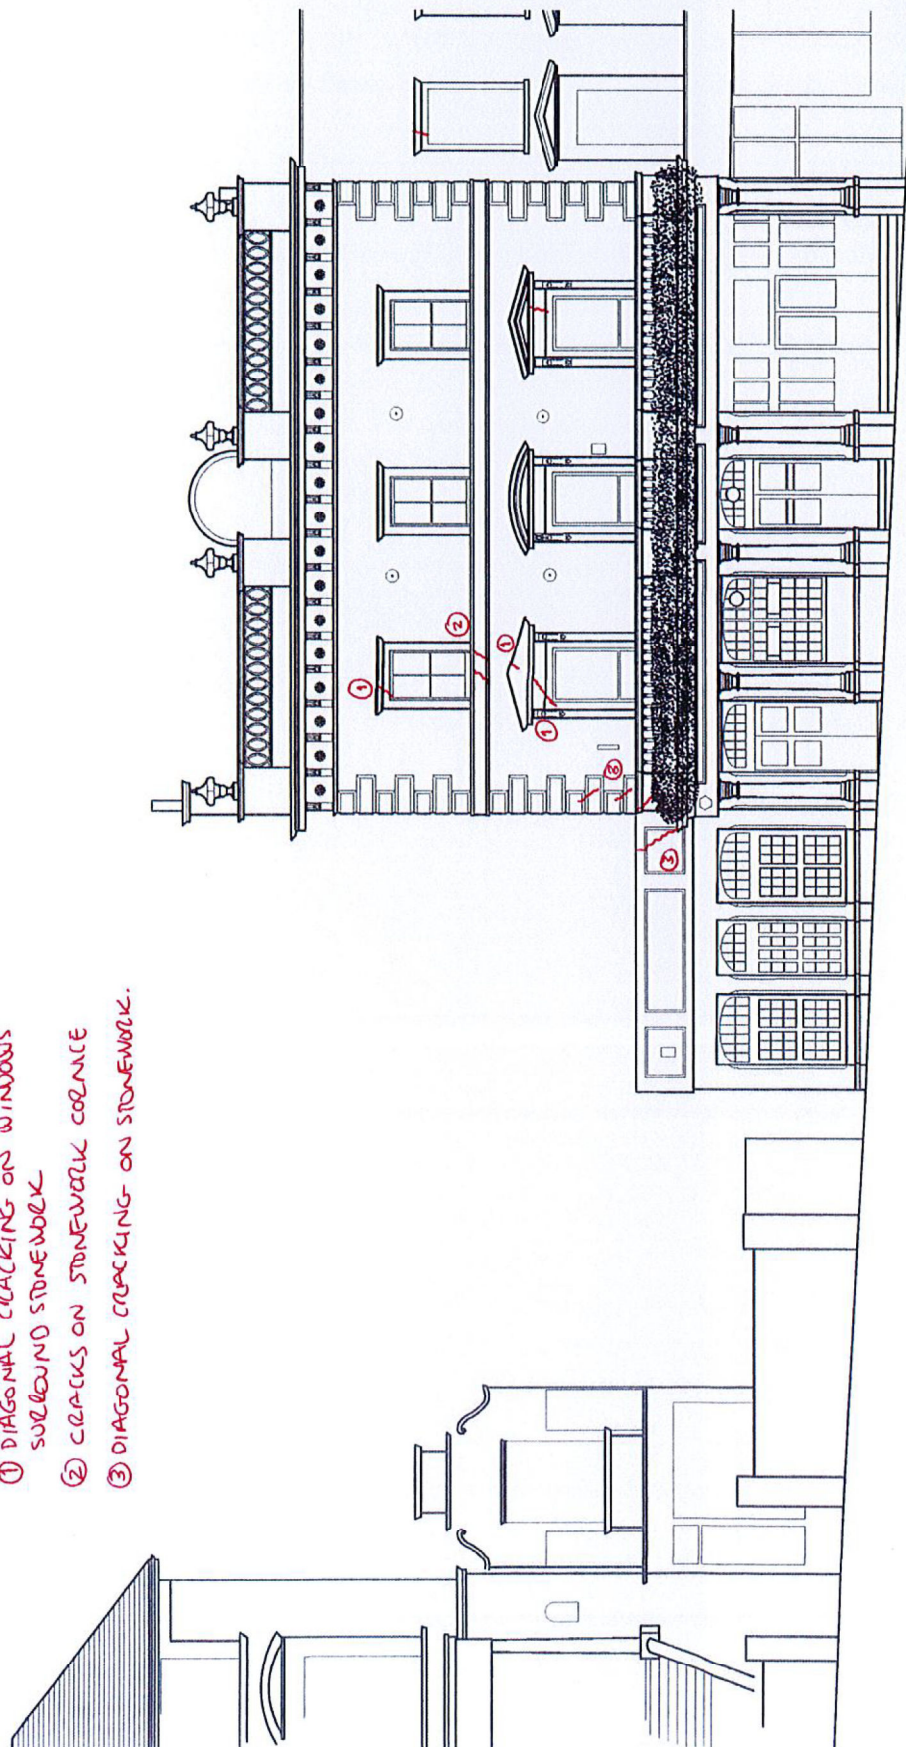
EXISTING SOUTH-WEST ELEVATION  
SCALE 1:100 @ A3

- ① DIAGONAL CRACKING ON WINDOWS SURROUND STONEWORK
- ② CRACKS ON STONEWORK CORNICE
- ③ DIAGONAL CRACKING ON STONEWORK

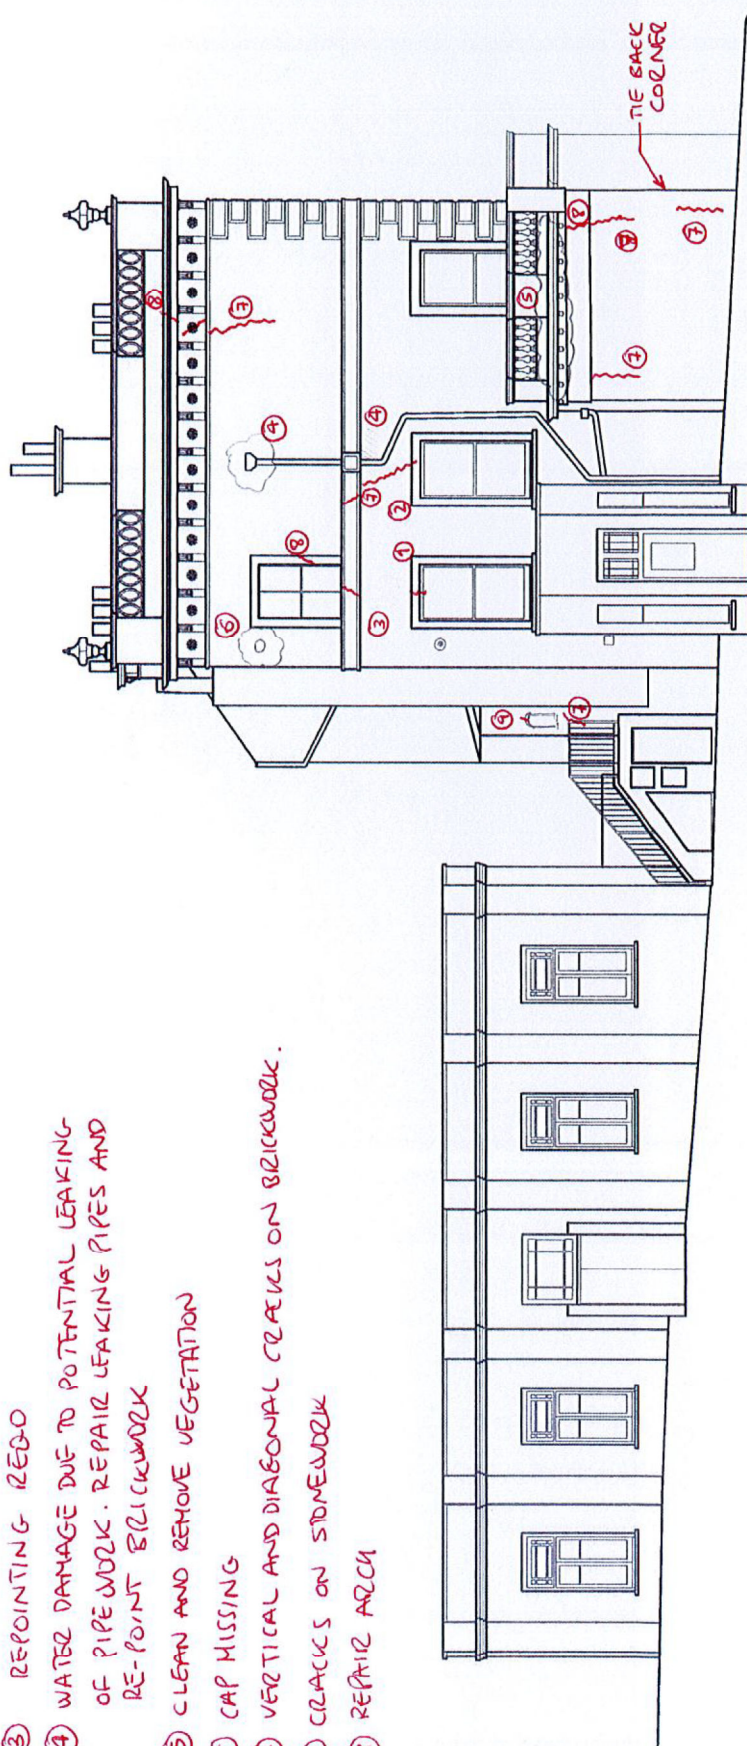
EXISTING NORTH-WEST ELEVATION

- ① - ② SECTIONS OF CORNICES TO BE REMOVED AND REPLACED
- ③ REPOINTING REQD
- ④ WATER DAMAGE DUE TO POTENTIAL LEAKING OF PIPE WORK. REPAIR LEAKING PIPES AND RE-POINT BRICKWORK
- ⑤ CLEAN AND REMOVE VEGETATION
- ⑥ CAP MISSING
- ⑦ VERTICAL AND DIAGONAL CRACKS ON BRICKWORK
- ⑧ CRACKS ON STONEWORK
- ⑨ REPAIR ARCH

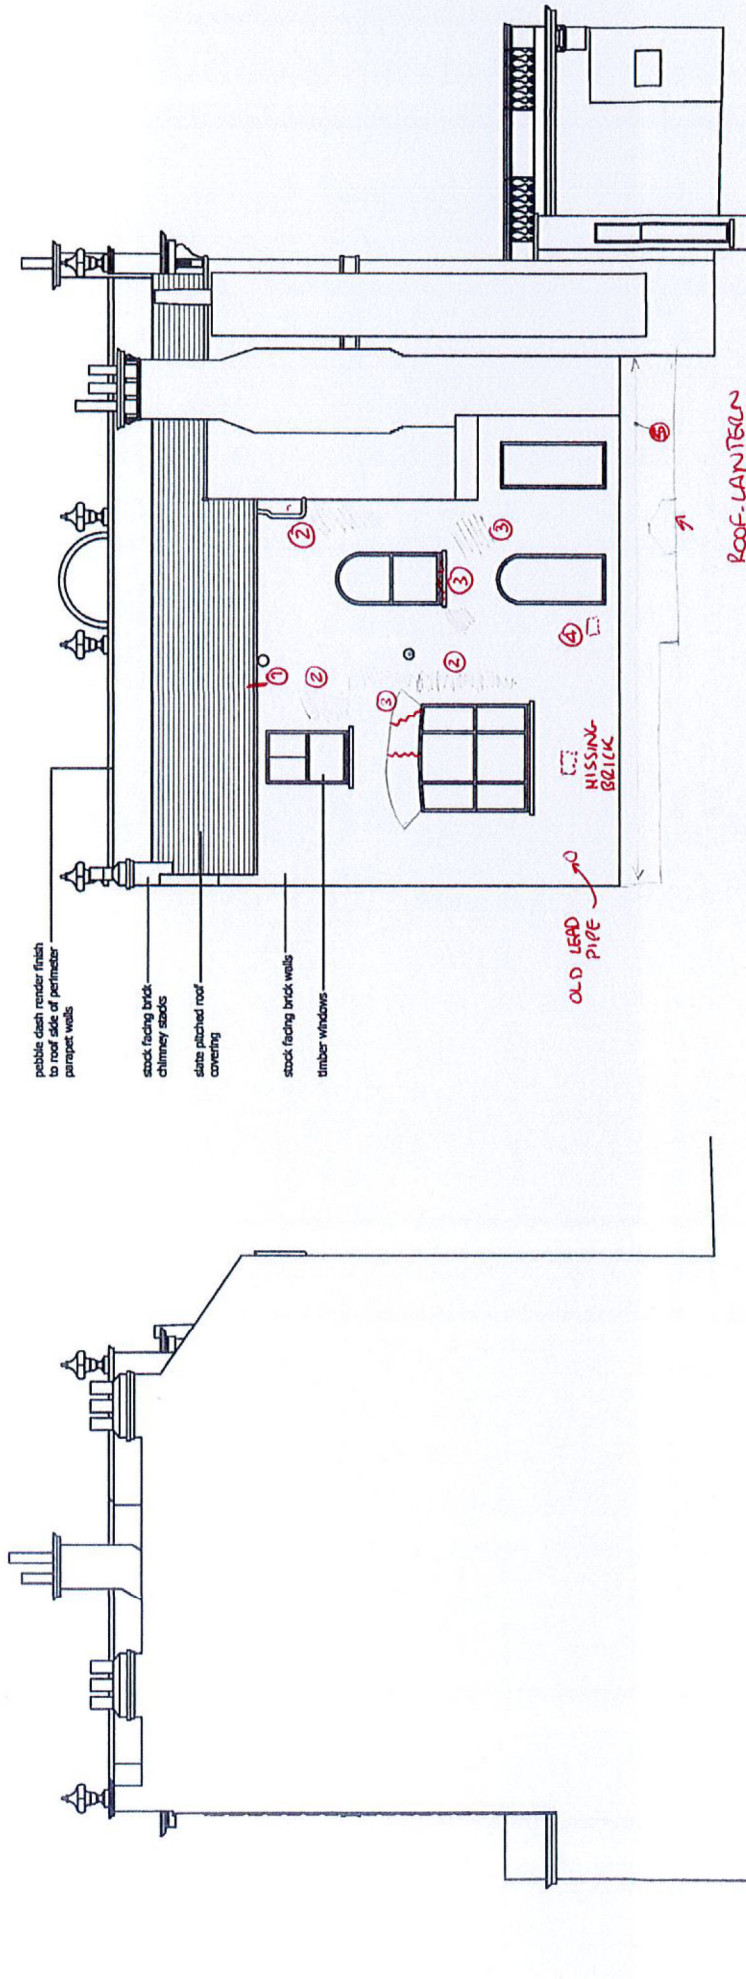
EXISTING SOUTH-EAST ELEVATION  
SCALE 1:100 @ A3

- ① BROKEN GUTTER TO BE REPAIRED
- ② WATER STAINING, DUE TO LEAKING PIPEWORK
- ③ REPAIR CRACKS AND RE-POINT
- ④ POSSIBLE REDUNDANT FLUE HOLE TO BE FILLED IN.
- ⑤ LOW LEVEL RE-POINTING

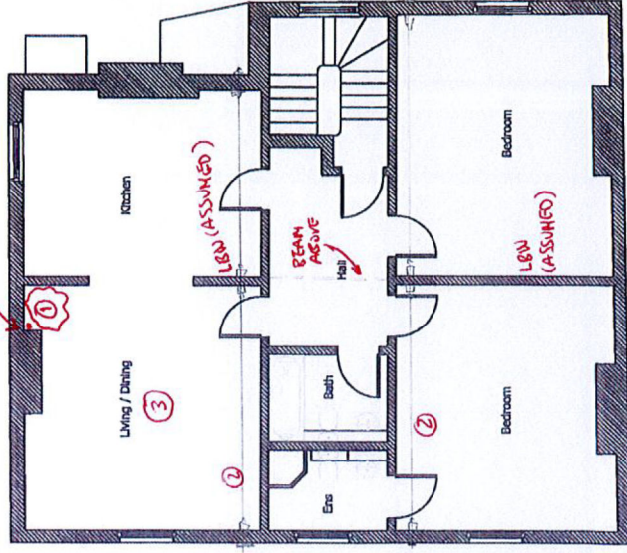
EXISTING SECOND FLOOR PLAN  
SCALE 1:100 @ A3

REDUNDANT PIPE  
RADIATOR  
∴ POTENTIAL  
WATER DAMAGE TO FLOOR

1. BEAMING OF FLOOR. EXPOSE TIMBER FLOOR JOISTS TO ASSESS CONDITION
2. EXISTING WALL TIES, BELOW CEILING LINE
3. FLOOR FEELS LEVELS.

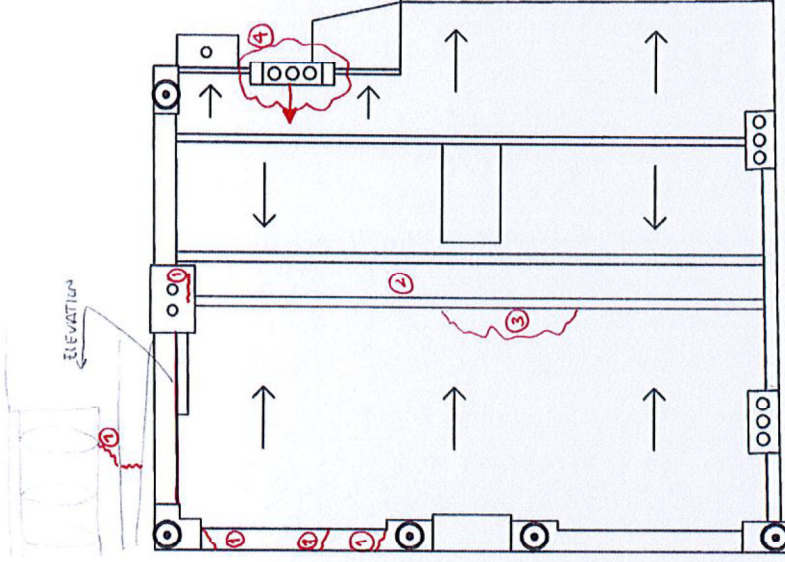
EXISTING ROOF PLAN  
SCALE 1:100 @ A3

1. CRACKING - REPAIR REQD.
2. ROOF COVERING HAS DETERIORATED
3. SLATES BROKEN OR/AND MISSING
4. CHIMNEY APPEARS TO BE LEANING-IN

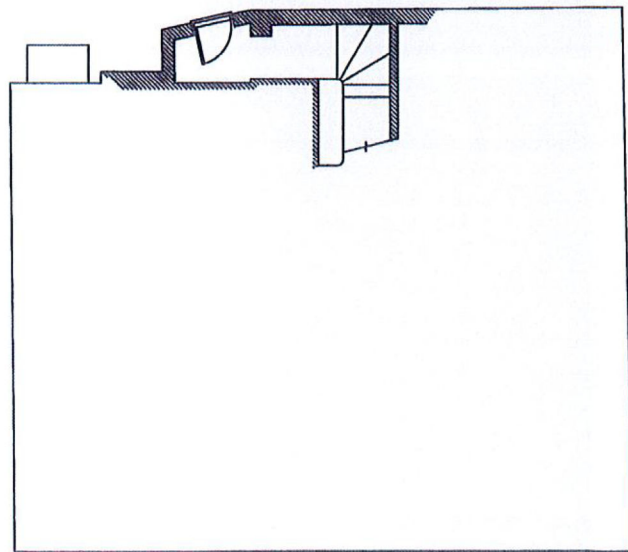
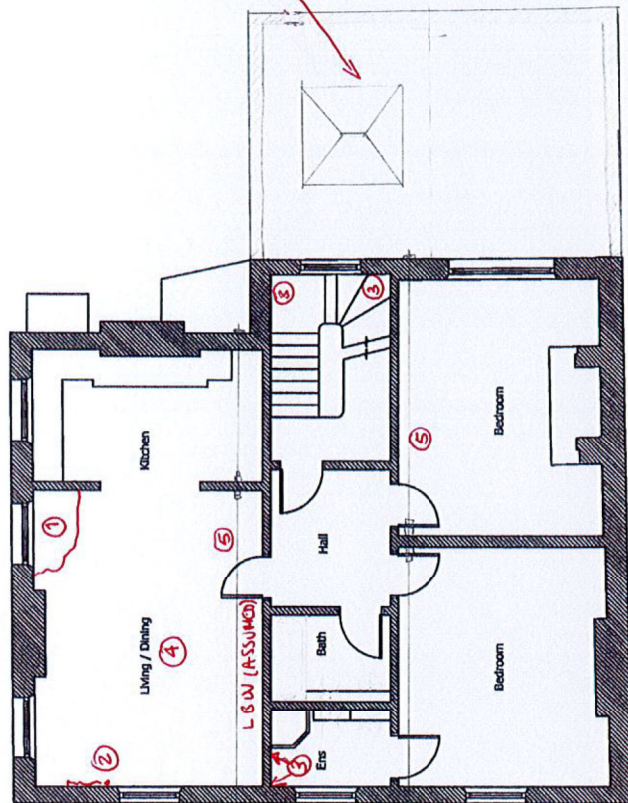
EXISTING FIRST FLOOR PLAN  
SCALE 1:100 @ A3

- ① WATER DAMAGE ON CEILING  
EXPOSE TIMBER JOISTS TO CONFIRM  
CONDITION
- ② RADIATOR LEAK - EXPOSE TIMBER FLOOR  
JOISTS TO CONFIRM CONDITION
- ③ HAIRLINE CRACKS ON WALL
- ④ FLOOR FEELS LIVELY
- ⑤ EXISTING WALL TIES
