B.H. MAULE & PARTNERS
Chartered Engineers and Surveyors.

6 November 2007

**ENGINEERING REPORT ON
FINDINGS OF SITE INVESTIGATION
AT
81 FORDWYCH ROAD
LONDON
NW2 3TL**

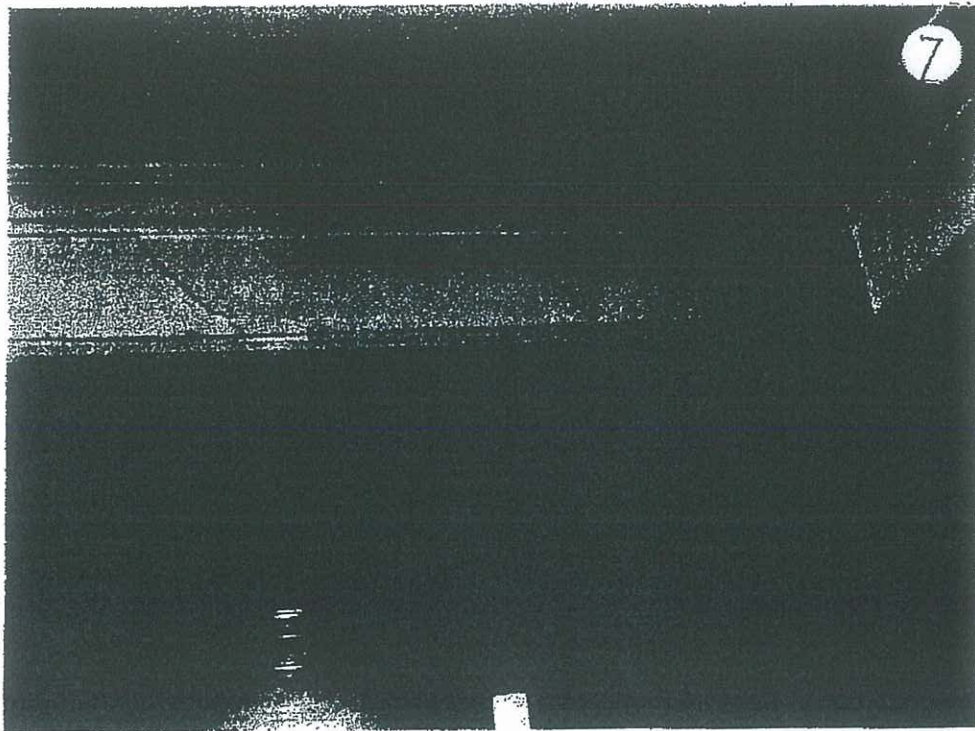
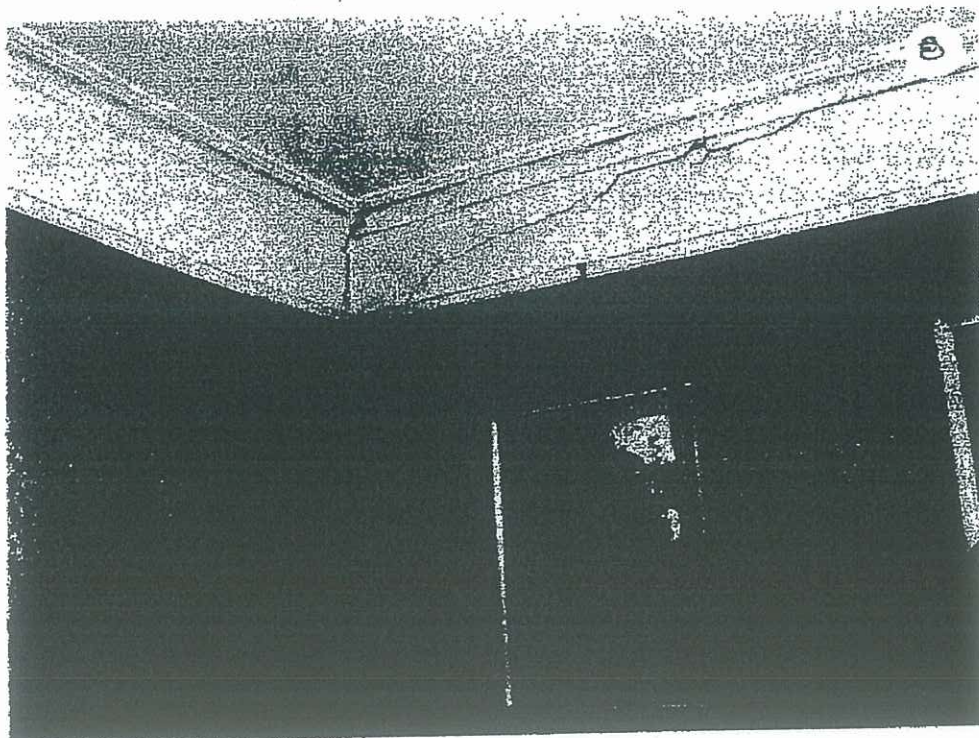
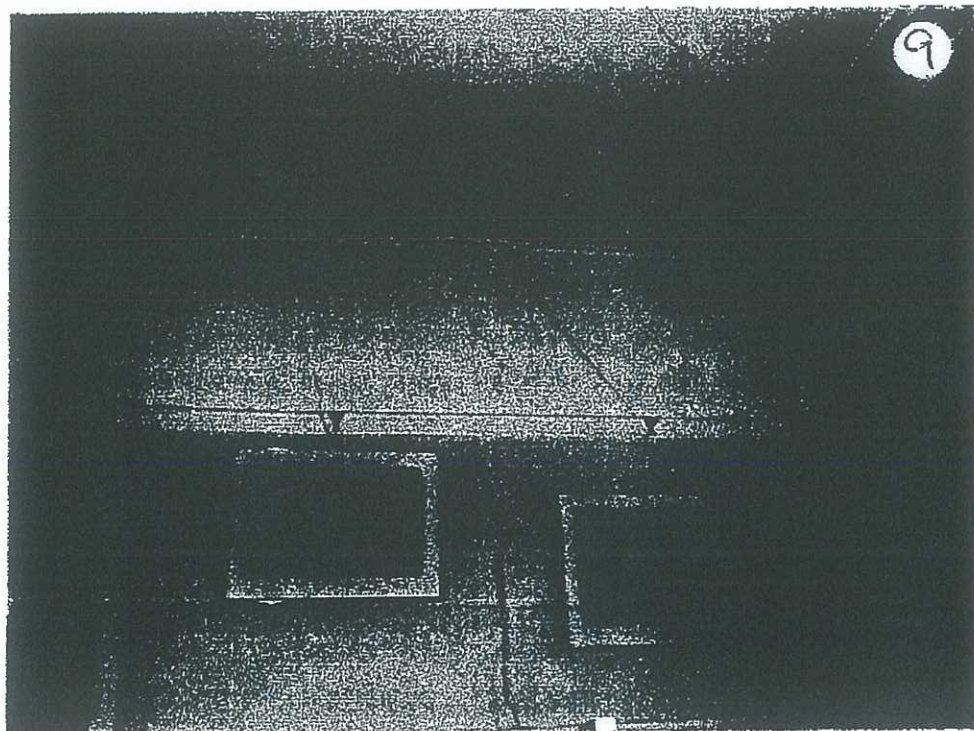
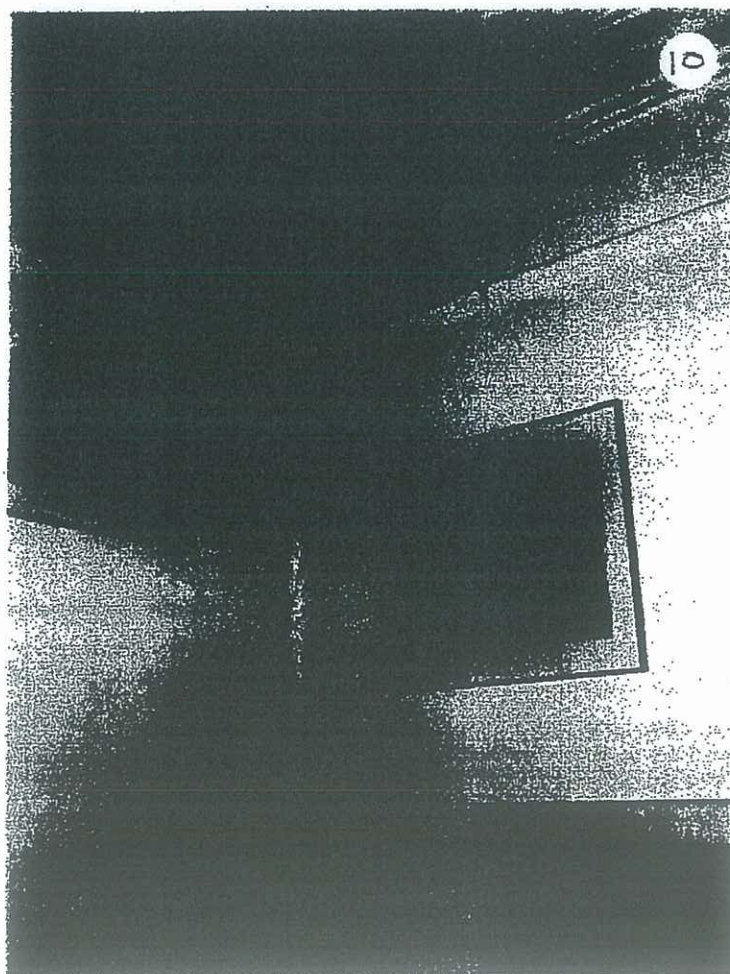
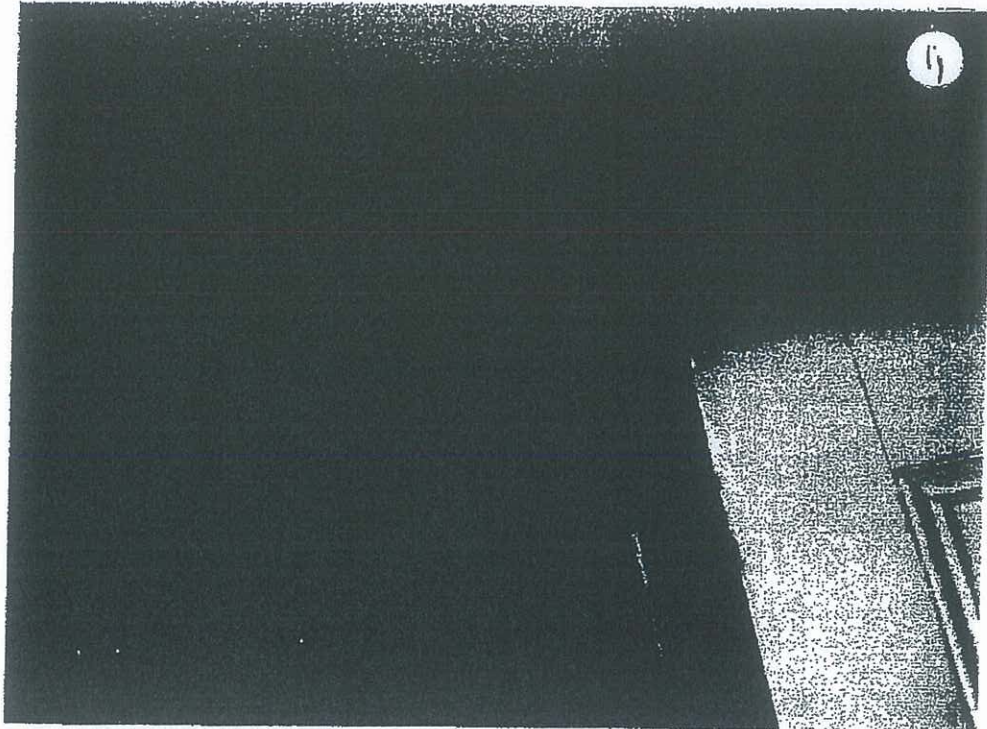
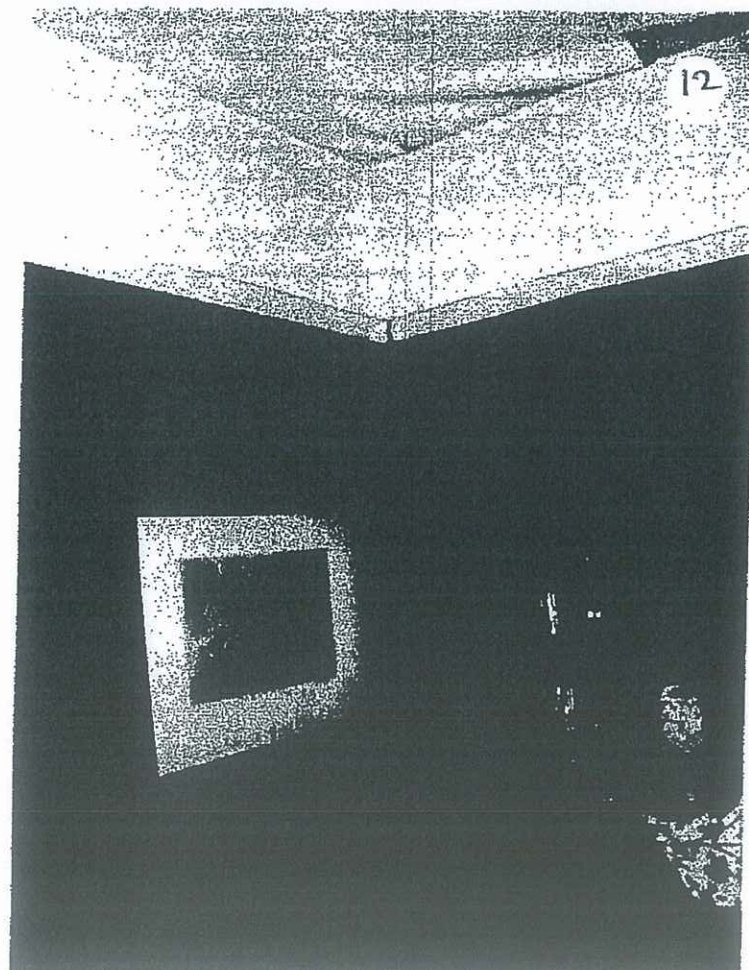
The visual inspection shows Category 4 (BRE Digest 251) damage with cracking throughout the height of the party wall at the position of the central staircase, and numerous cracks and distortions generally throughout the property.

Masonry reinforcement crack repairs are also required to the flank wall No. 81 and it would be appropriate to introduce continuous lines of reinforcement (helibeam) and to connect these to the internal cross walls. All crack repairs should follow normal good practice employing resin injection, plaster reinforced with expanded metal lath and masonry reinforcement repairs on all significant cracks.

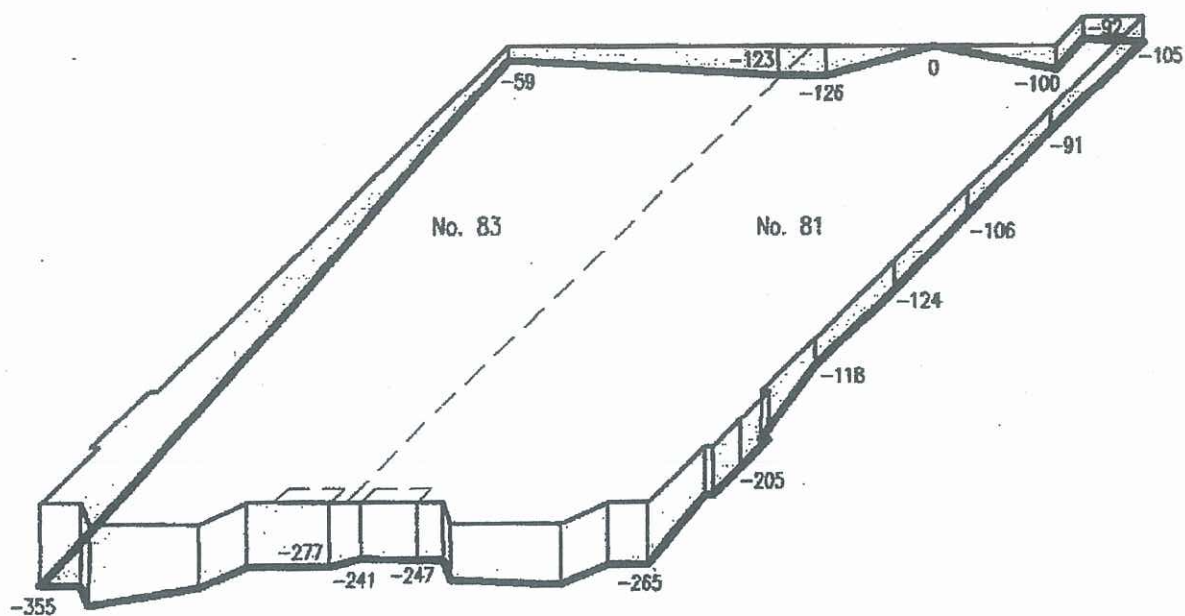
LEVEL DISTORTION SURVEY

The level distortion survey indicates the front of the house to have settled relative to the rear by an average of 150mm.

We included in the distortion survey the adjoining property No. 83 and the front left corner of that house is some 300mm lower than its rear left corner.

Taking the pair of houses as a whole, the front left corner is 90mm lower than the front right and generally the front of the house has settled relative to the rear. The level distortion survey also shows the rear part of the party wall has settled relative to each of the rear corners, this differential settlement being a maximum of some 60mm.

The level distortion survey indicates No. 83 has settled relative to No. 81 and over the years this has resulted in the front left corner being nearly 300mm lower than the rear left corner. It should be noted that where there are different depths of foundation in a building, some differential foundation movement is possible. In this case No. 83 now has foundation of the order of 2.5 - 3.0 metres deep. Whereas No. 81 has its rear wall and flank wall on much shallower foundations of the order of 0.6 metres deep.

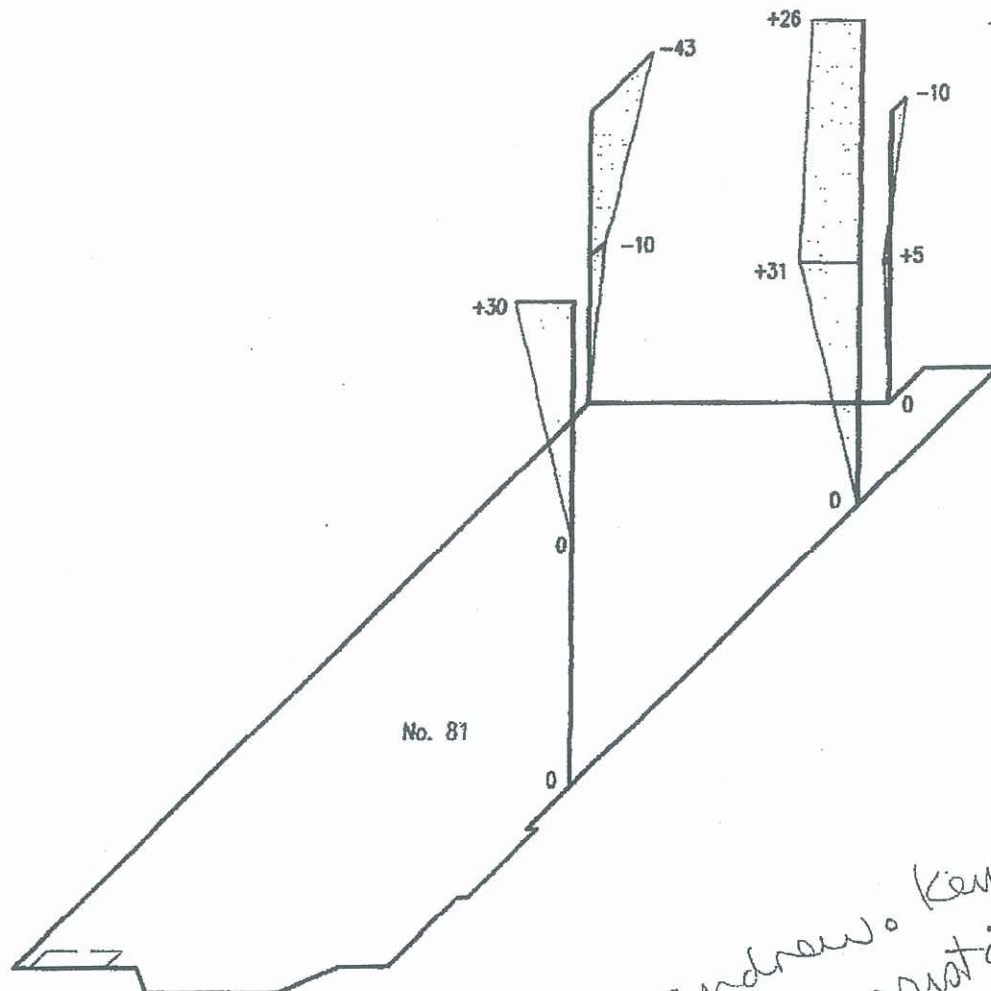
VERTICALITY SURVEY

The verticality survey shows the rear wall to be leaning outwards and the right flank wall to be leaning in. This is all consistent with the general pattern of cracking and the level distortion surveys.
