Site Details: 7 Compayne Gardens, London, NW6 3DG

Title: PUR\_7CG\_HCA\_001

Published Date: 18<sup>th</sup> August 2015

### T1 – *Crataegus monogyna* (Hawthorn) – TPO No: H3 – T41

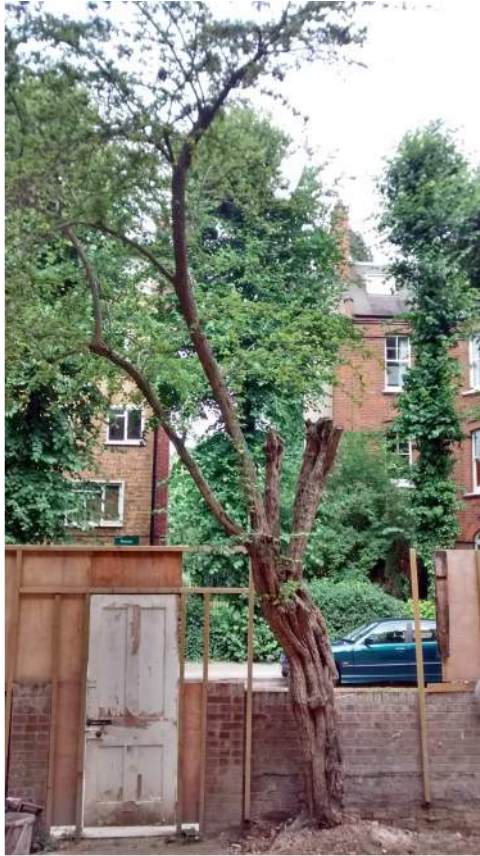
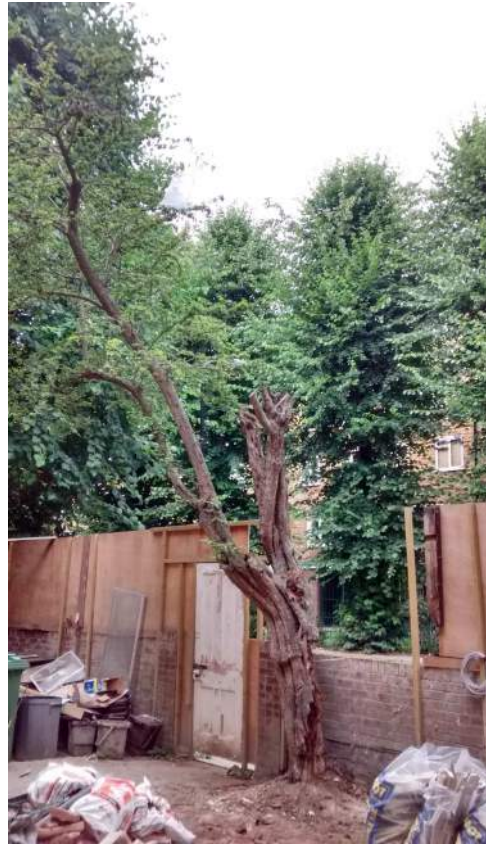
Tree No.	Species	Height (m)	Stem Diameter (mm)	Crown Spread (m)	Crown Height (m)	Age Class	Physiological Condition	Structural Condition	Comments	Recommendations	Priority
1	<i>Crataegus monogyna</i> (Hawthorn)	7	325	N – - E – - S – 3 W – 4	4	M	Fair	Poor	<p>50% of the overall crown has been lost historically. Suspected failure of a significant scaffold limb on the northeast side, due to heavy wind loading in the past, where the union point may have been structurally weak or defective. A distinctive failure point is visible at the limb/stem union (Approx 2m from stem base on the north side). At the time of failure, the limb has torn downwards, splitting the main stem and resulting in the loss of a significant amount of the stem wood tissue. The exposed heartwood on the northeast side has over time succumbed to the onset of decay which is visibly evident from the stem base to the limb failure point. Minimal wound wood is visible.</p> <p>Sounding hammer testing suggests the decay channel is extensive radially through the remaining stem and around the point of failure. Probe testing confirmed this with little or no resistance felt up to 200mm laterally into the stem. Probe testing was undertaken in three places on the stem, at 500mm, 1m and 2m from the stem base.</p> <p>Central scaffold limbs have also died back but remain, with visible evidence of boring insect infestation.</p> <p>The remaining crown is featured entirely on the south and west sides of the tree, where foliage is being produced in good amounts from the remaining branches, indicating that the cambium layer is intact and functional on this side of the tree.</p> <p>The strength of the supportive wood in the stem is however, severely compromised by the onset of the internal heartwood decay, which will worsen and subsequently increase the risk of stem failure. Particularly as the entire crown weight is on the south west side of the tree, creating a lever arm in strong winds which will exert high tensional stress loading on the weakened areas where the decay is most prevalent on the opposing northeast side of the stem.</p> <p><b>The tree is Subject to a Tree Preservation Order (TPO) and is located within the South Hampstead Conservation Area).</b></p>	<p><i>Fell tree and remove stump with a stump grinder.</i></p> <p><i>Target Assessment:</i></p> <ul style="list-style-type: none"> <li><i>Front garden (No.7),</i></li> <li><i>Public footpath and carriageway (Compayne Gardens).</i></li> </ul>	A

*T1 is located close to the front boundary of the property and in close proximity of the adjacent public footpath and carriageway (Compayne Gardens).*

*The tree is subject to a Tree Preservation Order (TPO) No: H3 – T41 and is situated within the South Hampstead Conservation Area.*

*50% of the crown structure has been lost in the past due to the failure of scaffold limbs on the northeast side of the tree. The remaining crown branches feature only on the south and west sides of the tree.*

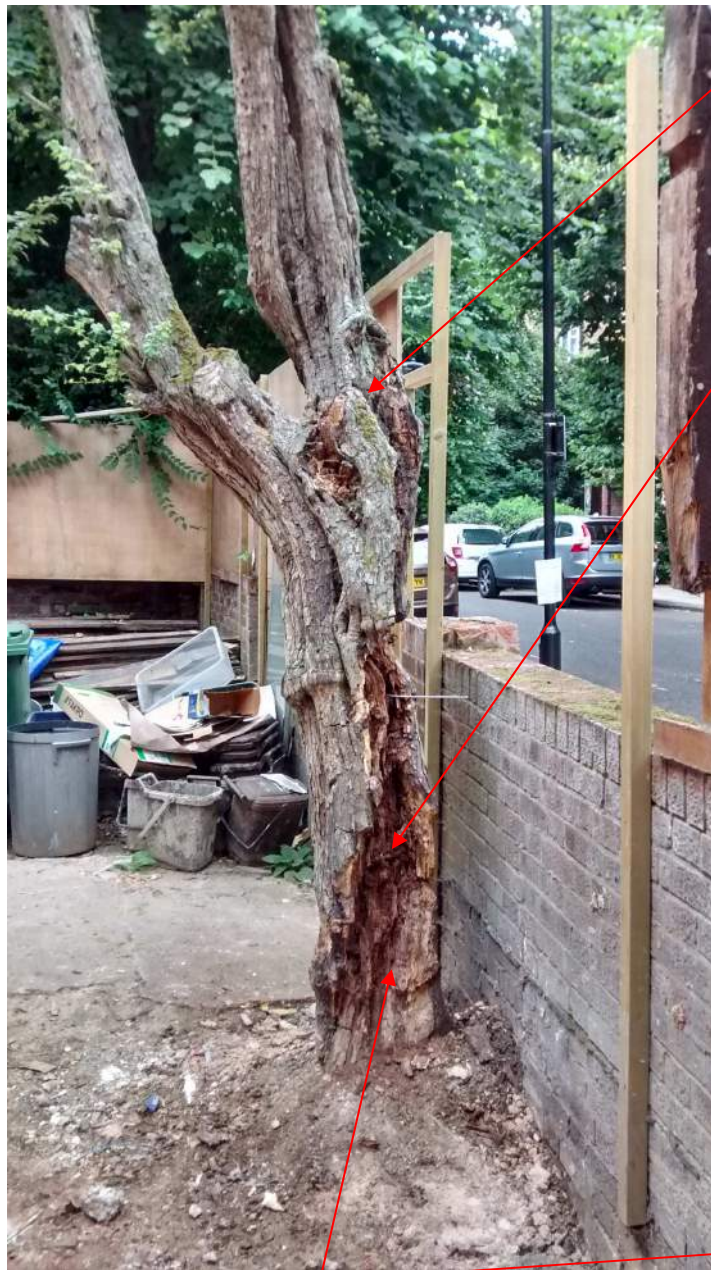
T1 – *Crataegus monogyna* (Hawthorn) – TPO No: H3 – T41

*The north side scaffold limb has been torn away from the stem at the point of union.*

*The failure of the limb has resulted in the loss of a significant amount of the wood tissue in the stem, which was torn away when the limb failed. It is suspected that the failure of the limb occurred due to excessive wind loading and a weak or defective limb/stem union.*

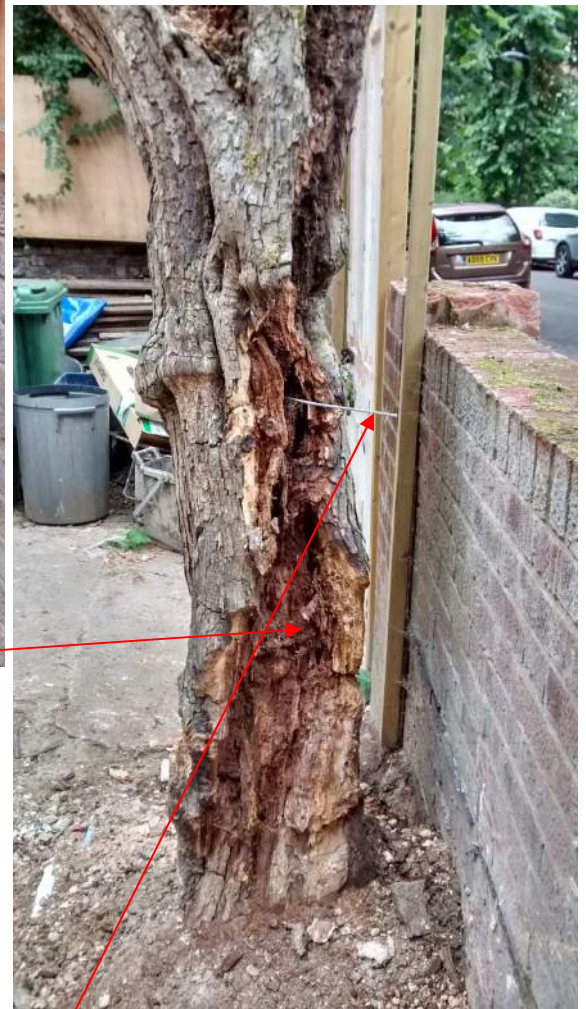
*The remaining stem exhibits significant internal heartwood decay. Sounding hammer testing suggested extensive decay channels in the stem both vertically and radially.*

*Probe testing in three separate areas felt little or no resistance to the probe to approx. 200mm laterally through the remaining stem.*

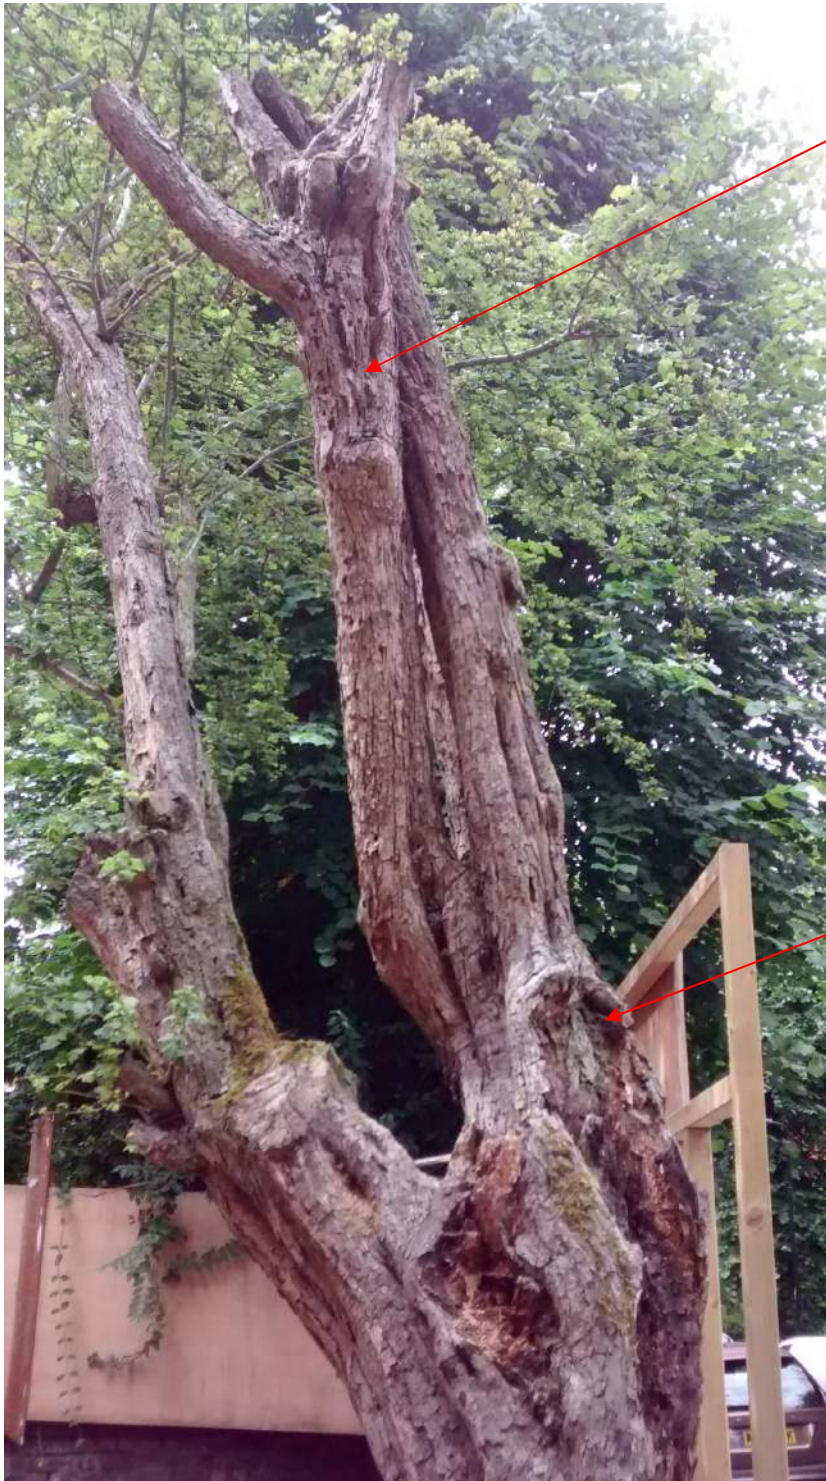
T1 – *Crataegus monogyna* (Hawthorn) – TPO No: H3 – T41

*Two central scaffold limbs have also died off but still remain.*

*Evidence of boring insect infestation is visible on the dead limbs.*

*A closer view of the stem union point, where the scaffold limb failed causing the extensive damage and the original loss of wood tissue in the main stem.*

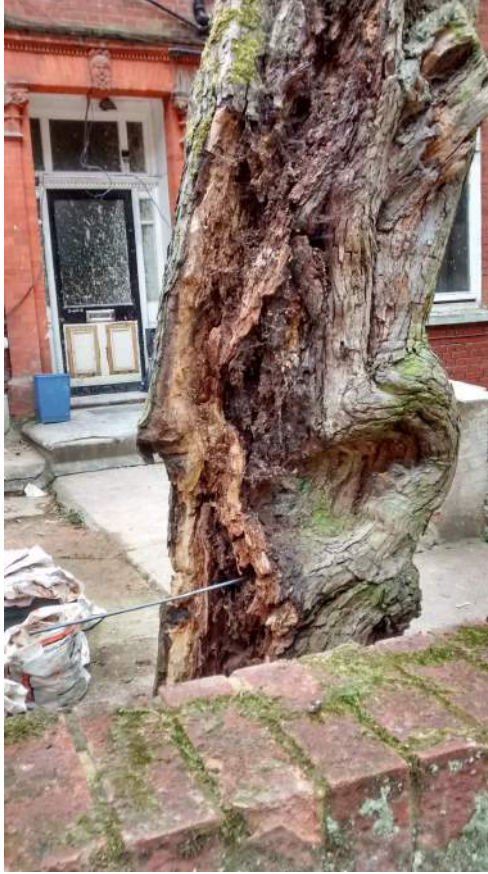
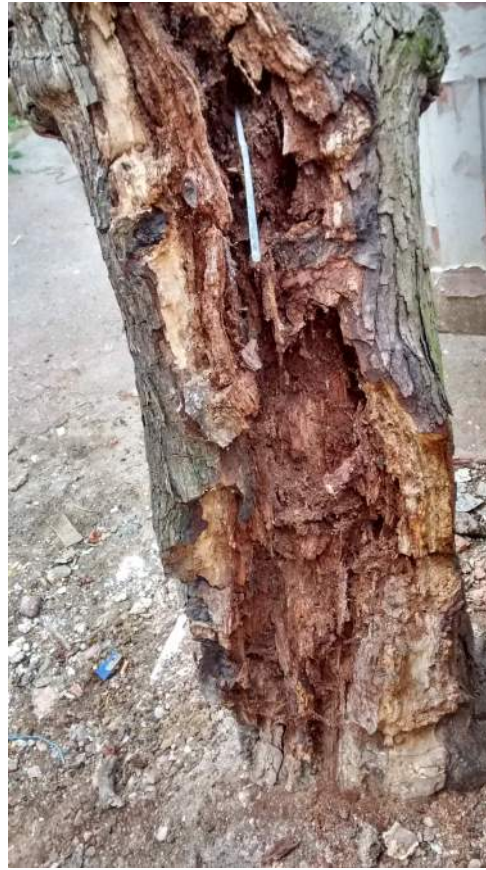
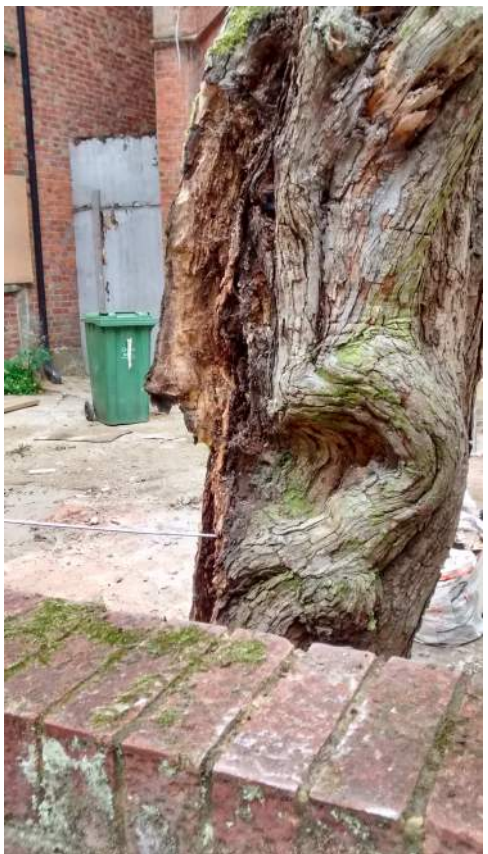
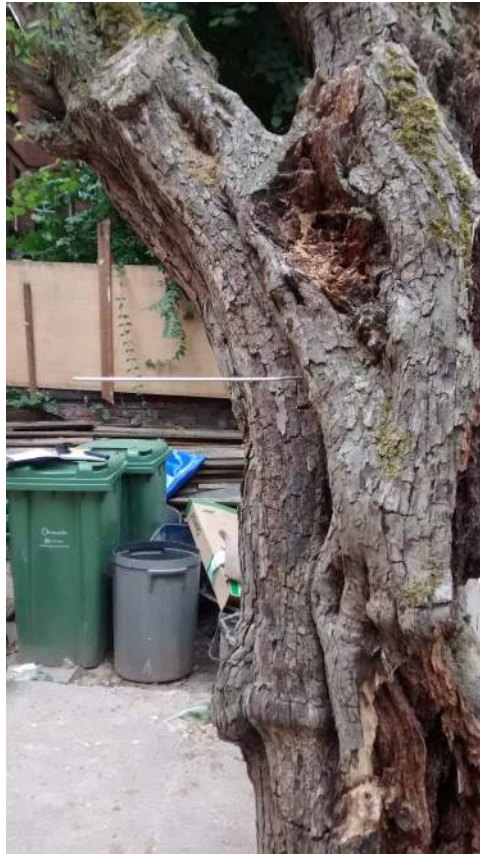
T1 – *Crataegus monogyna* (Hawthorn) – TPO No: H3 – T41

*The following photos show close up the extent of the internal heartwood decay and defects present in the stem of the tree:*

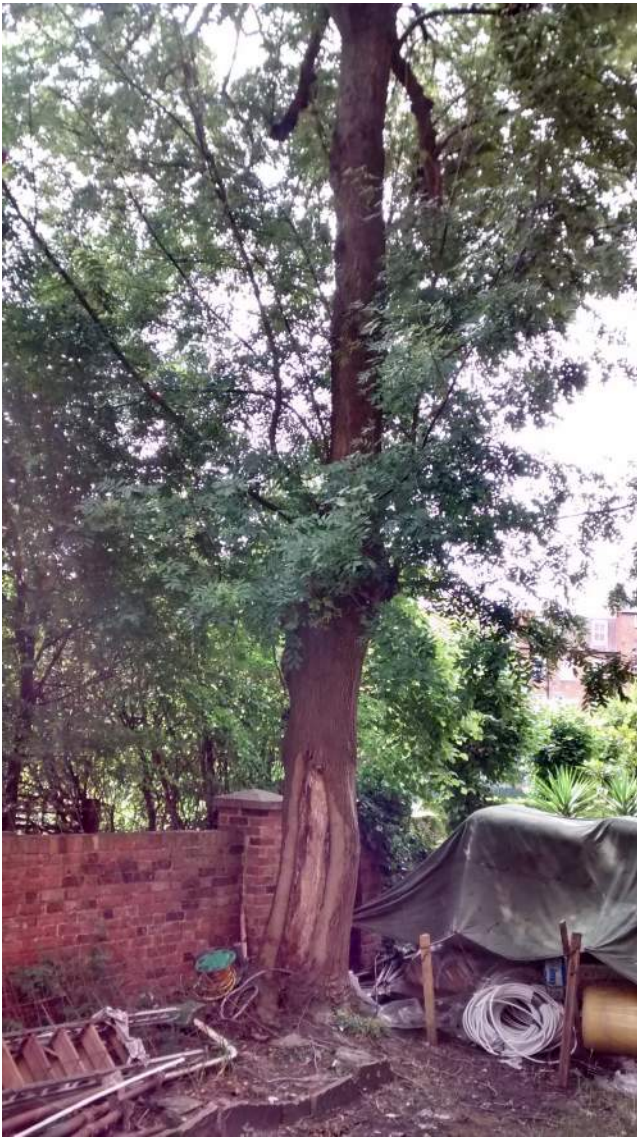
Lower Section

*T2 is located close to the southern boundary wall in the rear garden. Communal gardens feature further south beyond the boundary line.*

*The tree is not subject to a Tree Preservation Order (TPO), but is situated within the South Hampstead Conservation Area.*

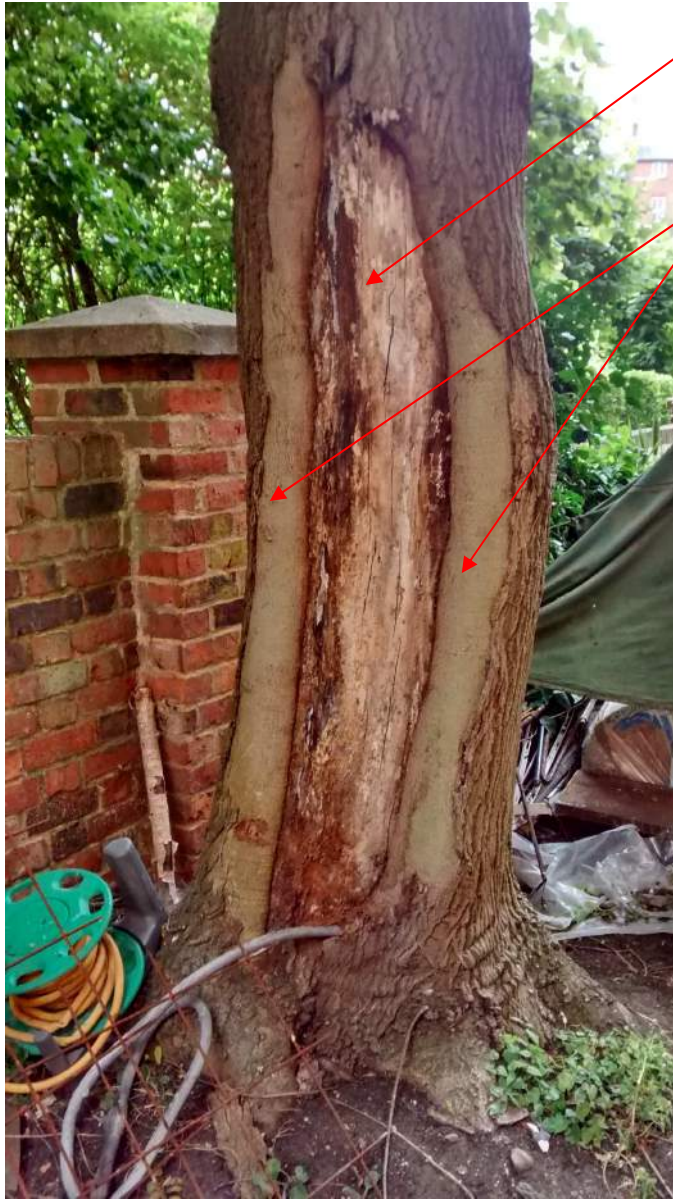
T2 – *Fraxinus excelsior* (Common Ash)

2	<i>Fraxinus excelsior</i> (Common Ash)	18	550	N – 6 E – 7 S – 7 W – 7	3	SM	Good	Fair	<p>Some minor deadwood visible in the crown. The main stem exhibits an area of missing bark on the eastern side from approx. 300m above the stem base to 2m. The area of scarring was measured to be 1.5m in length, and on average 250mm across. Good wound wood is visible around the scarred area and is occluding around the wound.</p> <p>The cause of the wound is unknown, but its appearance (including the advanced wound wood visible) suggests the wound occurred when the tree was much younger.</p> <p>Sounding hammer testing of the exposed heartwood and around the wound suggests a solid and intact stem. No decayed wood is visible. Due to the lack of protection that bark provides, the exposed heartwood will be more susceptible to pathogen attack and decay.</p> <p>The crown spread of the tree is significant on all directions, with northern spreading branches coming into direct contact with the building, roof and guttering.</p> <p><b>The tree is located within the South Hampstead Conservation Area.</b></p>	Crown reduction of up to 30%, removal of all hazardous deadwood.	A

Historically, the tree has suffered damage on the eastern side of the main stem, resulting in the loss of a significant amount of the protective bark covering.

The appearance suggests it is an old wound due to the amount of wound wood visible, as the tree attempts to occlude over the exposed heartwood.

Sounding hammer testing suggested that the heartwood is solid and intact.

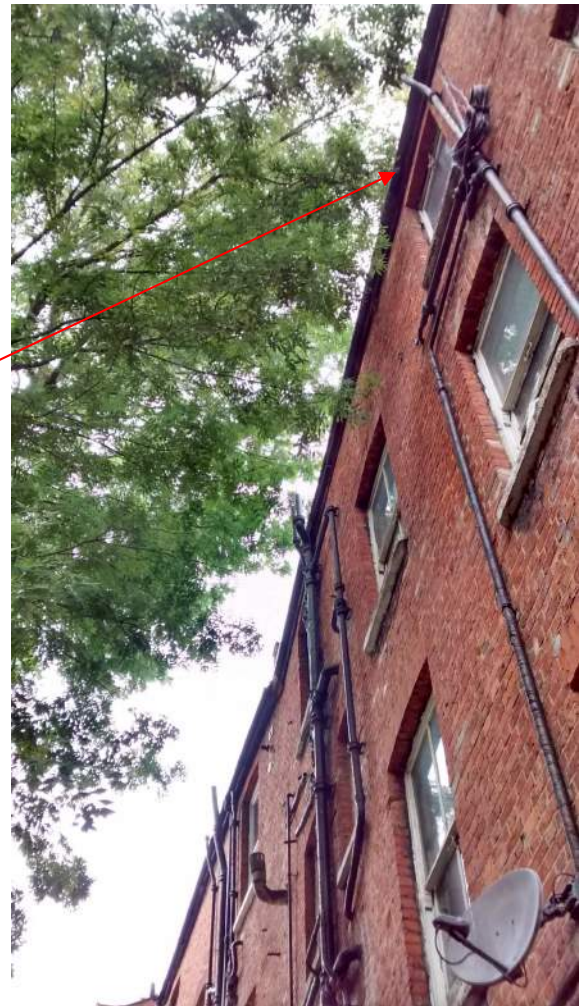
The crown spread of the tree is extensive and the northern spreading branches are in direct contact with the building, roof and guttering.
