TREE SURVEY, ARBORICULTURAL
IMPLICATION ASSESSMENT &
METHOD STATEMENT &
TREE PROTECTION PLAN
BS5837:2012

Title:	Arboricultural Report
Instructed by:	Felix Xylander 25 Hatton Garden London EC1N 8BQ
Site Address:	Christchurch Primary School Christchurch Hill London
Date of Site Visit:	Wednesday 13 th August 2014
Prepared by:	Reuben Hayes
Ref:	PA.S
Date

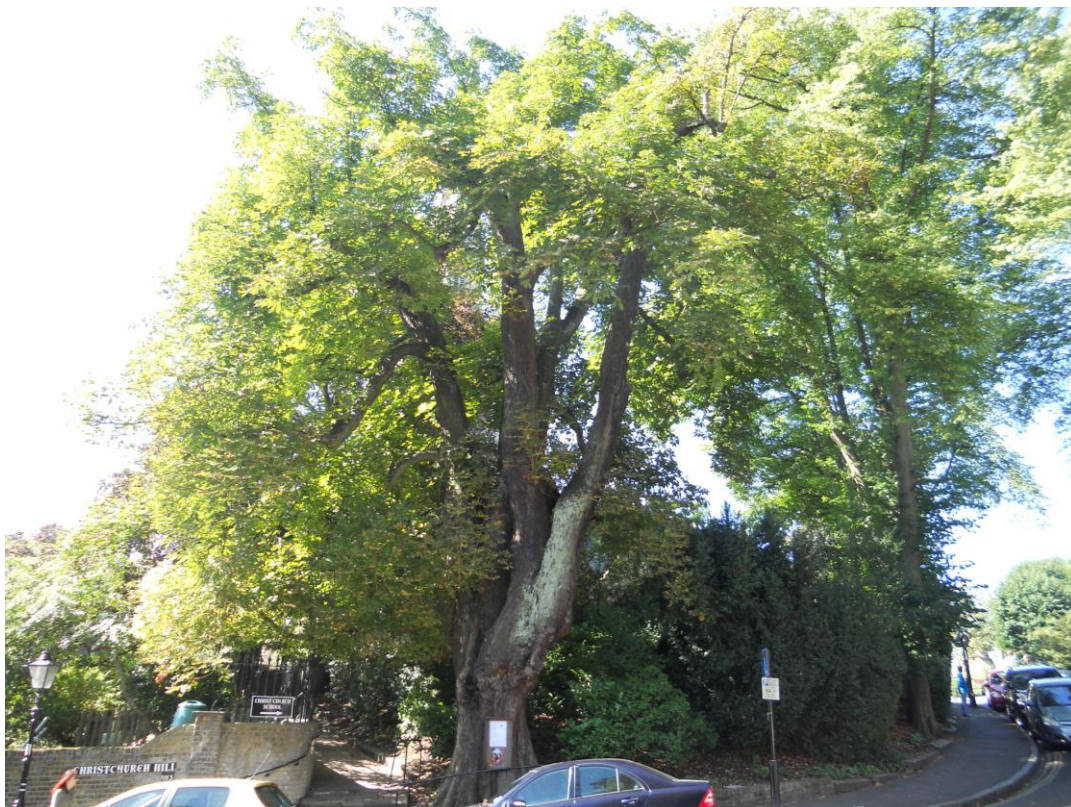
- 6.12. The significant trees on or near to the site are the Horse Chestnut tree, Beech tree and the Sycamore tree.
- 6.13. The Horse chestnut (T1) has high visually amenity value. The itself has a ganoderma spp fungus bracket on the main stem, this is an external sign that decay and rot is occurring on the inside. The tree has also been topped at some point in the recent past (within 10 years), and although new growth is forming, this will be of a weaker attachment.

Horse Chestnut tree (T1)

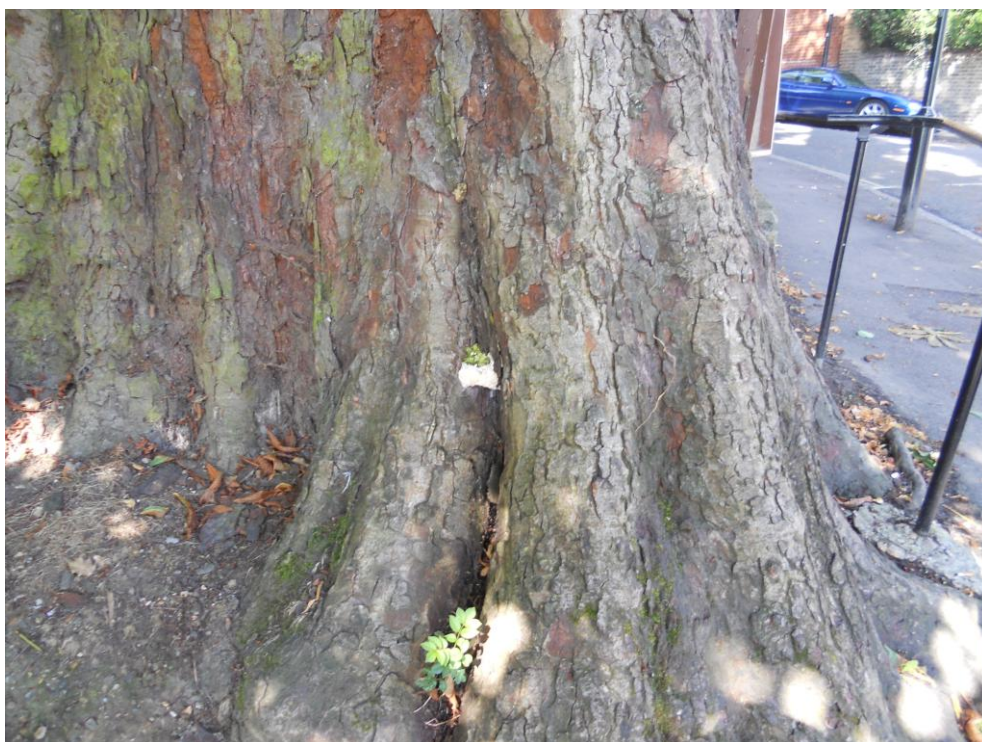
Ganoderma on Horse chestnut tree (T1)
