ARBORICULTURAL ASSESSMENT REPORT

For:	Client:	Oriel Services Limited
	Insurer:	
Site:	Policyholder:	
	Risk Address:	57 Aberdare Gardens, London, NW6 3AL
Refs:	OCA Ref:	58215
	Client Ref:	7885746
	Insurer Ref:

Report By:	James Allnutt		
Title:	Arborist	Date:	31 March 2015

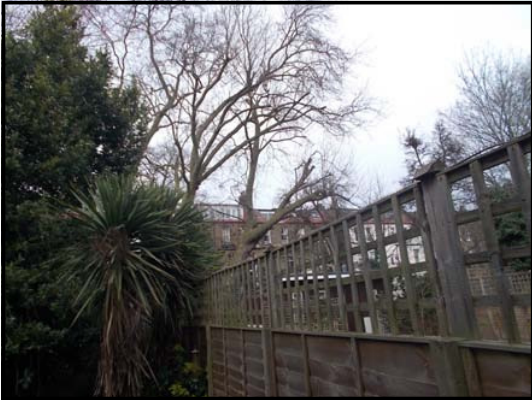
Roots have been recovered from TP1 and have been formally identified as *Platanus*. Given the size, species, and proximity to the location of the trial pit/borehole we consider that these roots have emanated from London Planes T1, T2, & T9.

1. T1 right, T2 left behind the policyholder's garden.

Tree No:	Species	Works Required
T1	London Plane	Fell as close to ground level as practicable and treat stump
T2	London Plane	Fell as close to ground level as practicable and treat stump
T3	Willow	Fell as close to ground level as practicable and treat stump
T4	Willow	Fell as close to ground level as practicable and treat stump
T8	Laurel	Fell as close to ground level as practicable and treat stump
T9	London Plane	Fell as close to ground level as practicable and treat stump

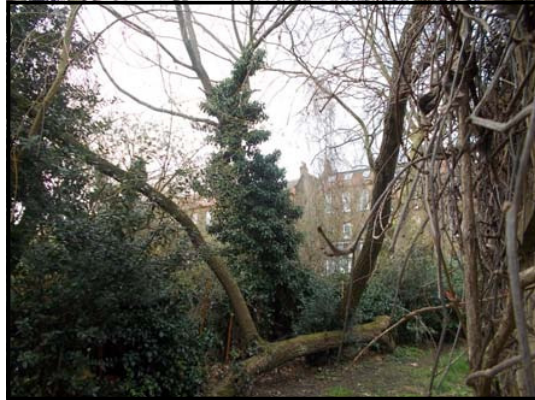
No roots relating to Willow or Laurel were recovered during investigations. However, given its size and proximity to the insured property we consider that it is likely that roots from Willows T3 & T4 as well as Laurel T8 have also extended beneath the depth of foundations.

2. T3 stem laying horizontally with T4 showing Ivy on stem.

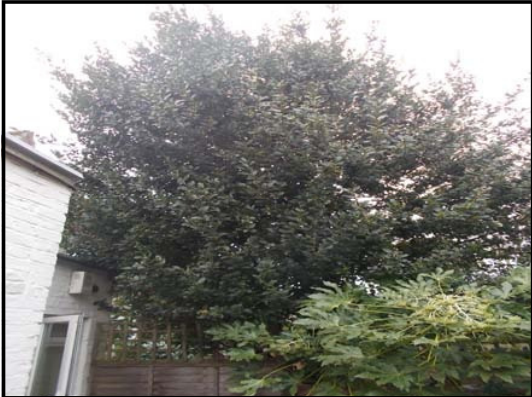
3. View showing T8.

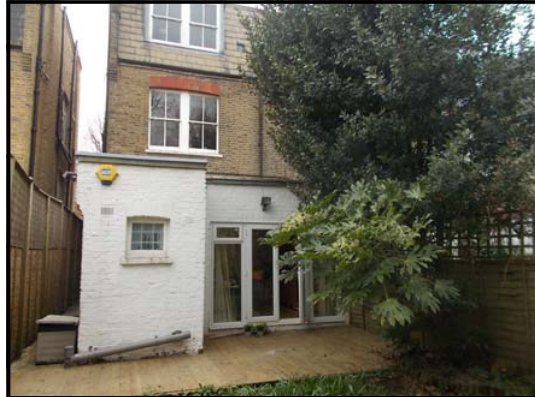
4. Rear of the property showing S1 and T8.

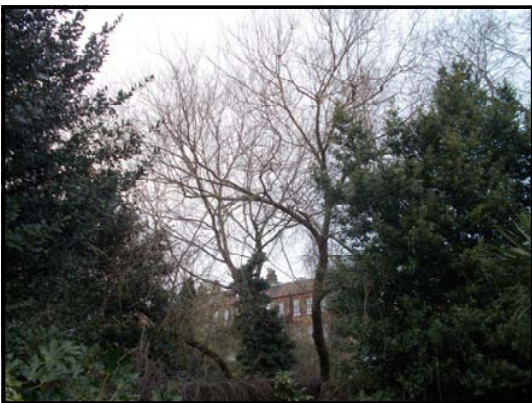
5. T4 left of centre and T3 right of centre.
