## SITE INVESTIGATION FACTUAL REPORT

Report No: 246035  
Client: Cunningham Lindsey - Maidstone  
Site: 57, Aberdare Gardens  
London  
Client Ref: 7851572-  
Date of Visit: 13/01/2015

# Investigation Layout Plan

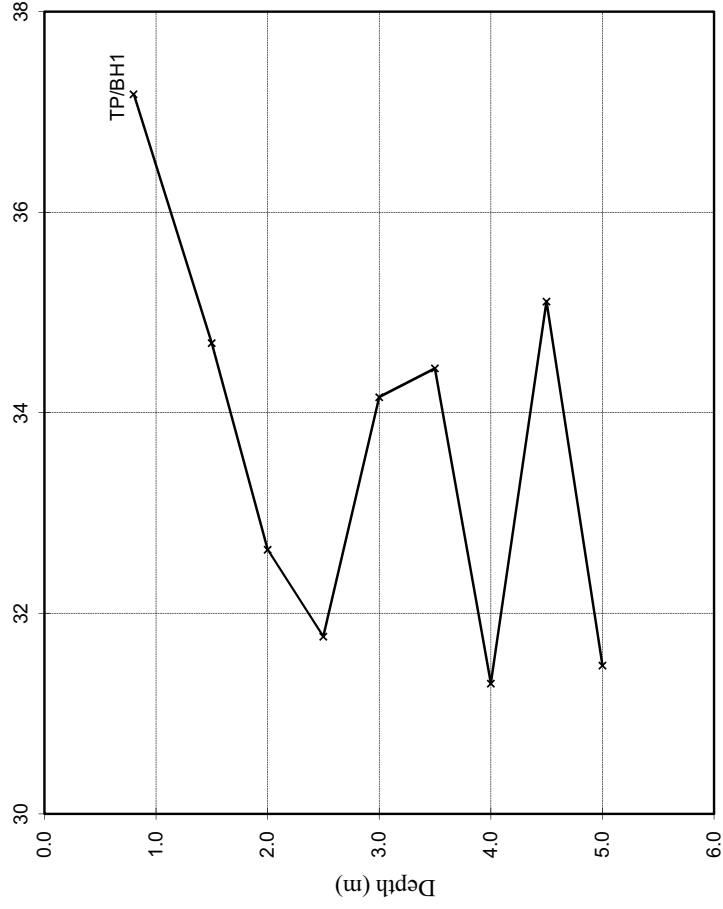
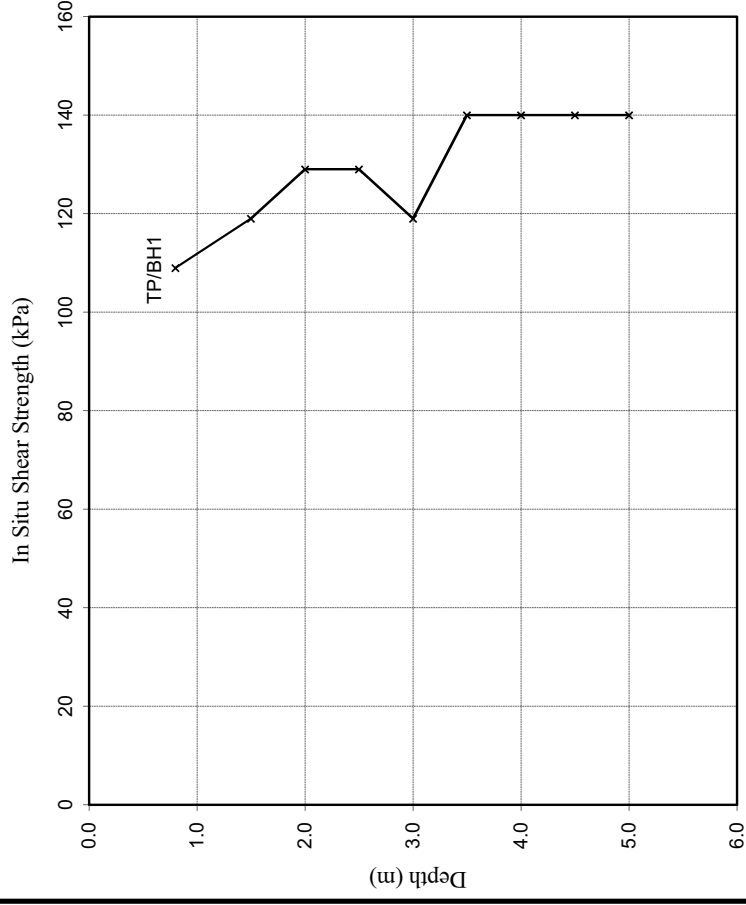
# Moisture Content and Shear Strength Profiles

Unless otherwise stated, values of Shear Strength were determined in situ by CET using a Pilcon Hand Vane the calibration of which is limited to a maximum reading of 140 kPa.
