1 - 42 Ashdown Crescent
Pages 20 - 24

146 - 152 Weedington Road

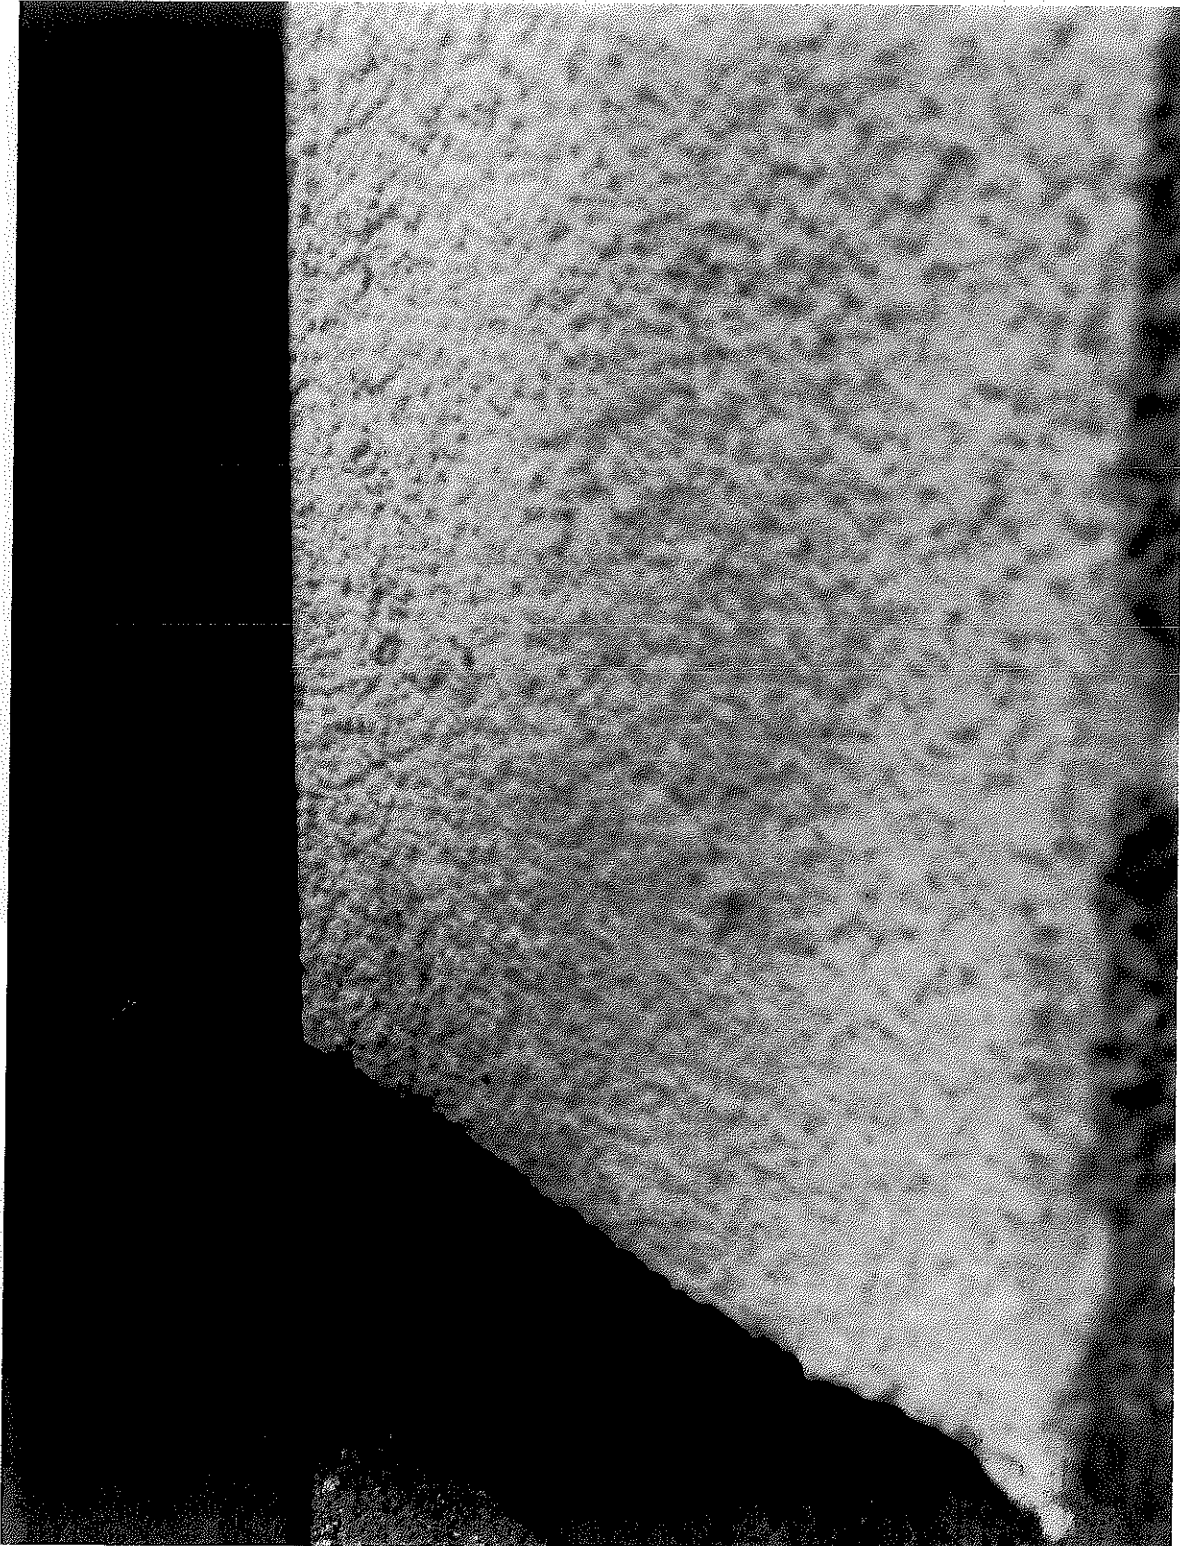
PHOTO 1: → RECENT METAL FABRICATION ON SITE HAS LEFT A SLIGHT STAIN. AS PART OF OUR DE-SNAGGING AND QMS THAT THIS WILL BE CLEANED WITH A 80 PSI PRESSURE WASH.

Plasterwork behind metal (aluminium?) fixture by entrance shows discolouration – rust marks?

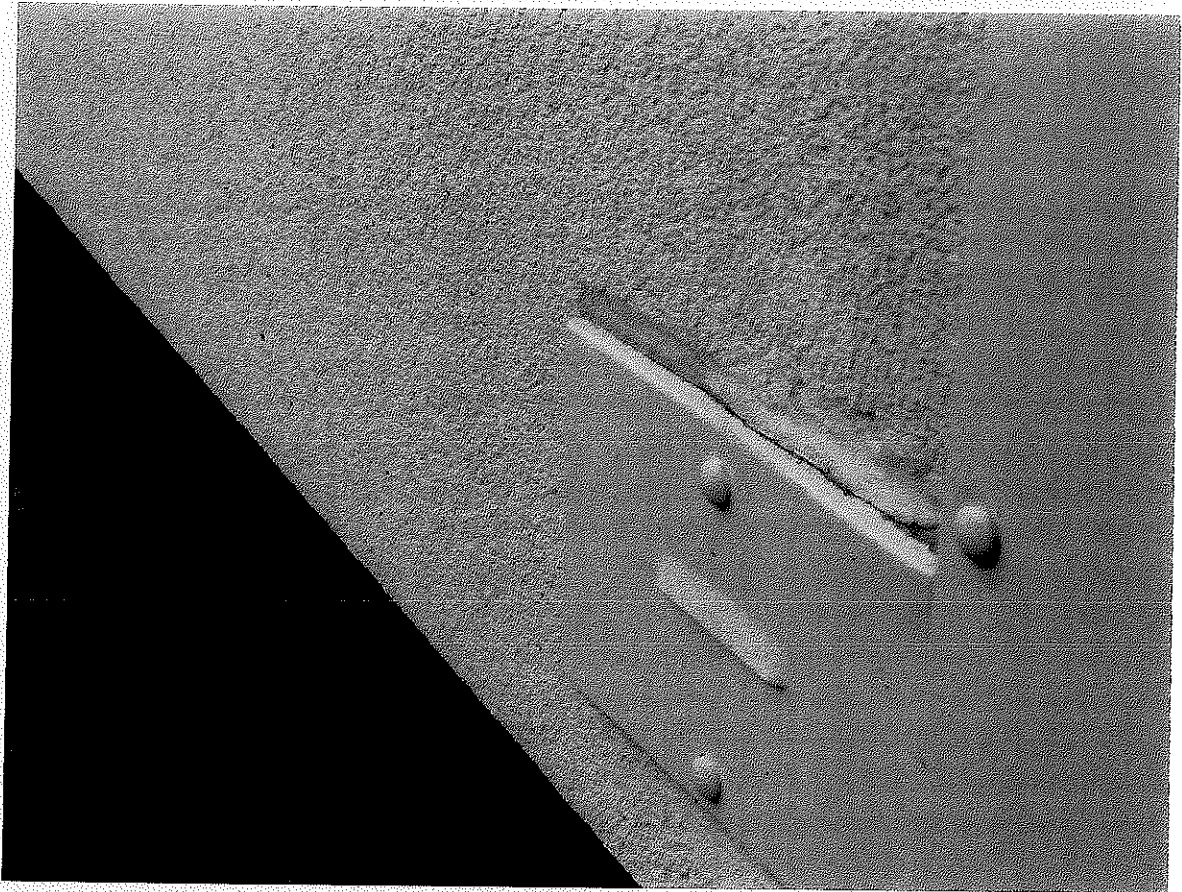
PHOTO 2

Area around fixture at front of building is badly filled and painted which could allow moisture to enter the building.

THIS AREA IS IDENTIFIED AS PART
OF OUR DE-SNAGGING AND IS BOOKED
IN FOR REPAIR ON 16TH SEPT 2015

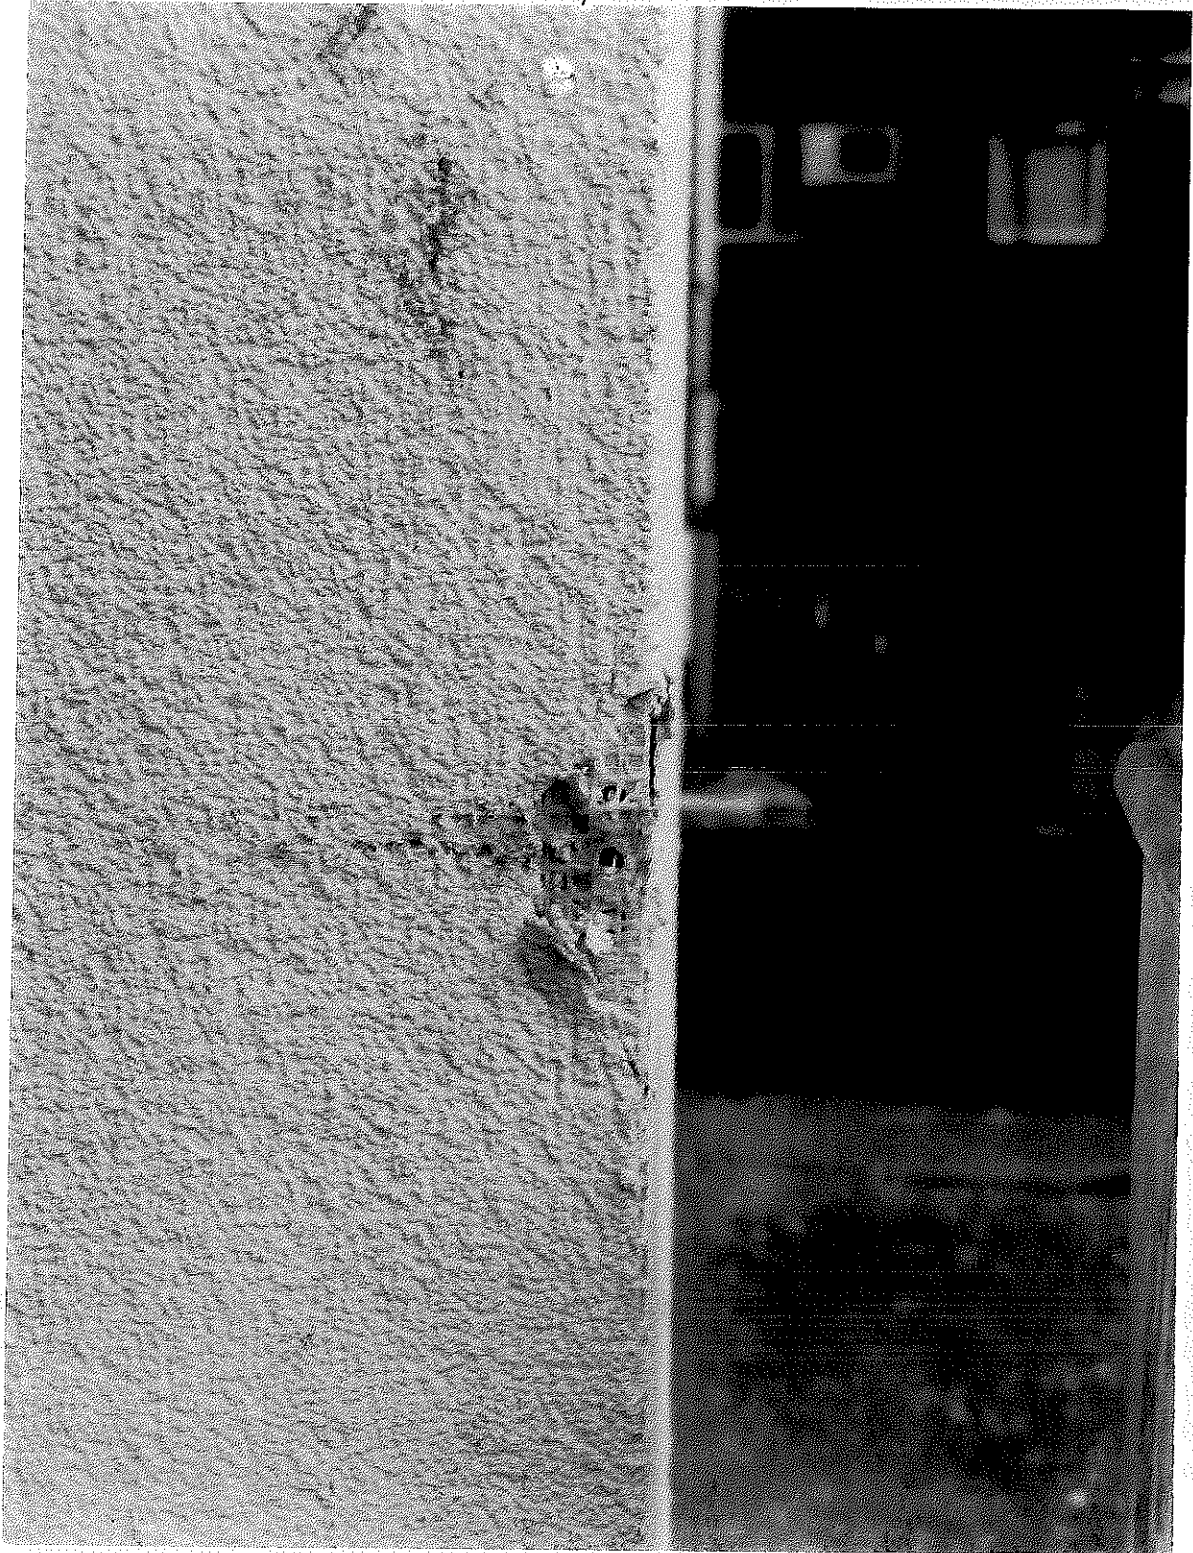
PHOTO 3B.

Broken plaster and stains by communal bin area.

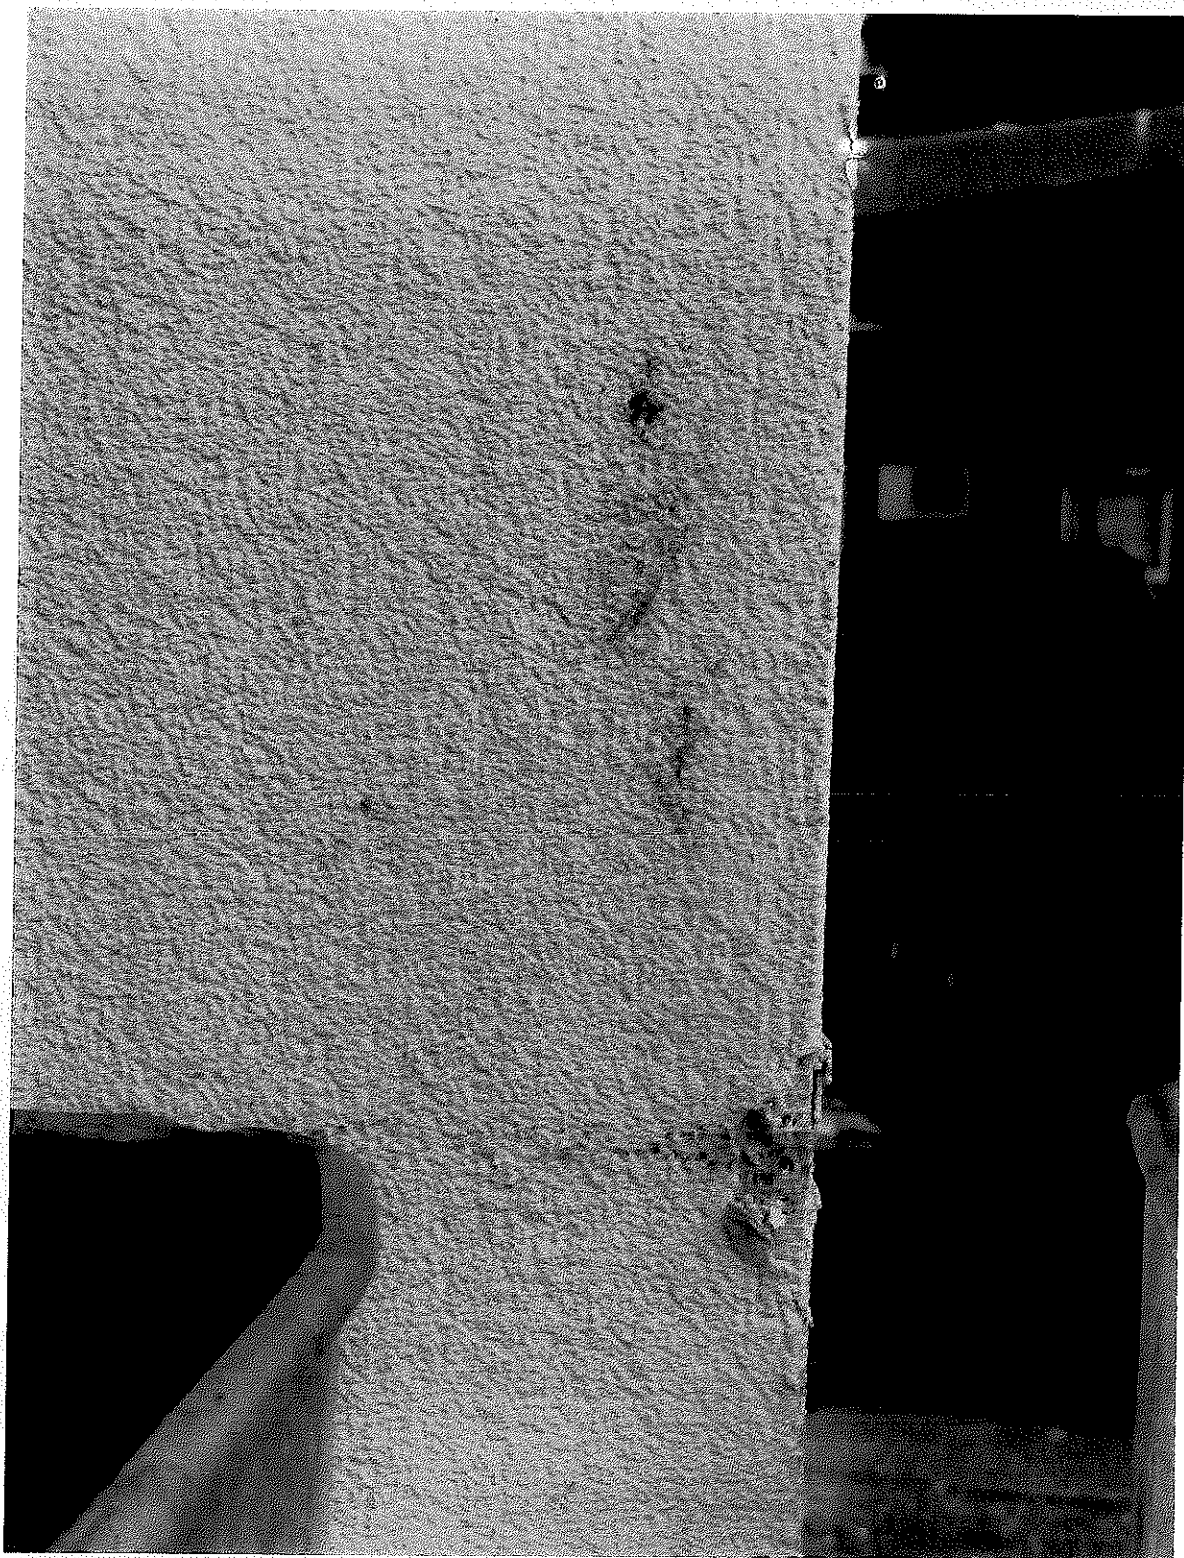
PHOTO 3A.

Broken plaster and stains by communal bin area.

THIS AREA HAS BEEN IDENTIFIED AS PART OF THE DE SNAGGING PROGRAM. WORKS HERE²⁸ ARE NOT COMPLETE AND WE HAD REQUESTED THAT THIS AREA IS UN-USED UNTIL THE ON SITE PROJECT IS IN PLACE

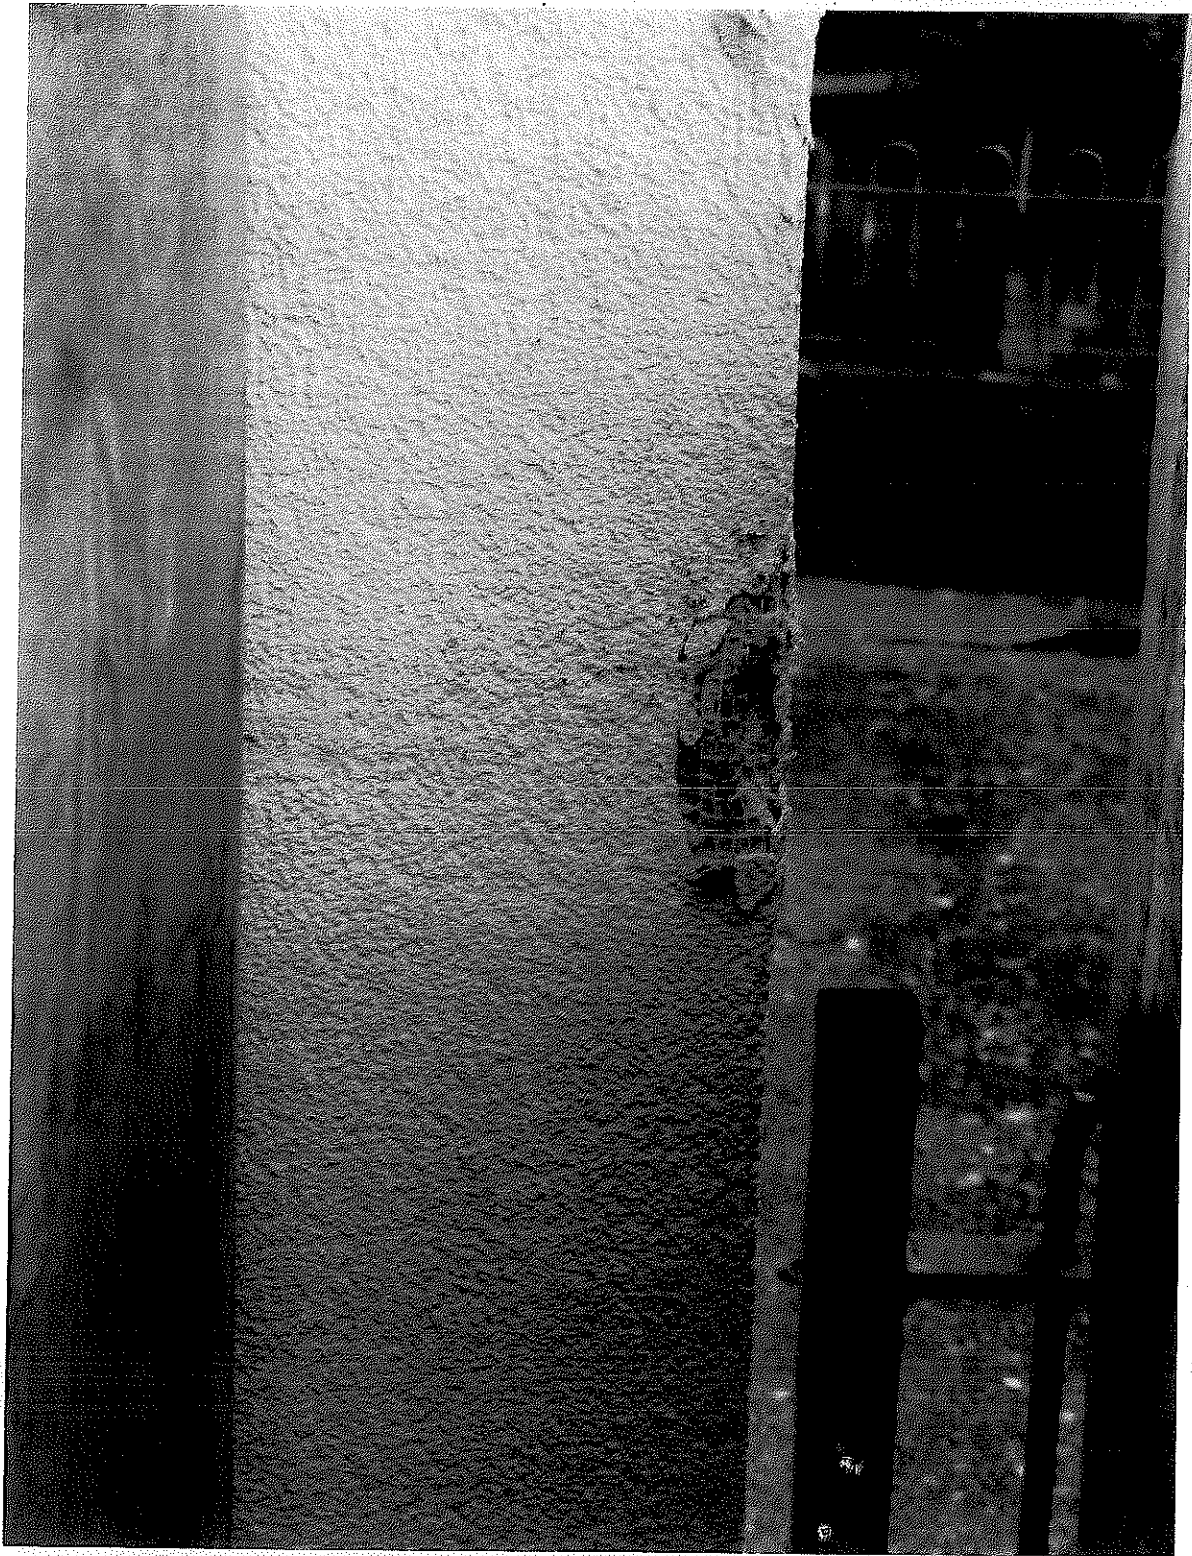
PHOTO 5

Broken plaster by communal bin area.

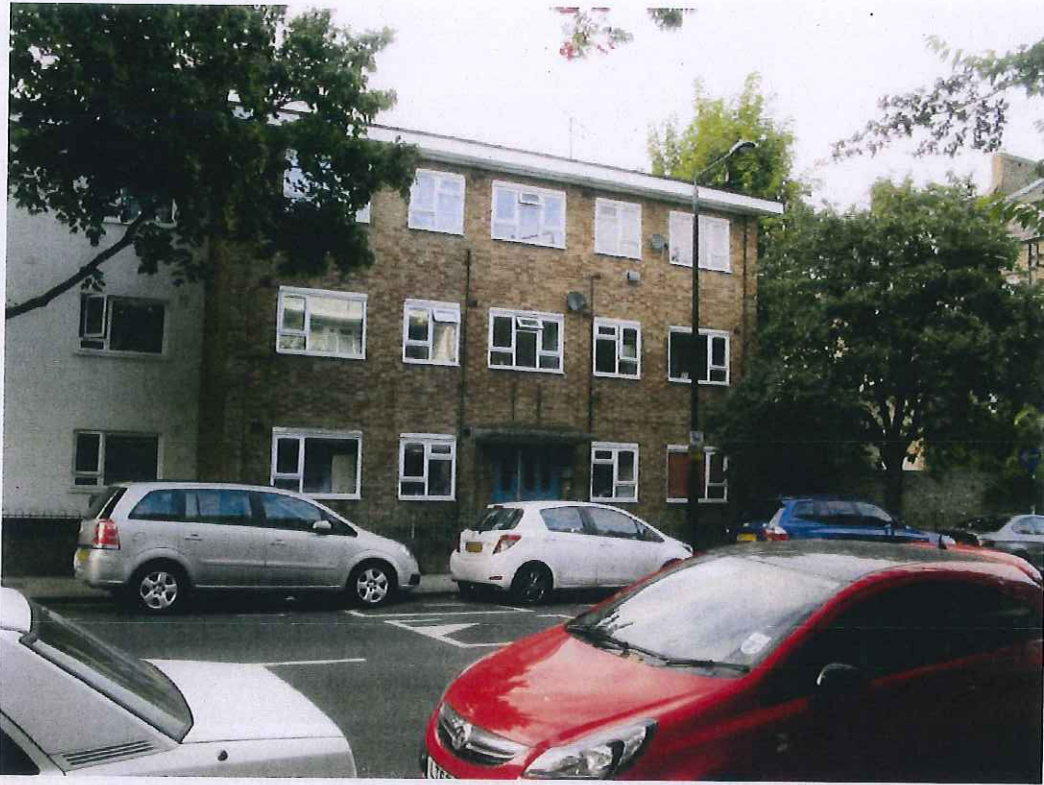
PHOTO 4A

Plender Court, bricked part of the building, which doesn't appear to have been clad.

WAS NOT EWI AS IT IS A FREEHOLD. FOLLOWING THE WORKS AT THE FREEHOLD MANAGEMENT OF PLENDER HAVE SOURCED FUNDING AND HAVE APPLIED FOR AND HAD PLANNING APPROVED FOR THE INSTALLATION OF EWI.

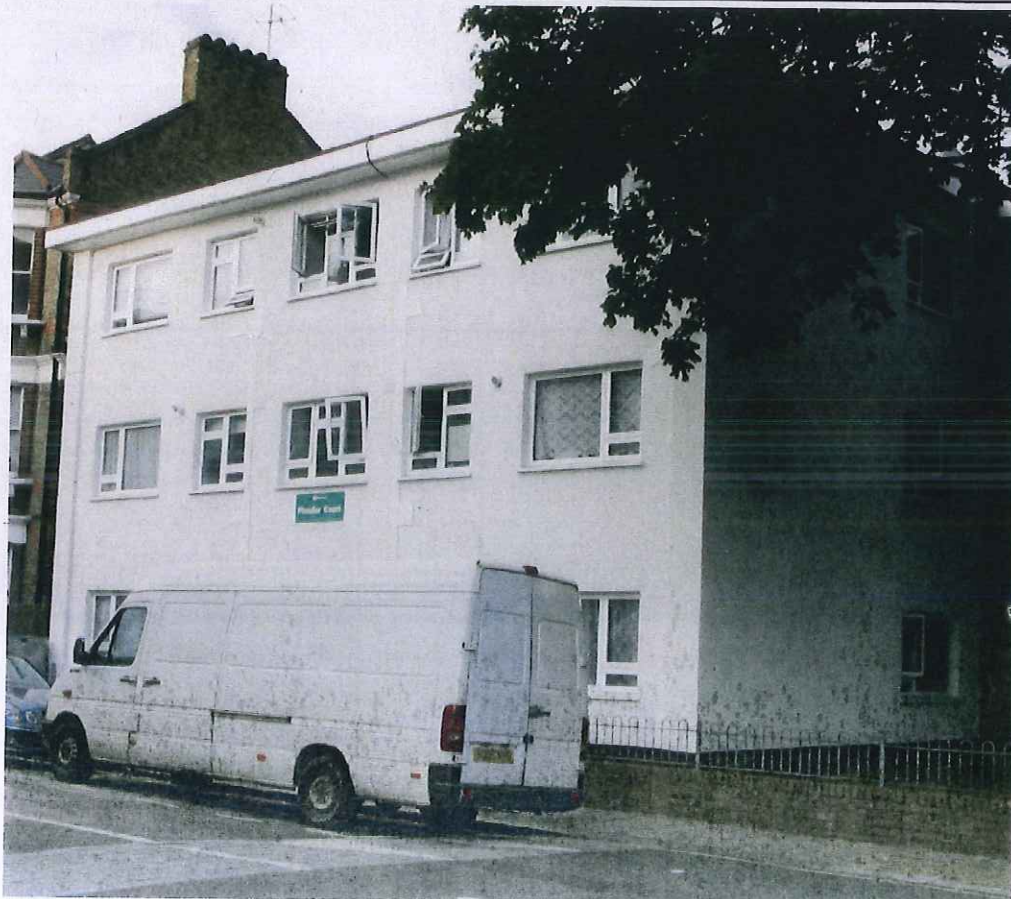
PHOTO 4B → AS PHOTO 4A.

Plender Court, rendered part of the building, which has been clad.

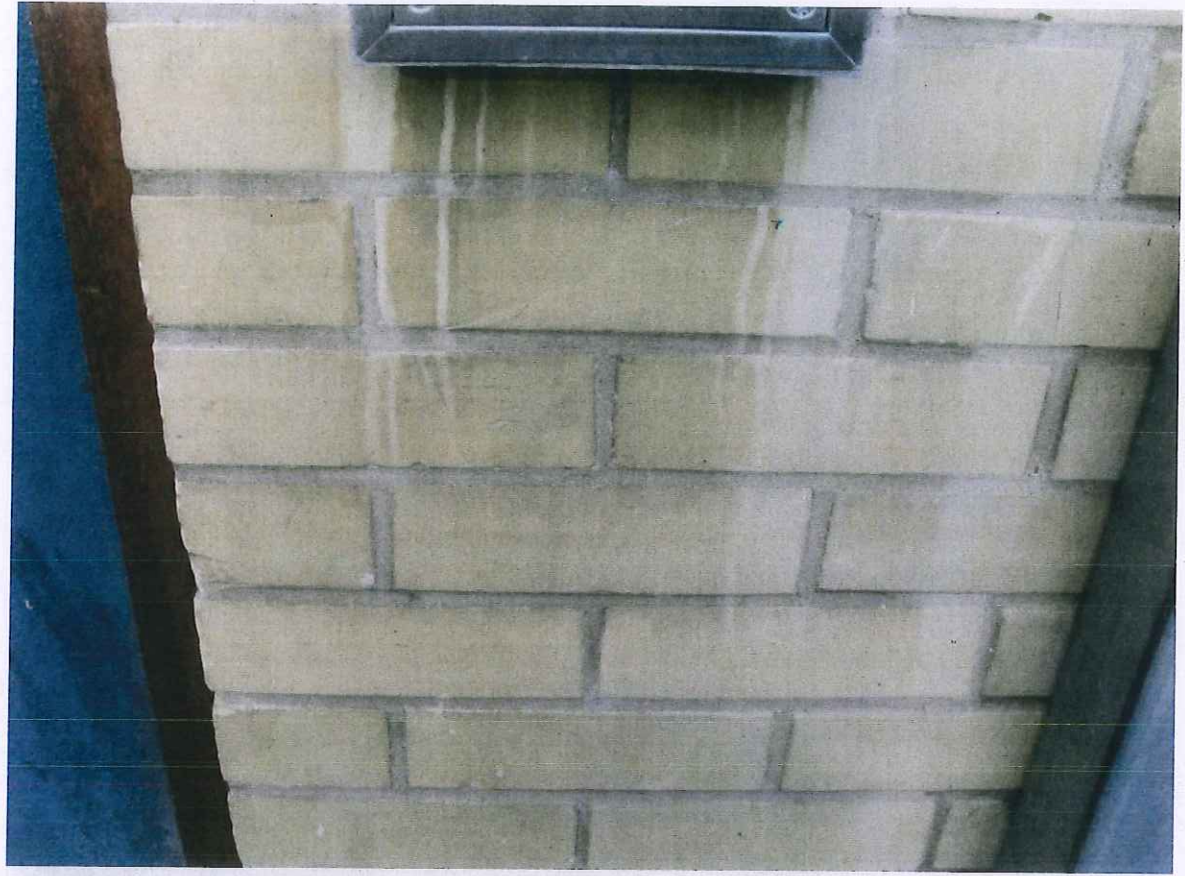
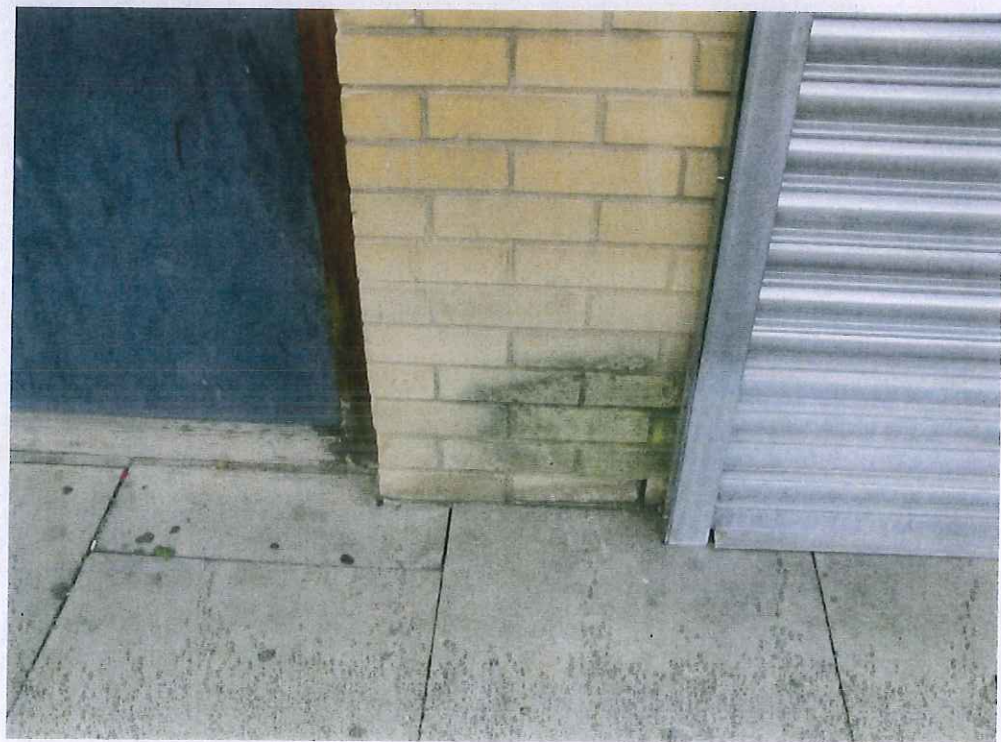
PHOTO 6.

Details of area by entrance hall. Walls are stained. Unclear if these walls have been recently clad or if they have been done previously and not upgraded when recent cladding has been done.

THESE WALLS ARE ORIGINAL MASONRY SUBSTRATES. AS THESE AREAS ARE NON HABITABLE AND UN-HEATED, INSULATING THESE AREAS WOULD REDUNDANT! THESE PICTURES CLEARLY SHOW THAT EVEN BRICK BUILDING CANNOT WITH STAND STAINING.

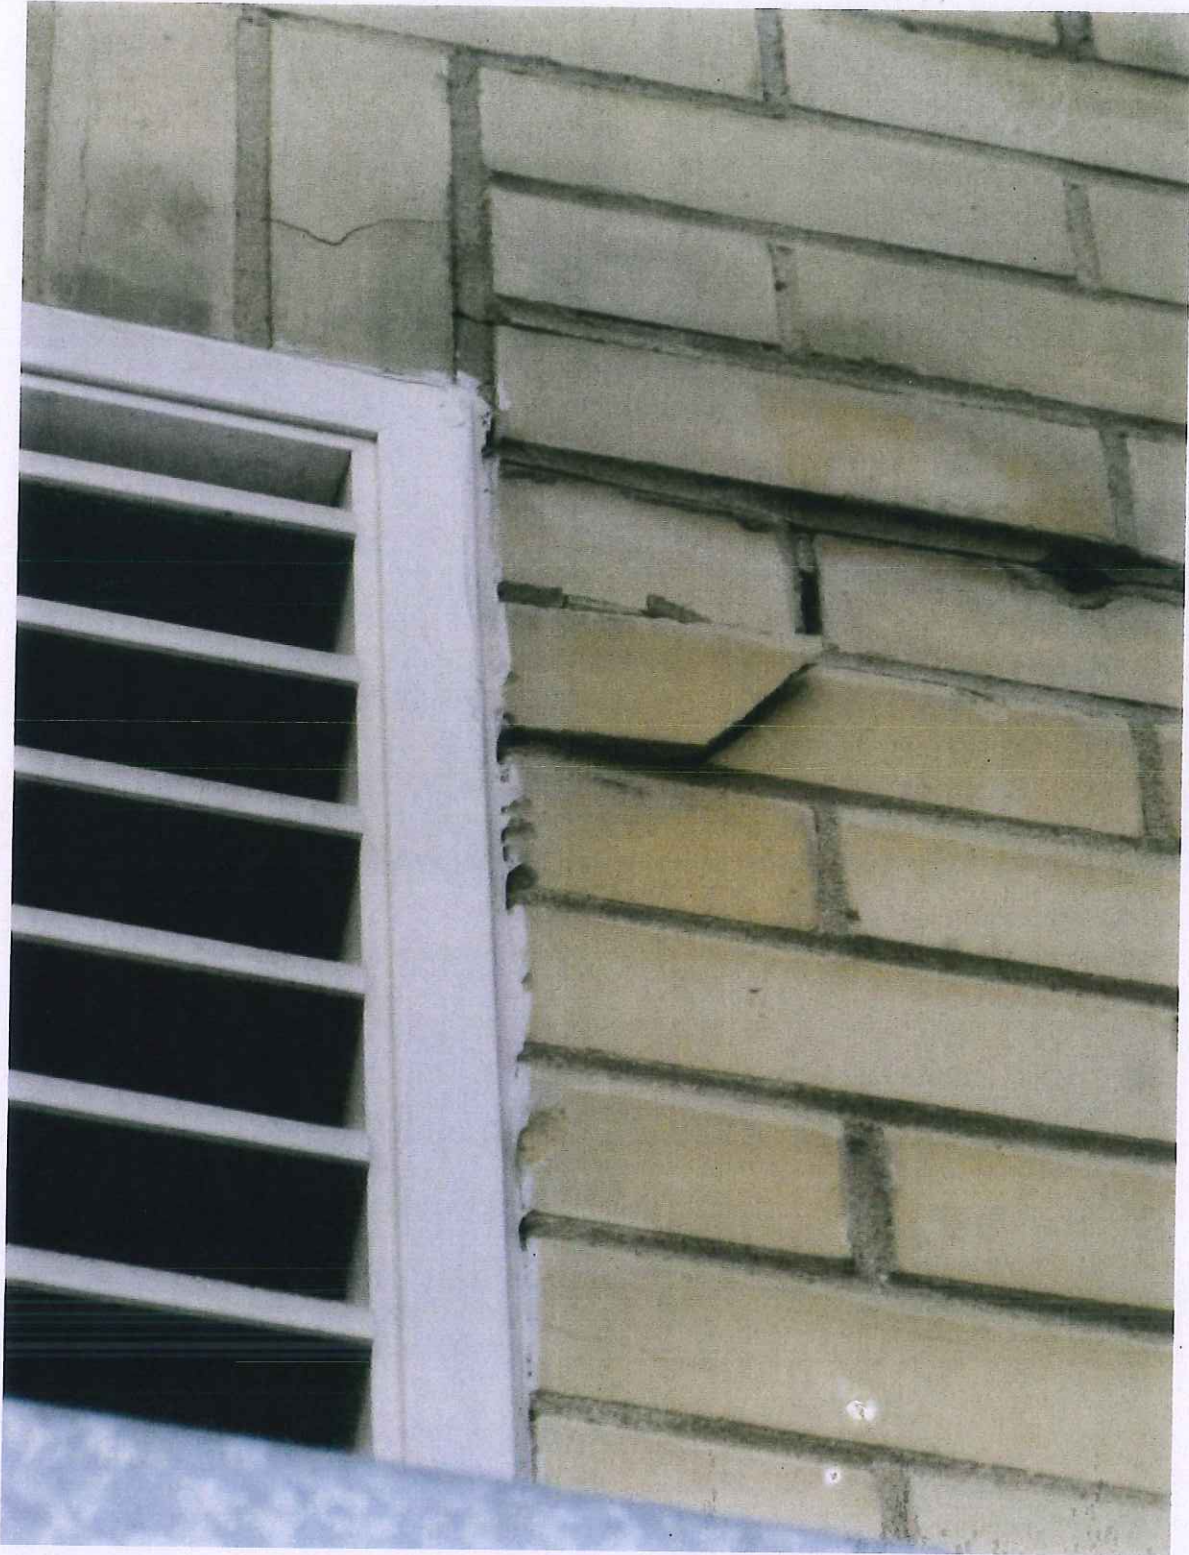
PHOTO 9.

Detail of wall above front entrance. Not sure what this wall is made of or if done alongside recent works. Cracks in brickwork, top layer (of cladding?) coming away in parts, pointing missing in places. From a design point of view, it does not sit well with new plastering which has been carried out beyond entrance hall.

THIS IS A REPAIR ISSUE AND THIS AREA HAS NOT BEEN PART OF THE EXTERNAL WORKS.

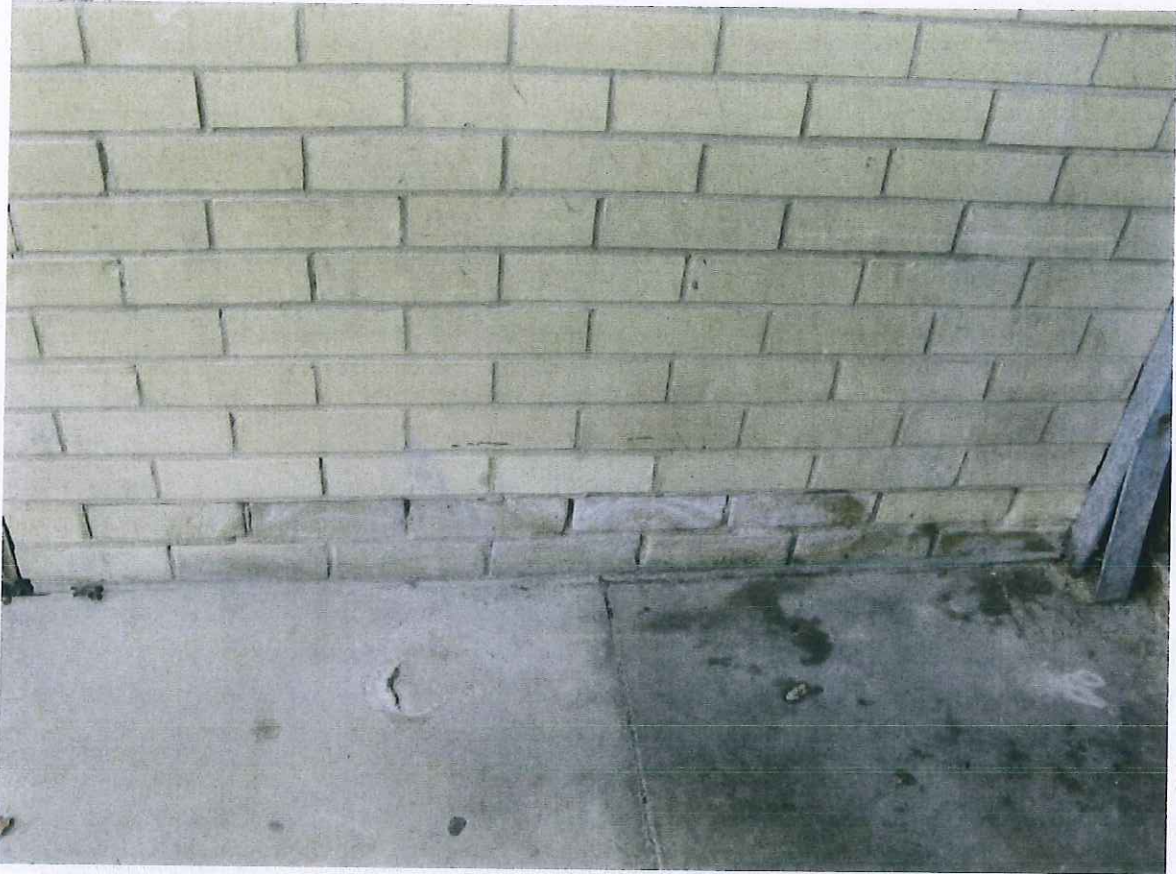
PHOTO 10

Details of wall to left of entrance hall. The top layer of the wall has come away at the bottom of the wall. Unclear if these walls have been recently clad or if they have been done previously and not upgraded when recent cladding has been done.

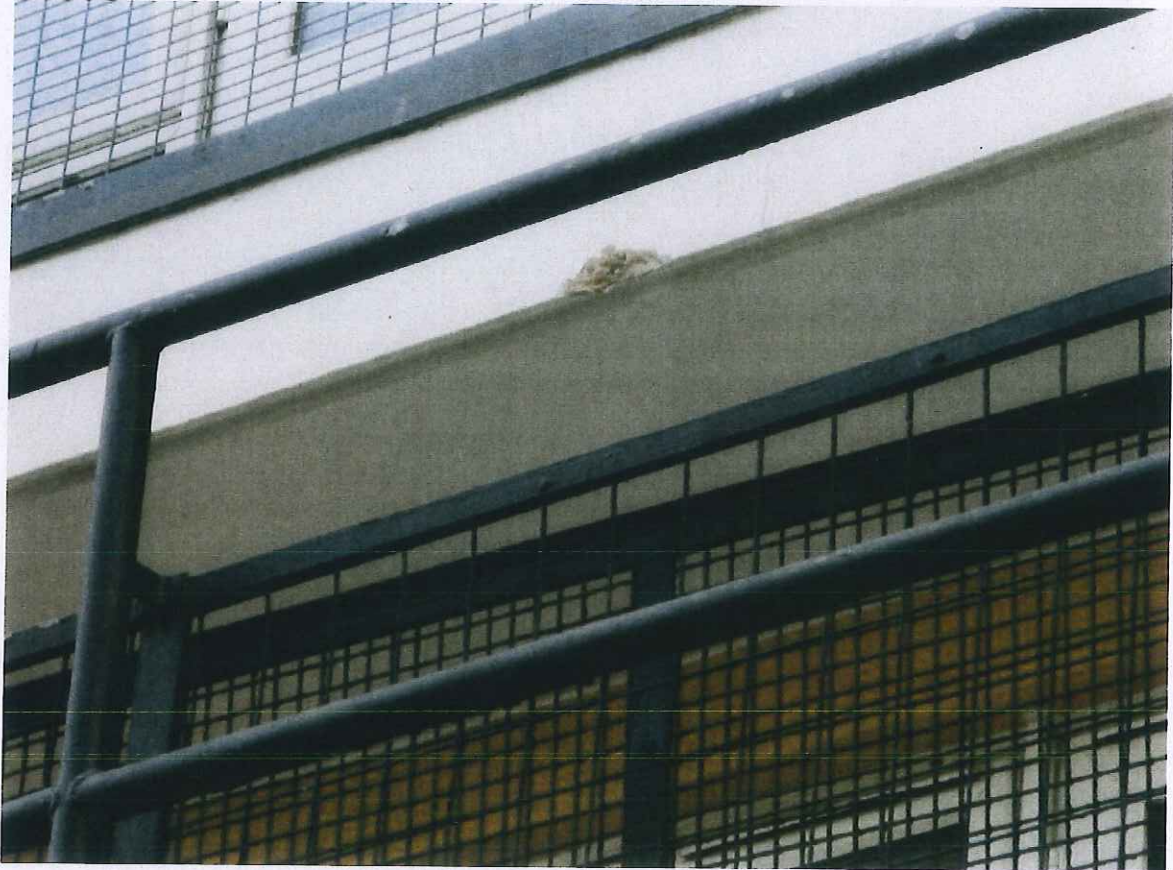
PHOTO 13.

Already showing signs of deterioration.

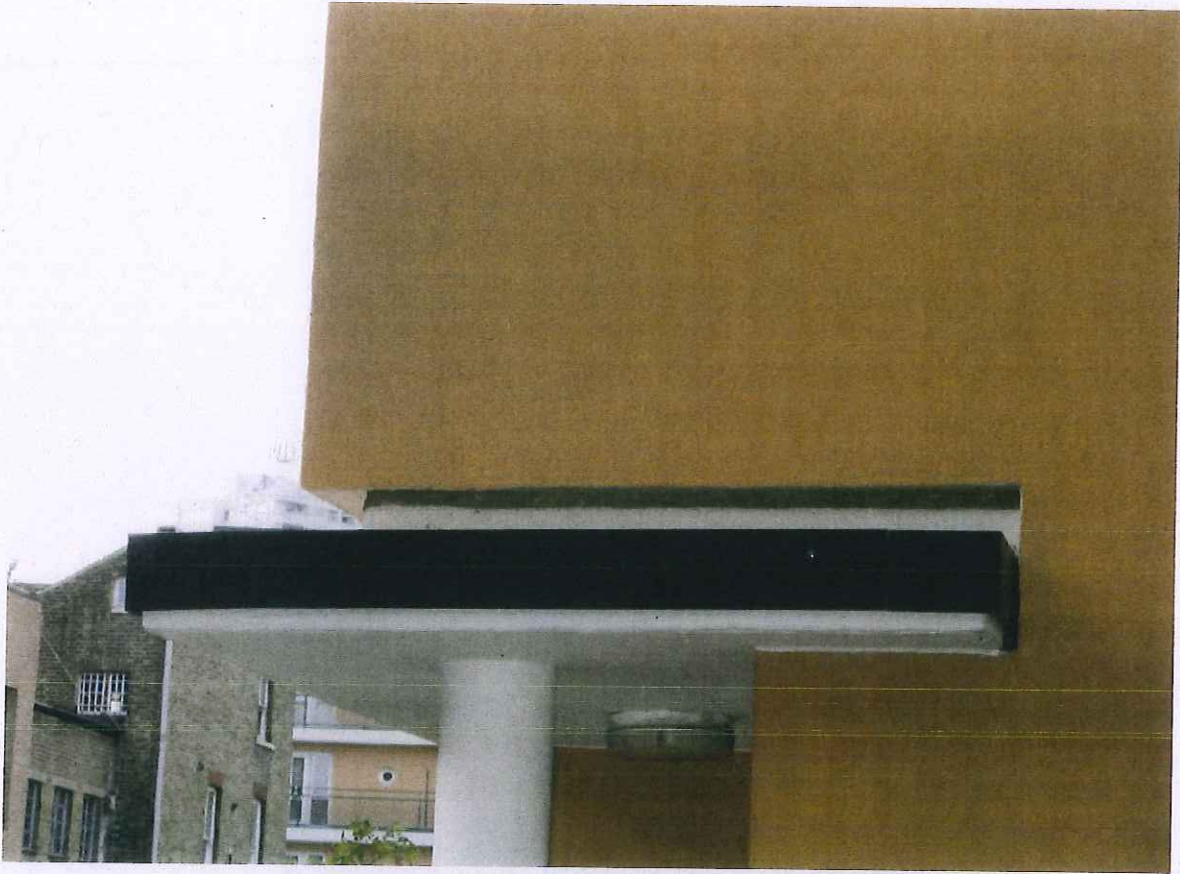
PHOTO 14.

Gap between render and entrance making an unattractive design feature.

THIS IS A STANDARD DETAIL FOR A FLAT ^{OK} ROOF JUNCTION. WE HAVE TO START THE INSULATION ABOVE THE WHITE UPSTAND / FLASHING PLEASE SEE ATTACHED PDF FLAT ROOF. PDF(73KB)

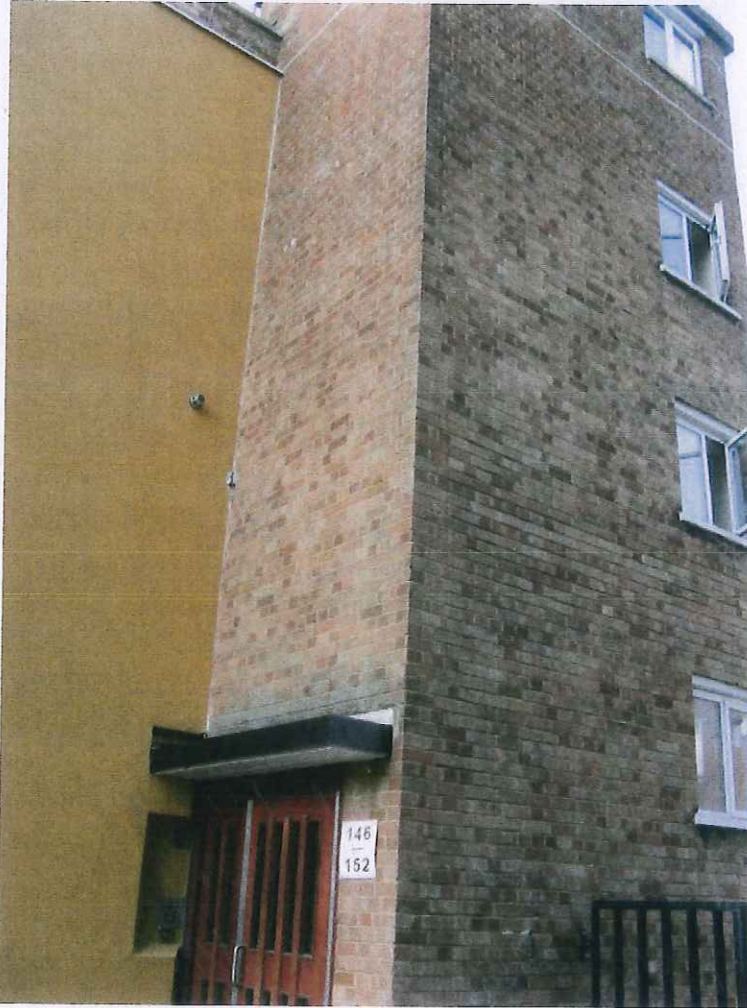
PHOTO 15

New rendering mixed with old brick work.

THIS WAS PART OF A PLANNING REQUIREMENT TO RETAIN EXISTING BRICKWORK.

ALSO THIS IS NON HABITABLE AREA.

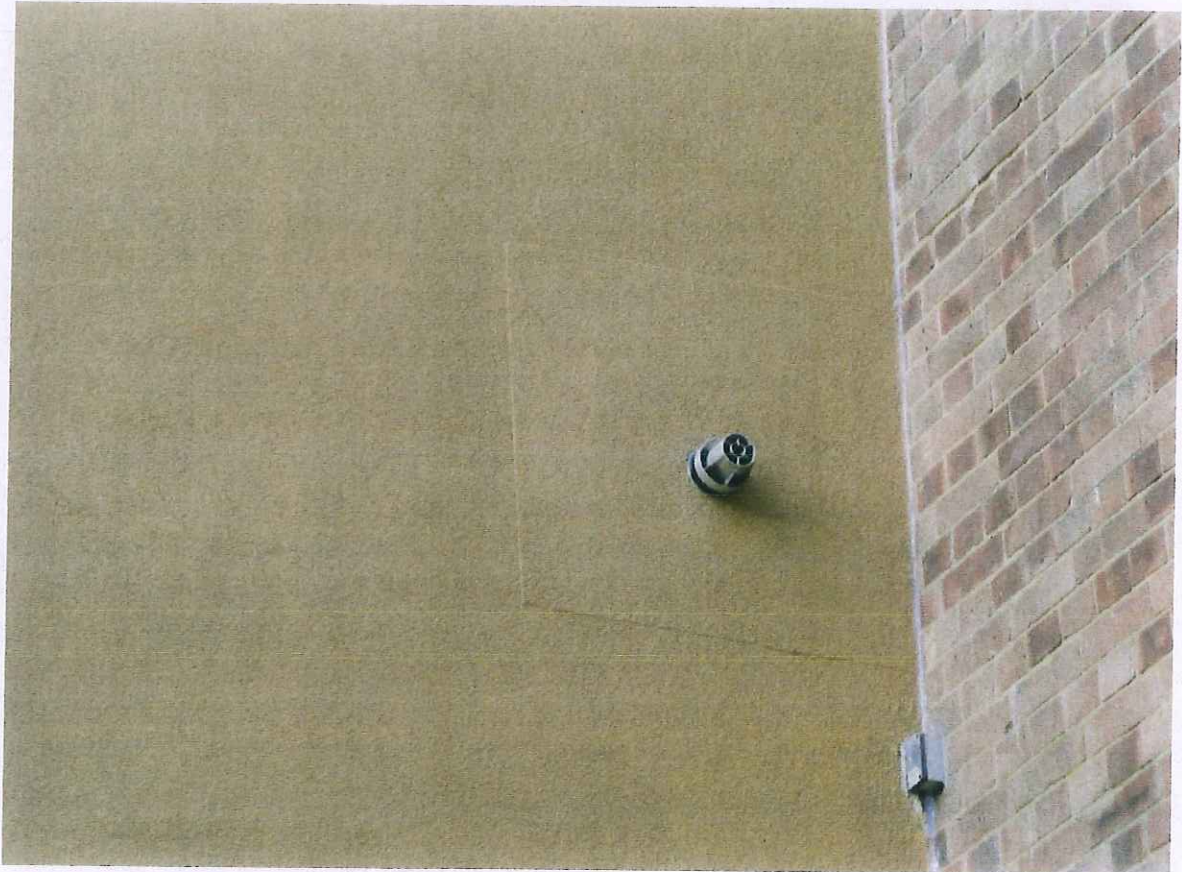
PHOTO 16-

Sticking plaster effect of placing a layer of the same colour on top of another layer around extractor. Poor finishing and design means that the extractor fan is not even central to the "sticking plaster".

THIS IS A STANDARD DETAIL FOR WORKING AROUND
A FLUE AREA WHEN WE DONT HAVE ACCESS.

WE WILL AIM TO REDUCE ANY POSSIBLE VISIBLE LINES

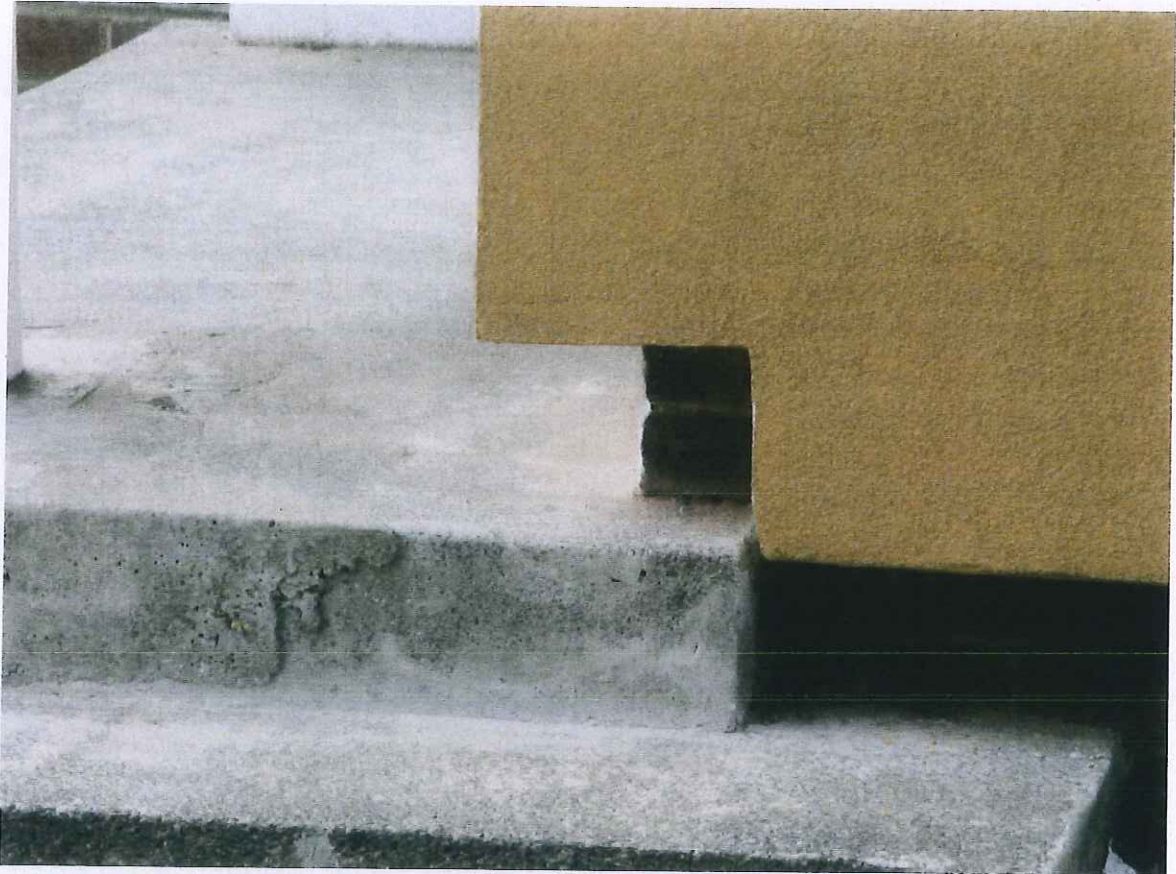
PHOTO 17.

Dangerous sharp edges to left of entrance. Also, an unattractive design feature.

AS PART OF OUR DE SNAGGING AND QM'S THIS AREA WILL BE CLEANED. THIS DESIGN IS A STANDARD EWI DETAIL THAT FOLLOWS THE DPC COURSE.

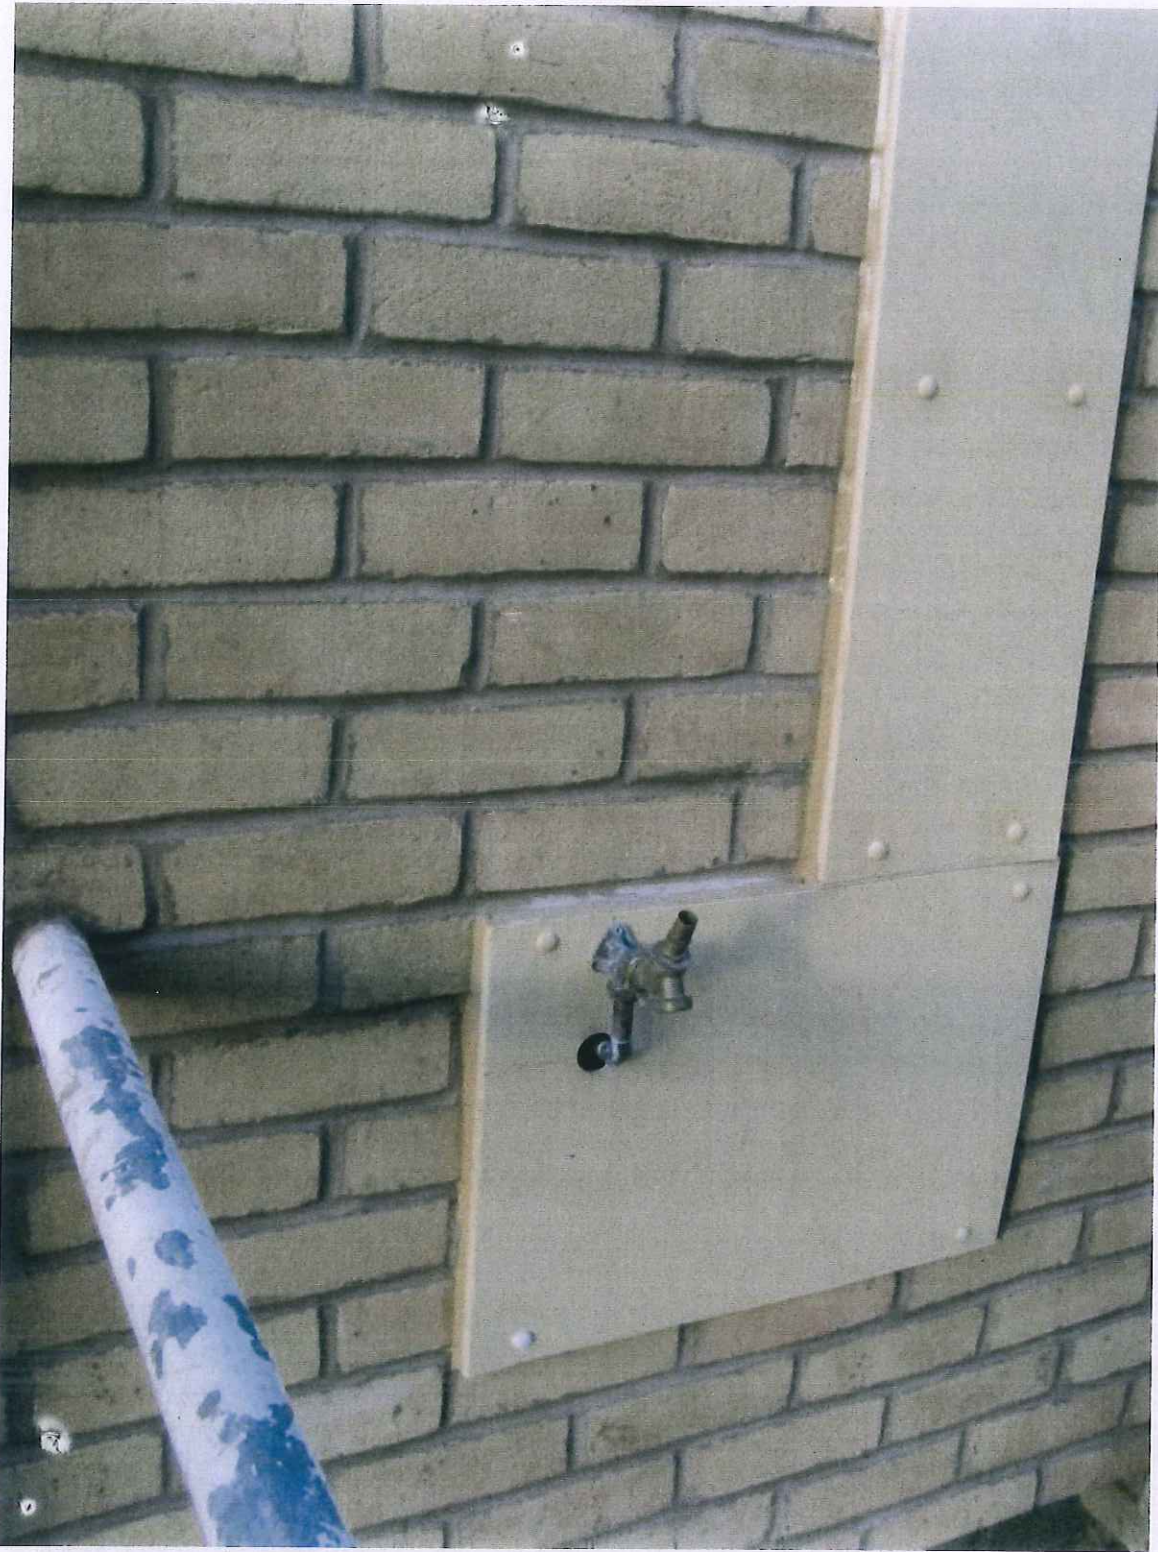
PHOTO 20

Unattractive design
