1 - 42 Ashdown Crescent
Pages 20 - 24

146 - 152 Weedington Road

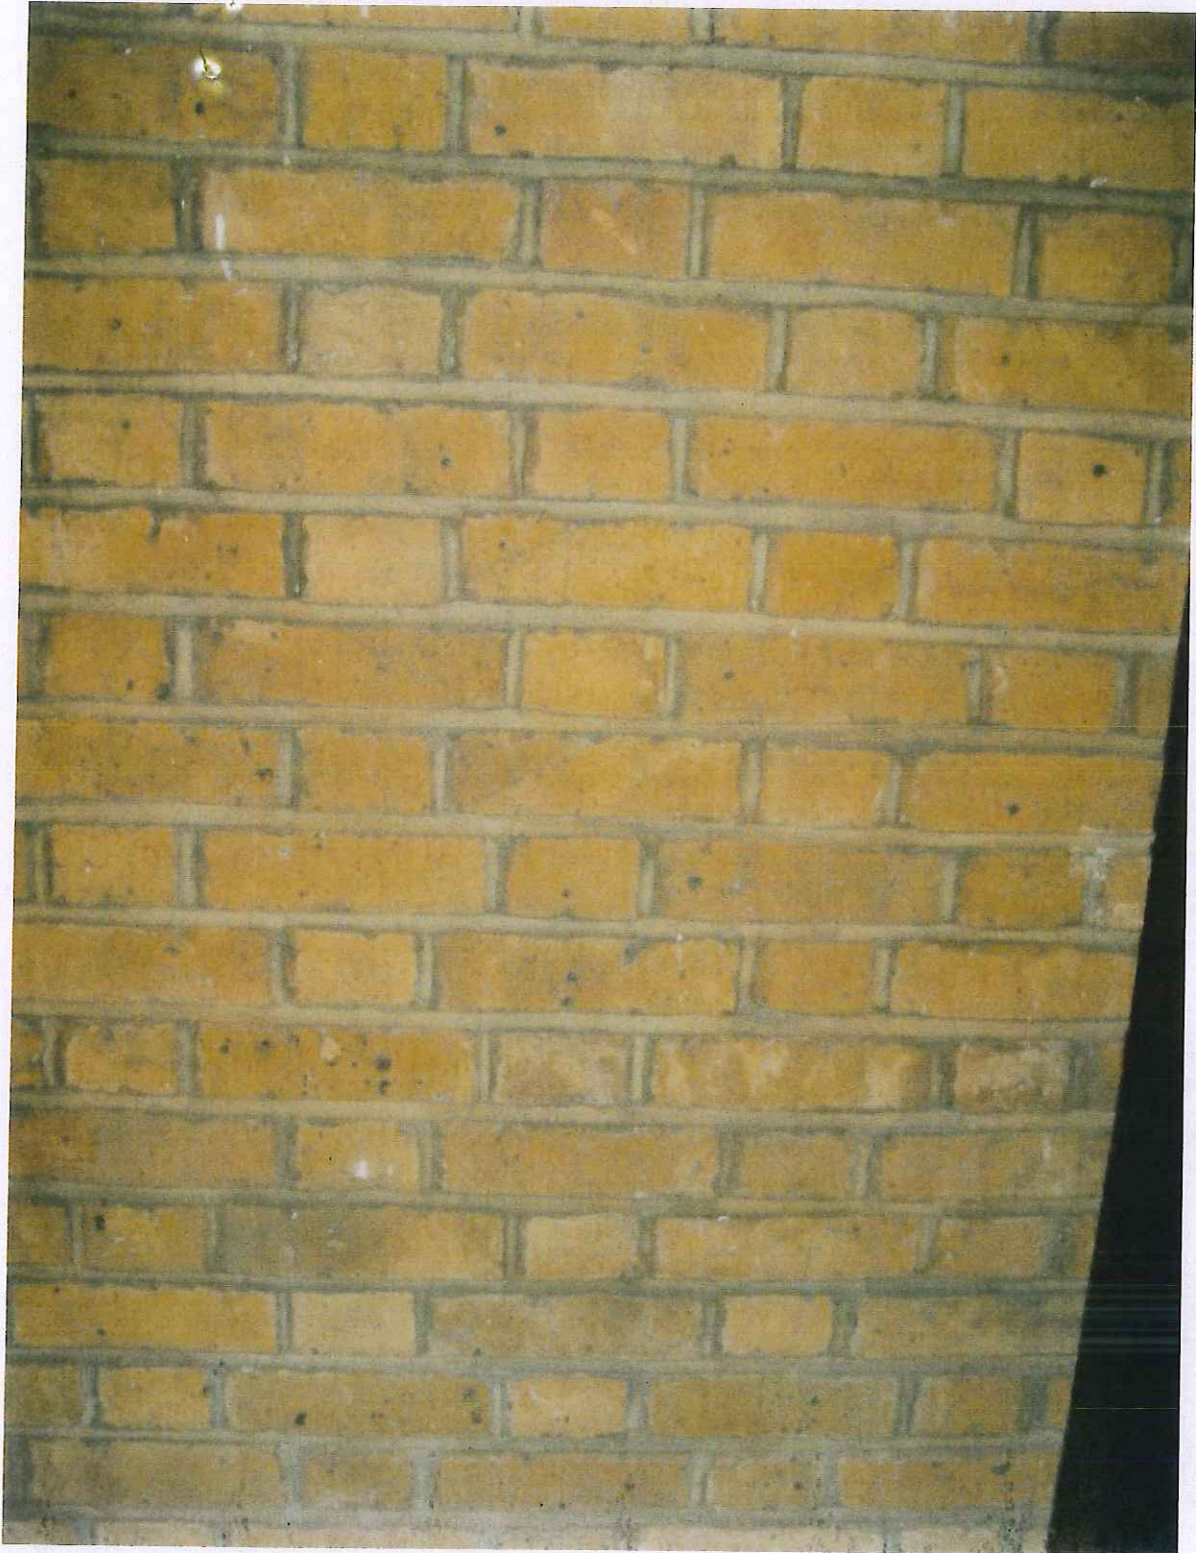
PHOTO 21:

Detail of the last bit of attractive old brick work with well-laid bricks which remains. This has been replaced by what has been shown on the previous pages.

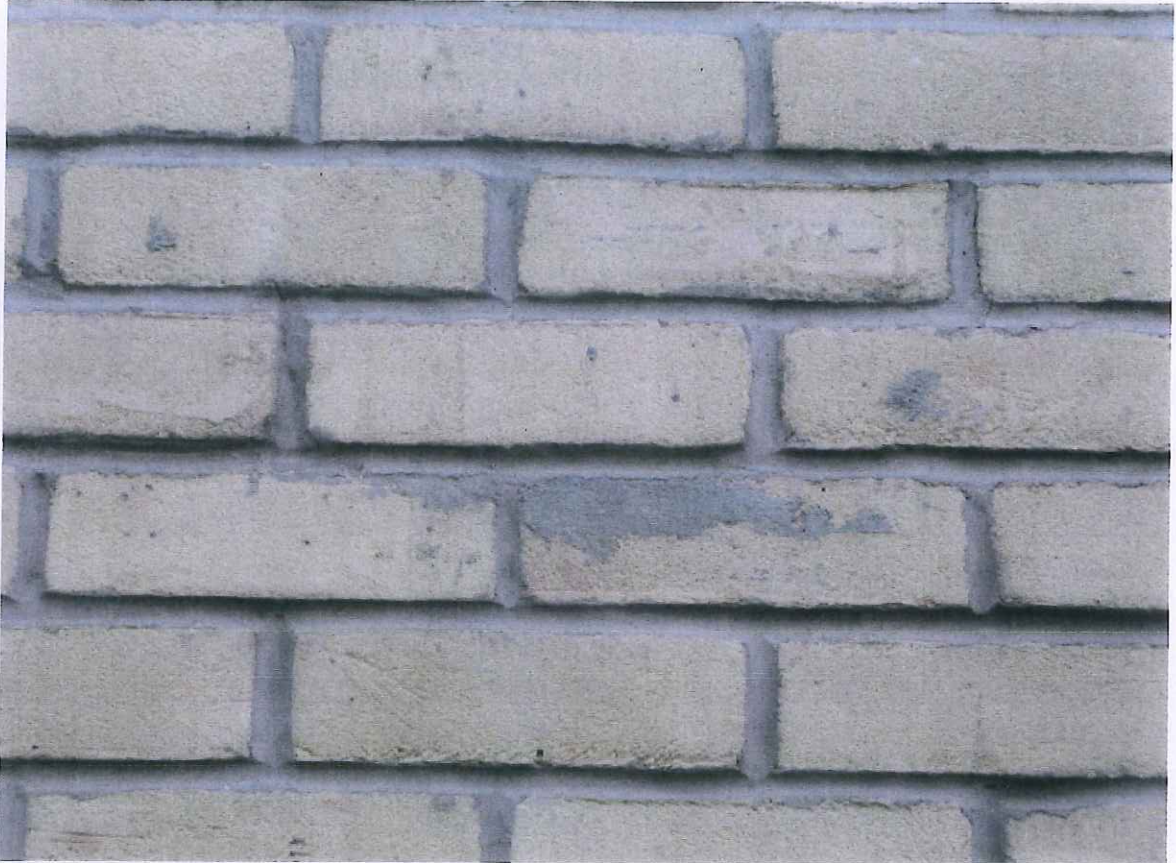
PHOTO 22

Stained brick work

AS PART OF THE RE-SLAGGING & QMS
ALL AREAS LIKE THIS WILL HAVE A MORTAR
WASH

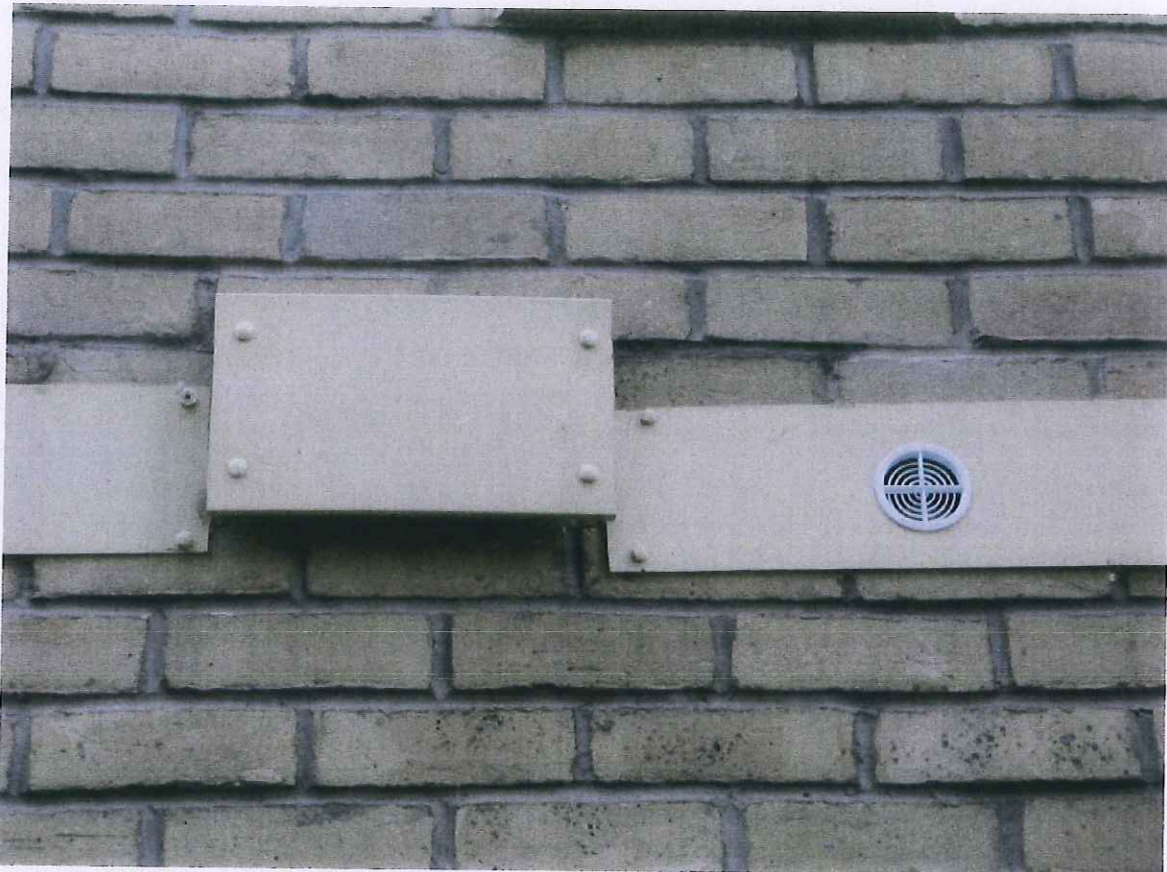
PHOTO 23.

Unattractive design and poorly applied pointing work between bricks.

NB: One of the screw covers is already missing.

AS PER PHOTO 22.
THE SCREEN COVER WILL BE RE-FIT AS PART
OF DE-SNAGGING AND QWAS SIGN OFF.

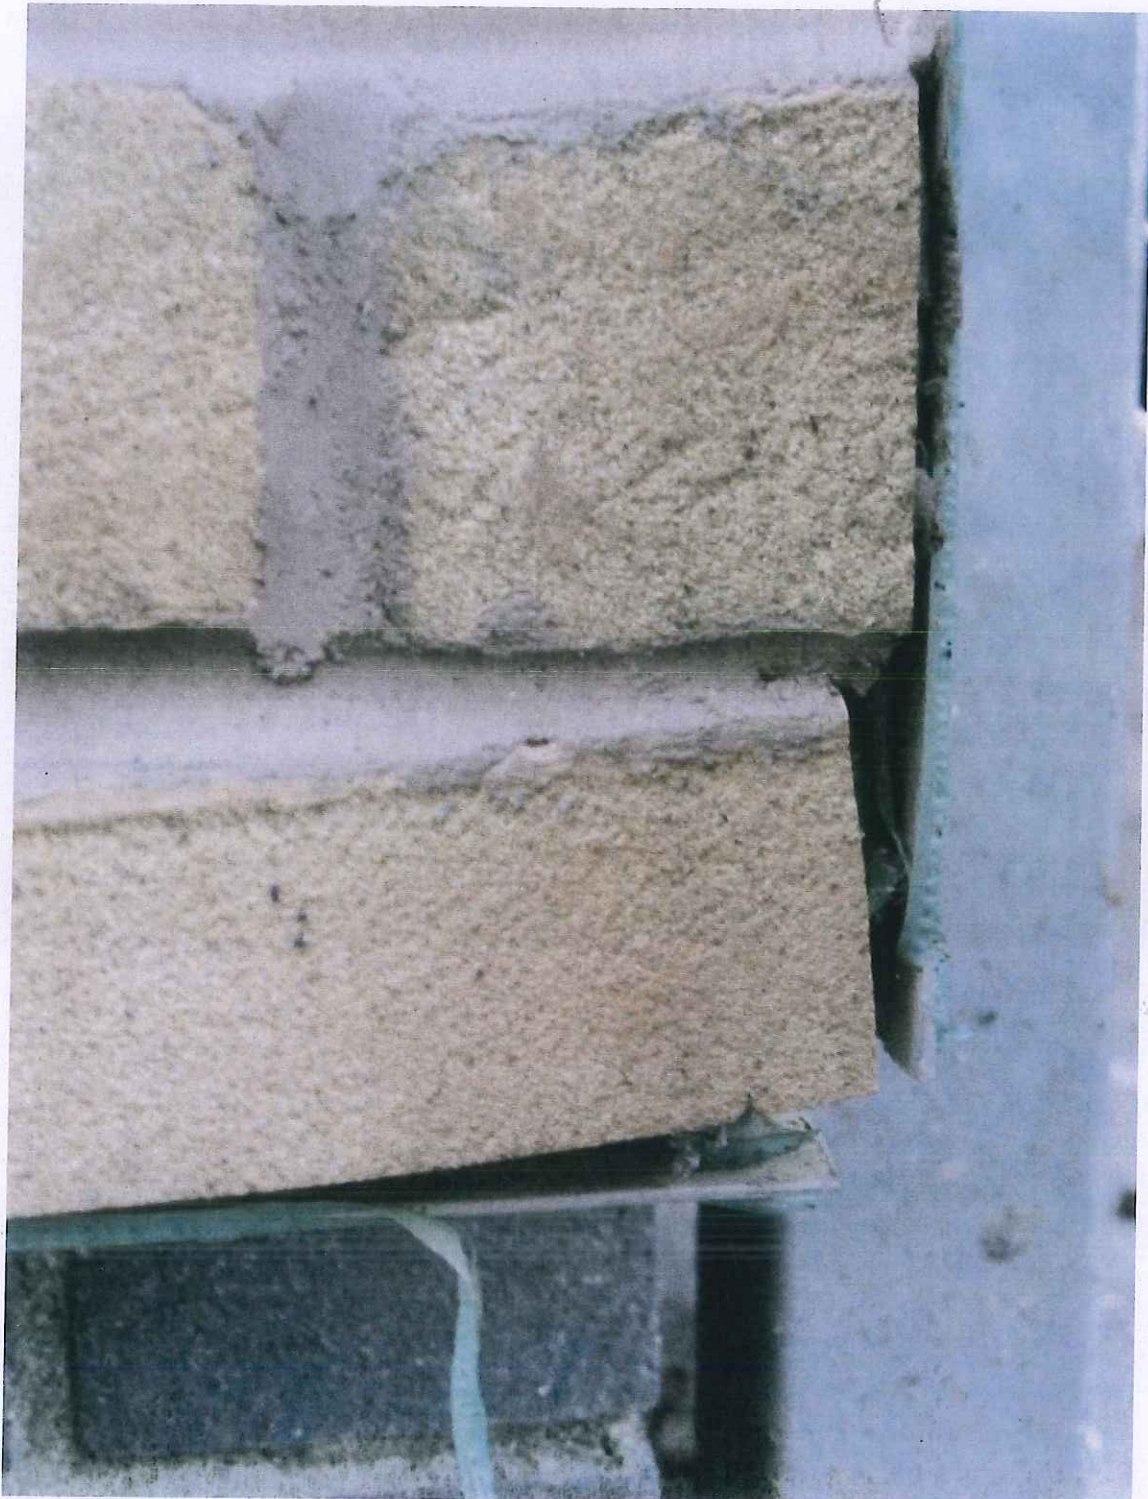
PHOTO 24.

Close up of previous photo.

OUR DE SNAGGING AND QMS SIGN OFF HAVE
ALREADY IDENTIFIED AND COMPLETED THE ABOVE WORKS.

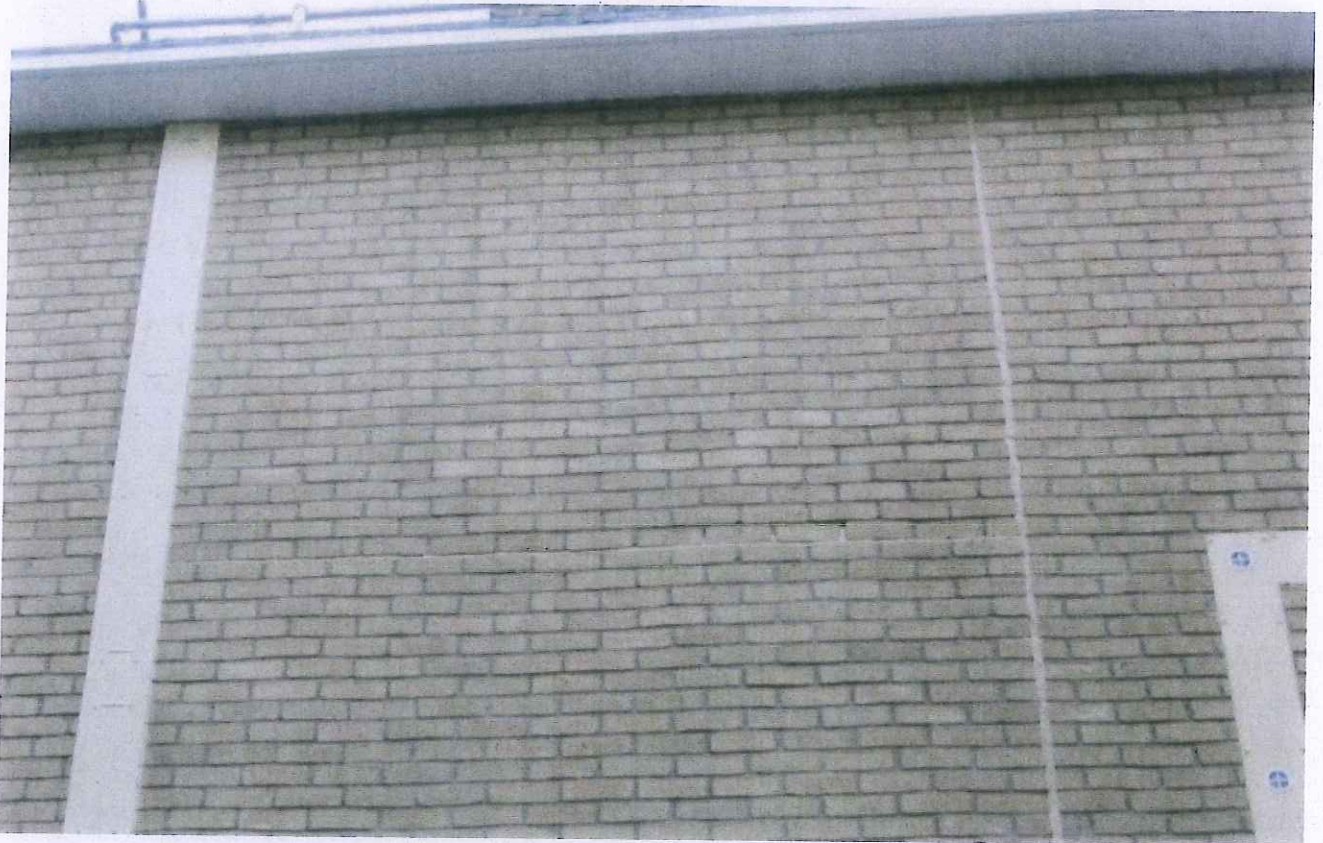
PHOTO 25.

Uneven brick work halfway up side wall.

THIS HAS BEEN SIGNED OFF BY ROCKWOOL, THE SYSTEM MANUFACTURER, LB CAMDEN'S CLERK OF WORKS *ok*.
THE BRICKSLIP ARE HAND CUT AND HAND APPLIED
AND THEREFORE INCONSISTANCIES ARE TO BE EXPECTED.

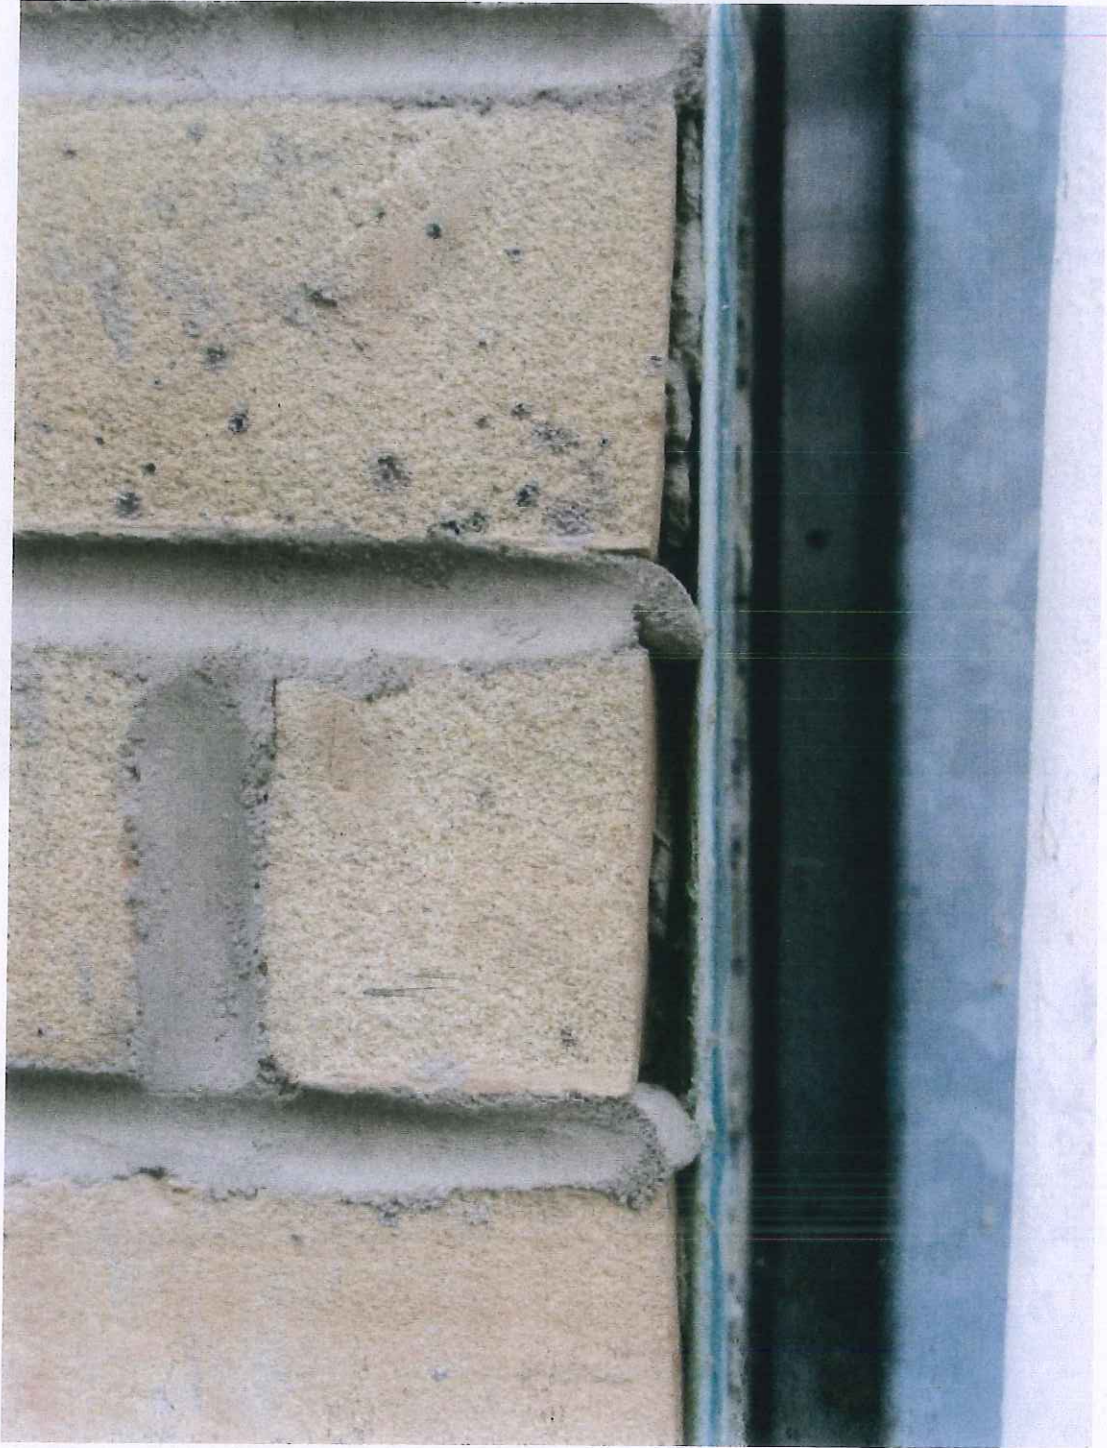
PHOTO 26.

Gap between brickwork and side aluminium sheet. Poor finish of pointing at end of bricks.

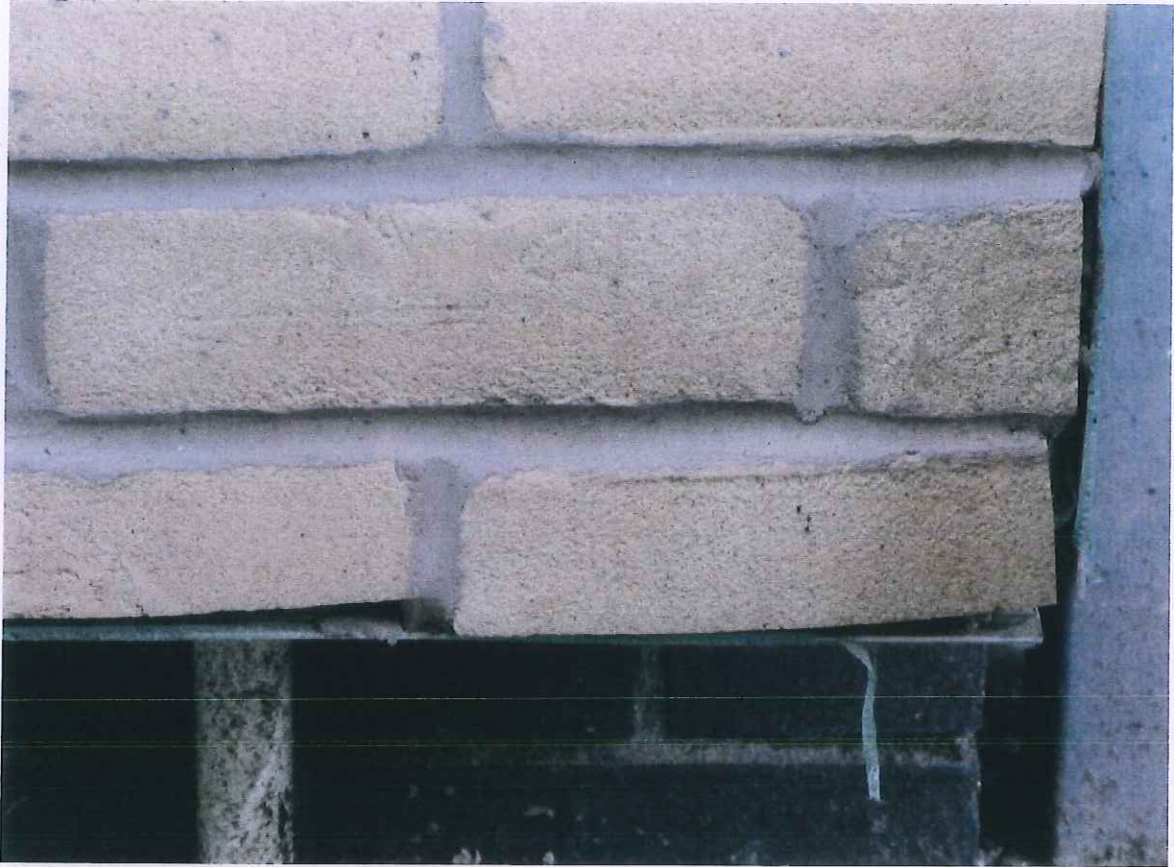
PHOTO 27.

Wonky brick work and gap between aluminium (?) sheet.

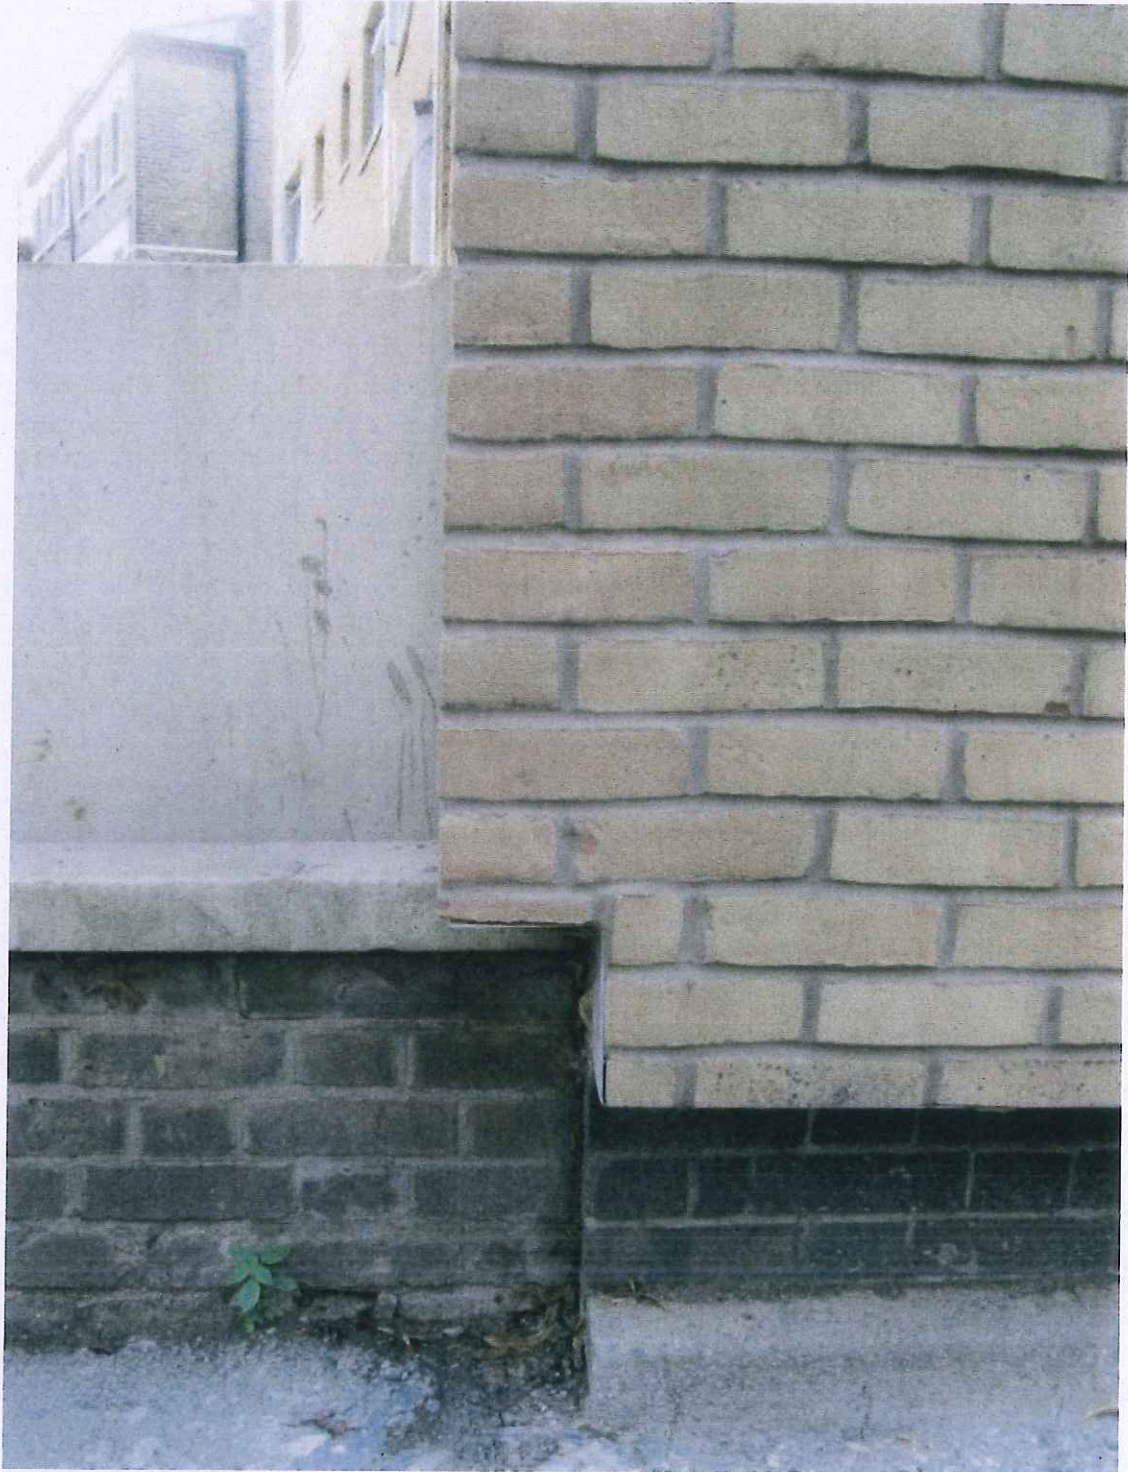
Unattractive design feature. Little thought has been given as to where the brick slips should end (as in what is the normal shape of a brick), or what the shape its cut into will look like once applied. The aluminium on the left does not appear to go right to the end of the slips.

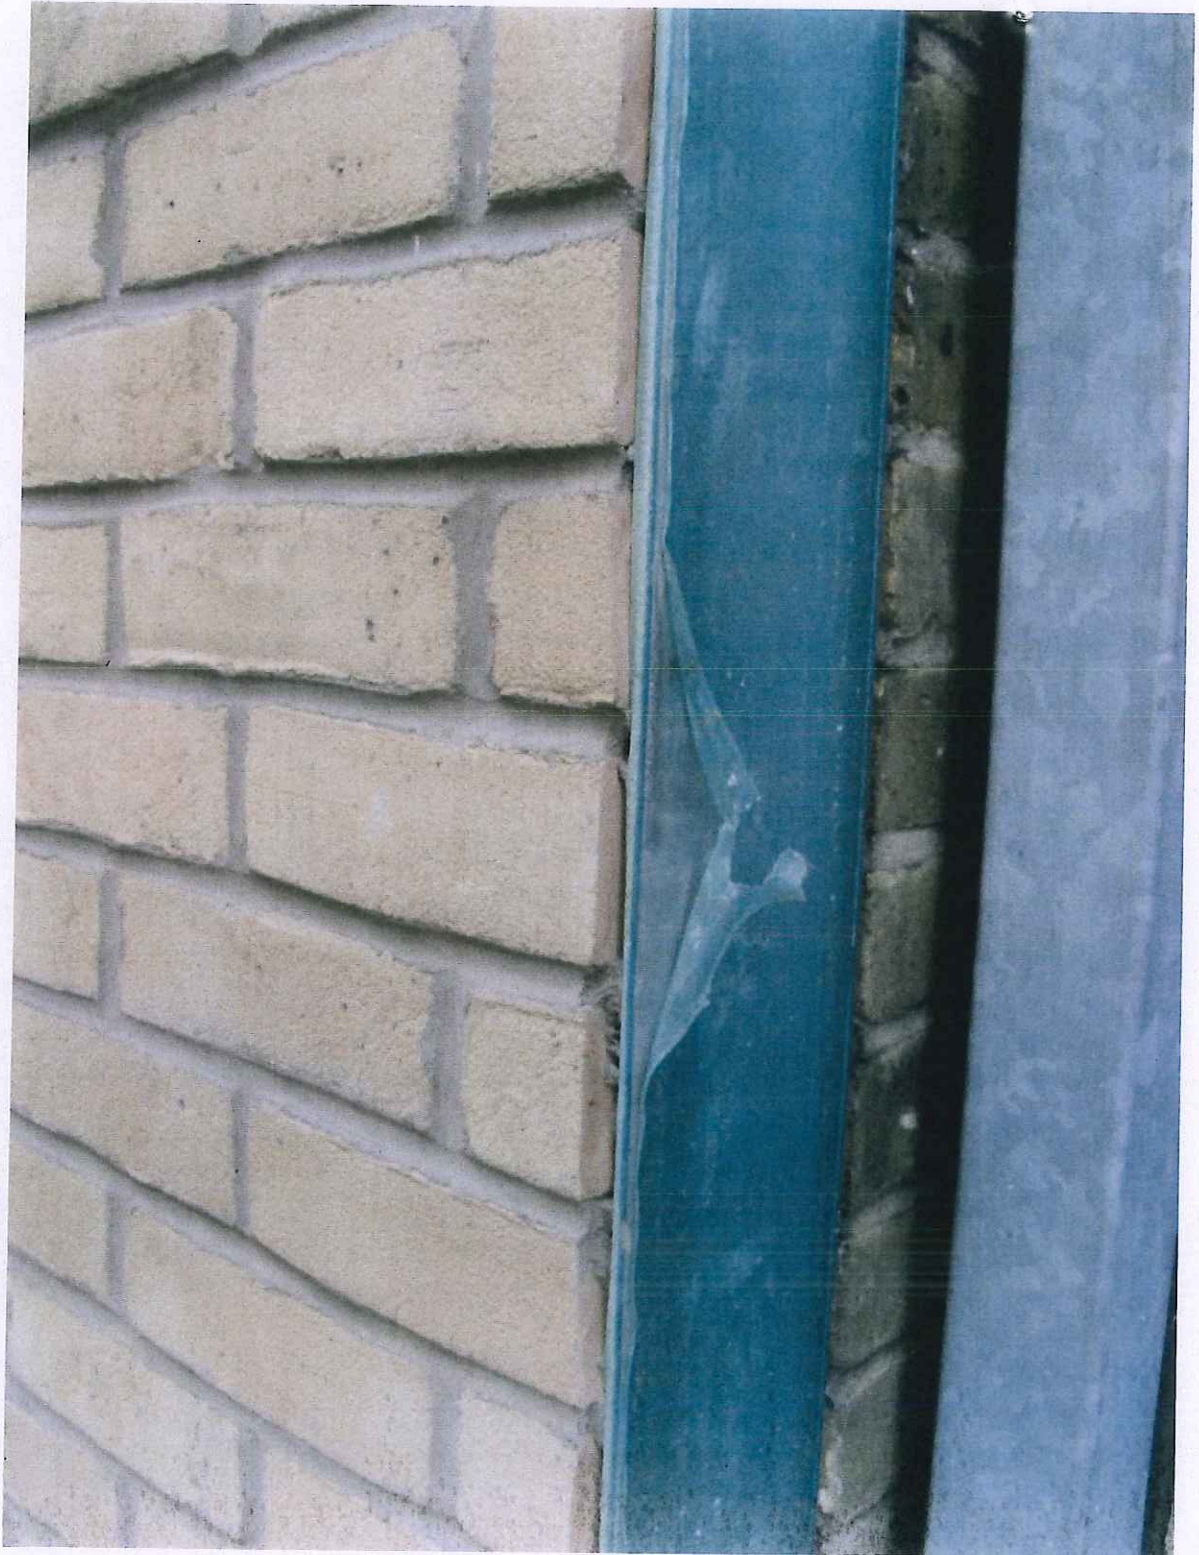
PHOTO 29.

Irregular brickwork – both in terms of how they sit horizontally and how they sit vertically. No-one has bothered to remove plastic from aluminium (?) sheeting.

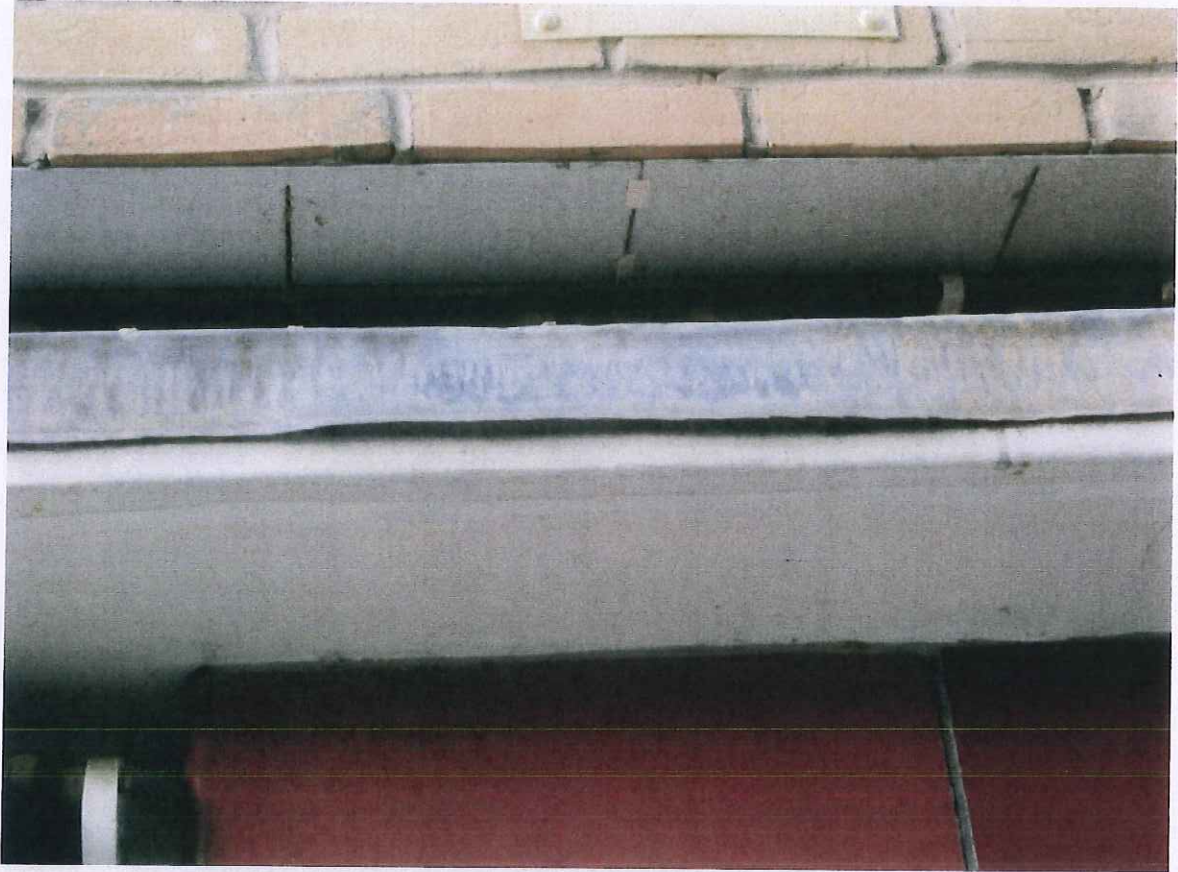
PHOTO 30-

Close up showing wonky brick work and irregular pointing which could allow water penetration.

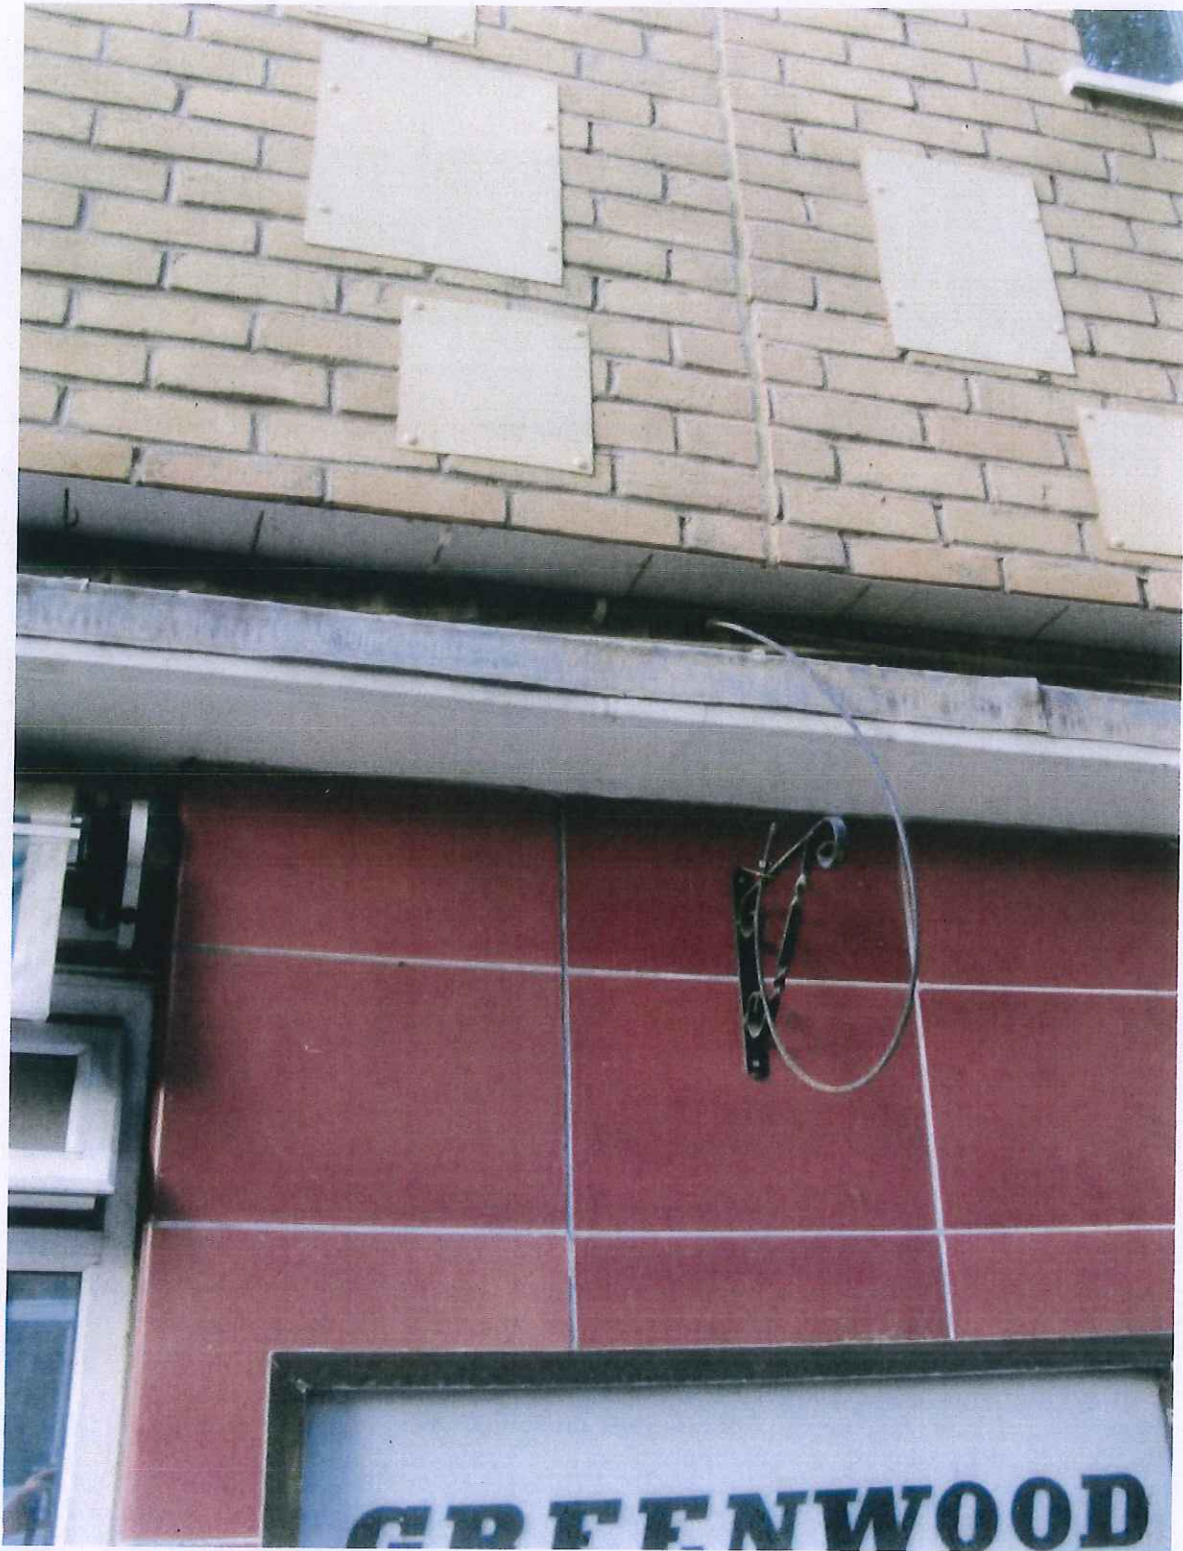
PHOTO 31.

Close up showing metal/plastic fittings which have been attached to brick slips, gap above front entrance and loose wires which have been left hanging down.
